## EMERGENCY REPAIRS RESTORE LPG CARRIER'S B&W 6S50MC MAIN ENGINE IN HOUSTON

### FAST, PRECISION RESPONSE RESTORES LPG CARRIER TO OPERATION

#### PROJECT FACTS: LPG CARRIER MAIN ENGINE

Work Location:	Houston, Texas
Engine Make/Model:	Hitachi Zosen B&W 6S50MC
Engine Output:	6845Kw at 115RPM

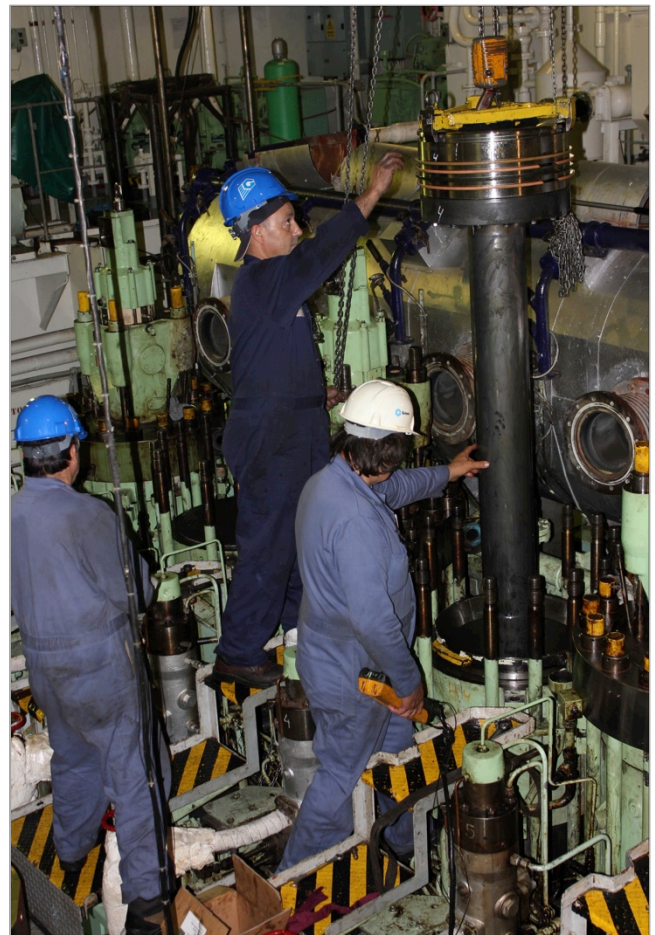
Goltens' technicians installing repaired piston

Shore side workshop and machining services proved to be vital as all six piston rods were removed and taken to the Houston Service Center for machining. Additional machining was required to manufacture spare piston rod spacer plates to replace the missing in-service component and provide the vessel with an onboard spare.

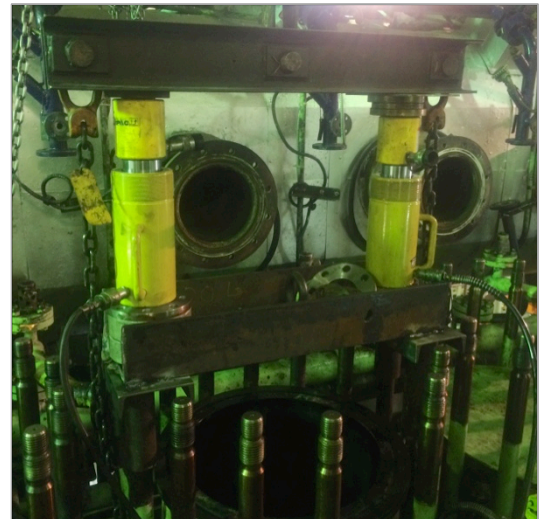
A comprehensive service plan was developed with the vessel's technical management team to perform the work pier side in the Port of Houston. The aggressive repair schedule was initially challenged when the first liners pulled were seized due to sediment build up in the area of the lower block landing surface. Goltens mobilized additional tooling, strong backs and jacks to facilitate the removal of the seized liners. At the request of the vessel, additional service engineers were dispatched and a second shift was run until the schedule was again on track.

Hydraulics employed to remove seized liner

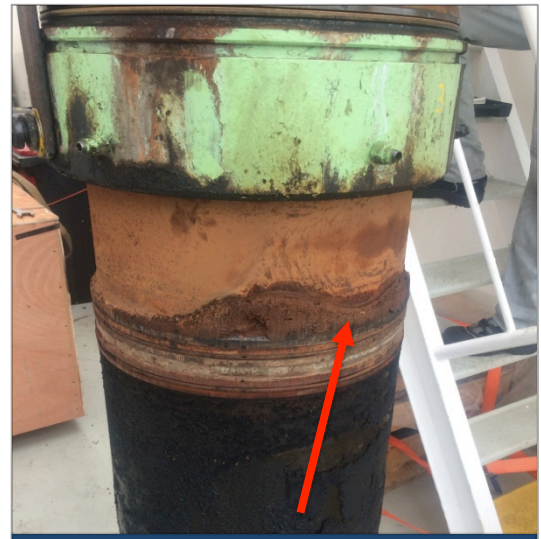
Significant sediment build up on lower liner
