IN-SITU MACHINING AVOIDS COSTLY SHAFT REMOVAL CRANKSHAFT STUB SHAFT REPAIR FOR MAK 12M43C MAIN ENGINE

PROJECT FACTS: Bulk Carrier

Engine:	MaK 12M43C
Engine Output:	14,684 HP (500rpm)
Material removed from Shaft:	4.0mm
Original Shaft Dia.:	450mm
Conical Ratio:	1:50

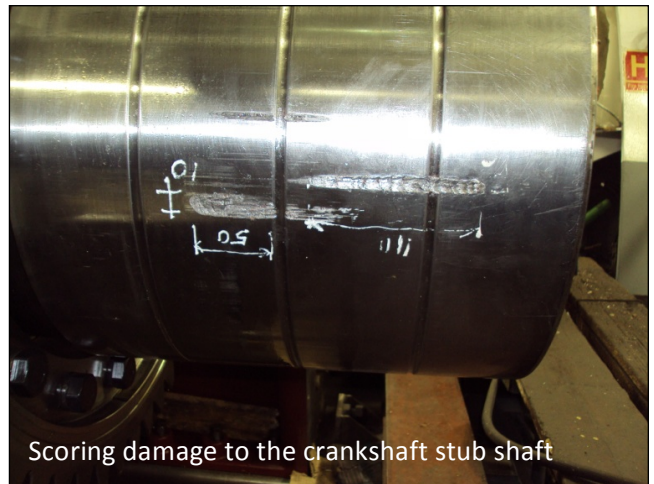
During major overhaul and repairs to the main engine of a 50,619 DWT bulk carrier, serious damage resulted when the flywheel mounting hub was removed from the crankshaft stub shaft. The extent of the scoring damage to the shaft and hub was so extensive that it was not possible to reinstall the hub onto the shaft after overhaul.

Scoring damage to the crankshaft stub shaft

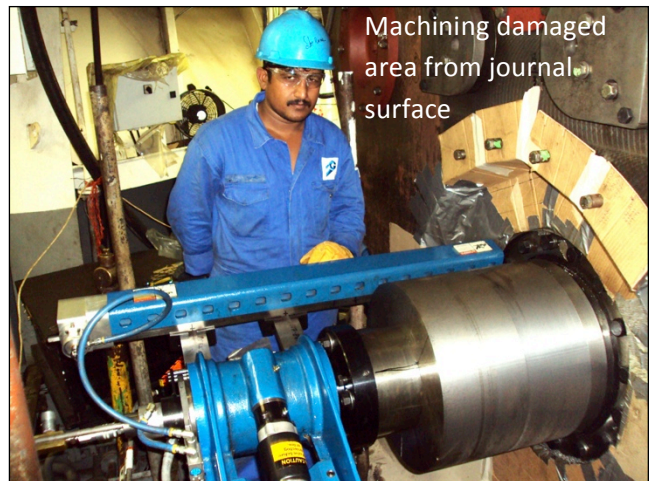
Machining damaged area from journal surface

The first stage of the job was to carry out the removal of the damaged area by in-situ machining. This was successfully carried out using Goltens portable lathe machine, with a total of 4.0mm being machined from the 450mm shaft diameter, the dimensional and surface finish parameters were achieved. This in itself posed difficulties as the 1:50 taper on the shaft had to be maintained to within a very tight tolerance, not only the correct angle but the surface finish was also critical to the correct reinstallation.

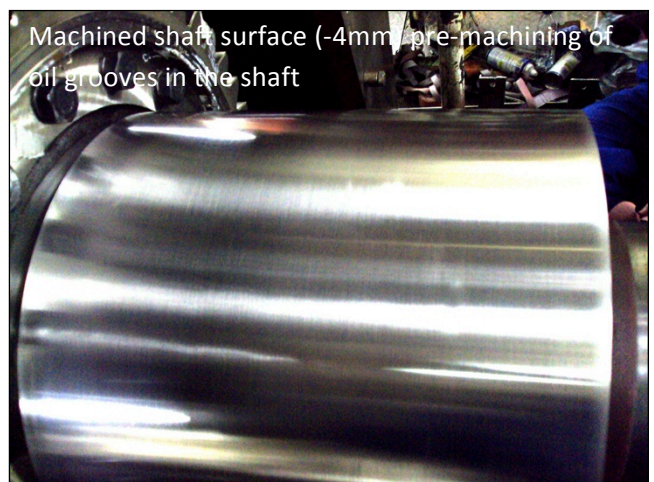
Machined shaft surface (-4mm) pre-machining of oil grooves in the shaft

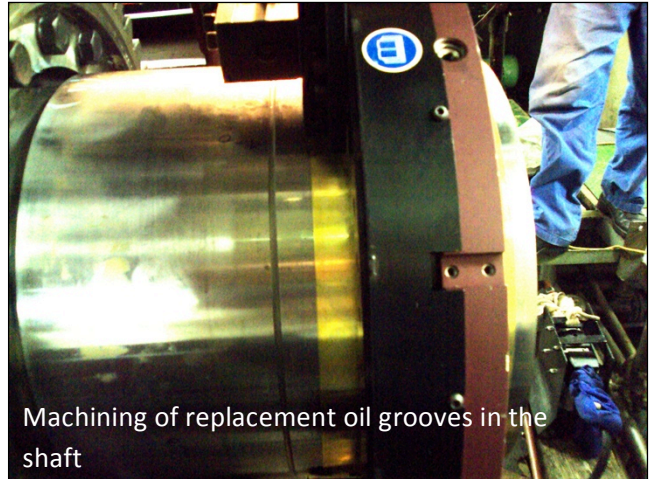
Machining of replacement oil grooves in the shaft

With the surface finish and dimensional tolerance achieved, the next stage was to replicate the oil grooves that had been present before surface machining. This was achieved by utilizing an orbital pipe-cutting machine and a pre-formed tool to achieve the exact form of the grooves.

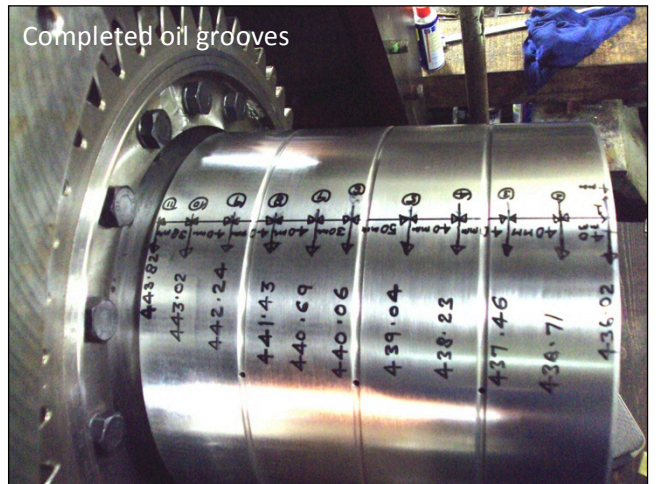
Completed oil grooves

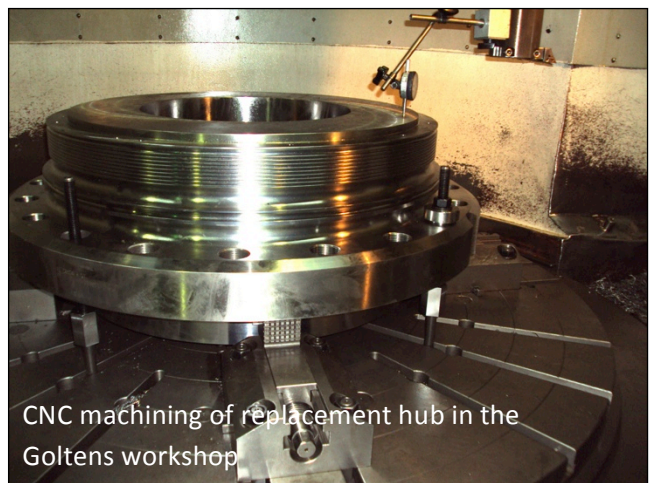
CNC machining of replacement hub in the Goltens workshop

The machining of the taper was carried out on Goltens CNC vertical lathe per the dimensions provided by the maker. The machining was carried out in small increments so as not to risk overcutting the taper. After each cut on the bore of the hub, the earlier made “dummy” was inserted in the bore of the new hub to measure the standoff distance. With the correct standoff distance achieved, the hub was delivered onboard the vessel and installation was carried out by a representative from the engine maker.

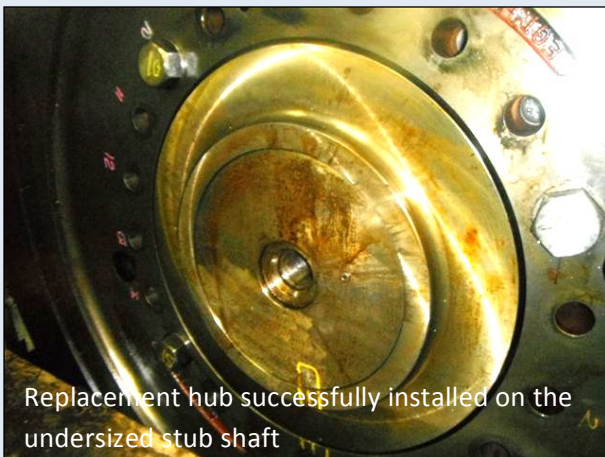
Replacement hub successfully installed on the undersized stub shaft

The installation was completed and the resultant standoff distance was within that specified by the makers. The job was carried out in-situ removing the necessity to remove the crankshaft from the engine and eliminating the extra cost and downtime associated with the disassembly of the engine, transport of the shaft and reassembly of the engine.
