IN-SITU INSPECTION RESULTS IN CRANKSHAFT REPLACEMENT AND COMPLETE OVERHAUL

CRANKSHAFT REPLACEMENT, ENGINE AND TURBOCHARGER OVERHAUL AND LASER ALIGNMENT & CHOCKING ON MAK 6M32C

PROJECT FACTS: M/V KEREM-D

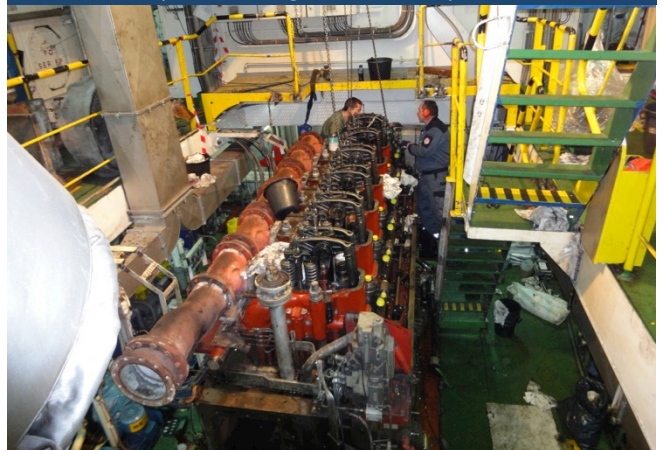
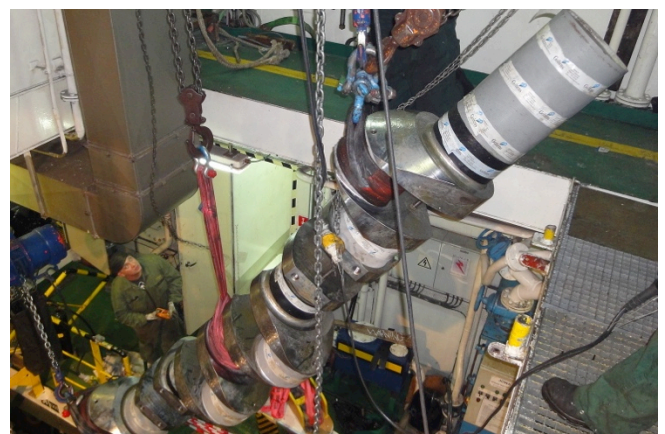
Rigging replacement crankshaft into the engine room

Goltens arranged for the delivery of the replacement crankshaft and overhauled all parts including the turbocharger and air cooler in its workshop.

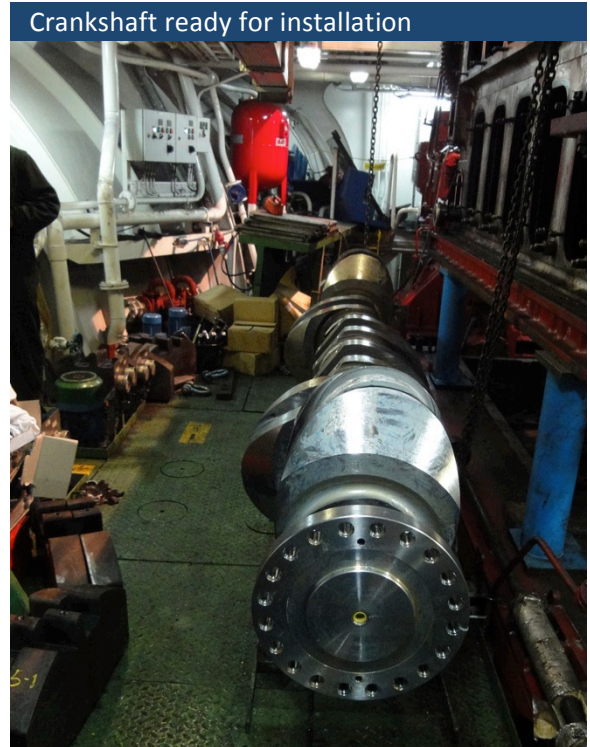
Crankshaft ready for installation

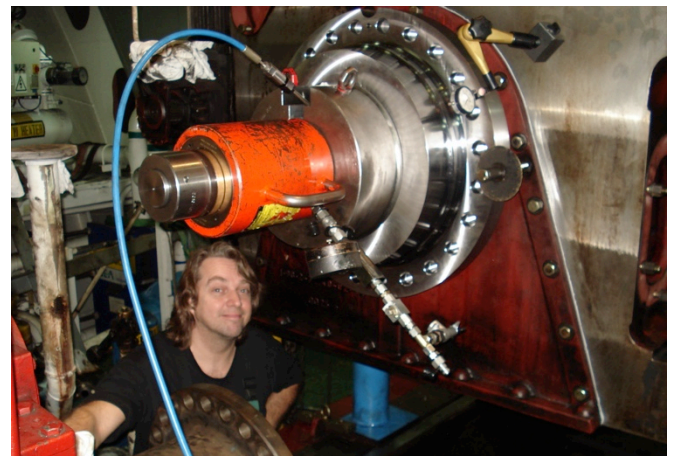
Preparing hydraulic installation of the flywheel hub

With specially designed hydraulic tools, Goltens removed the flywheel hub from the crankshaft and reinstalled the flywheel hub on the replacement crankshaft.
