RENEWAL OF CAMSHAFT CHAINWHEEL SPROCKET ON HYUNDAI-MAN 2-STROKE ENGINE

HYUNDAI-MAN B&W 10K98MC-C 2-STROKE ENGINE REPAIR AT ANCHORAGE IN SINGAPORE

M/E CAMSHAFT REPAIR

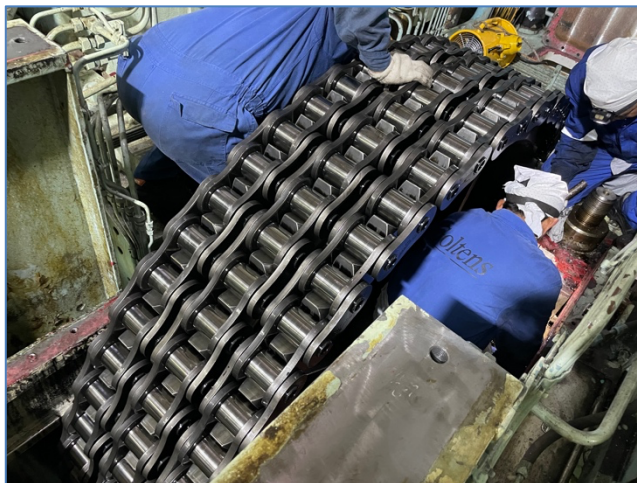
Top Cover removed

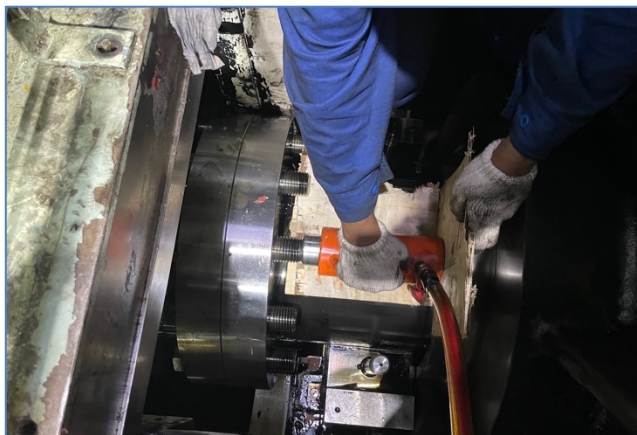
Jacking out fitted bolts

Goltens' specialists performed a check of the injection timing before and after the chainwheel prior to removing the chain. They placed the crankshaft so that unit 1 was at top dead center before removing all the fitted bolts with hydraulic jacks. They then loosened the chain and removed the chain linkage and removed the camshaft bearing cap before removing the Chainwheel Sprocket for transport to Goltens' workshop.

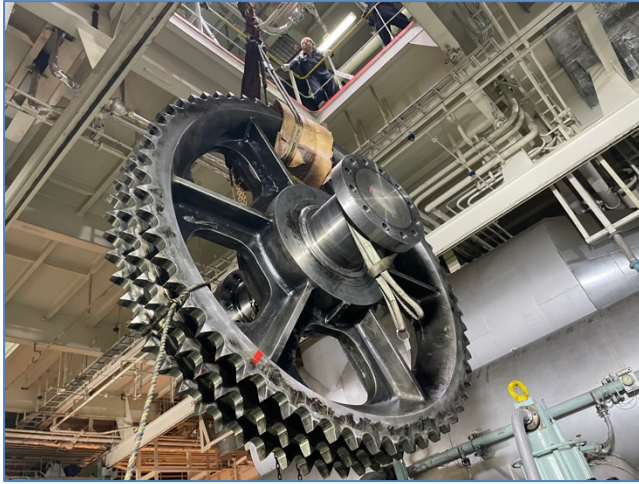
Rigging of Chainwheel Sprocket from the engine room

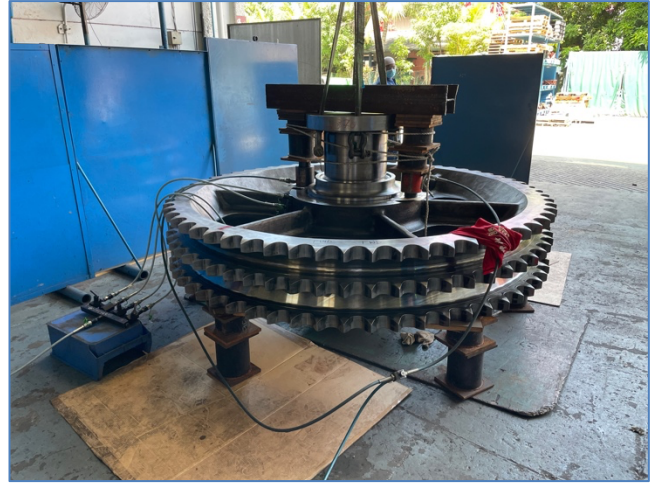
Attempt to jack out Chainwheel Sprocket Shaft

At the workshop, Goltens attempted to jack out the shaft from the sprocket but were forced to machine the shaft to remove it. Chainwheel bore and new shaft diameters were measured to calculate the interference clearance before heating the bore side to 250°C and Chainwheel side 130°C to install the new shaft. Finally, the damaged bearing housing was machined and a new thrust collar installed.

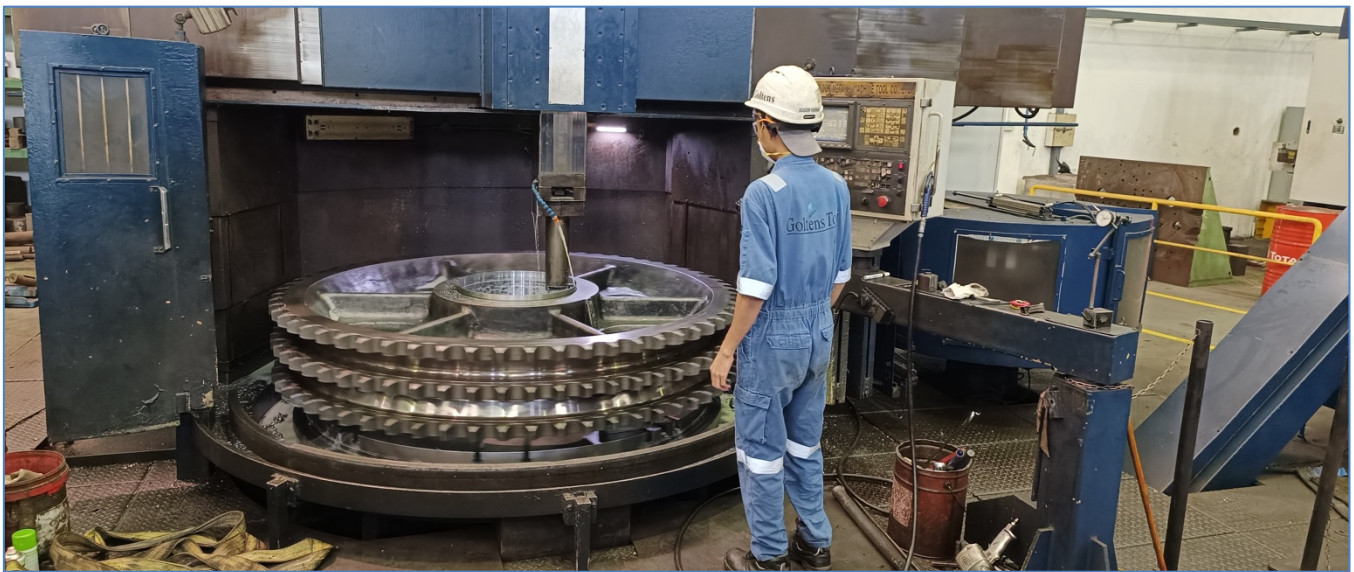
Machining out Chainwheel Sprocket Shaft

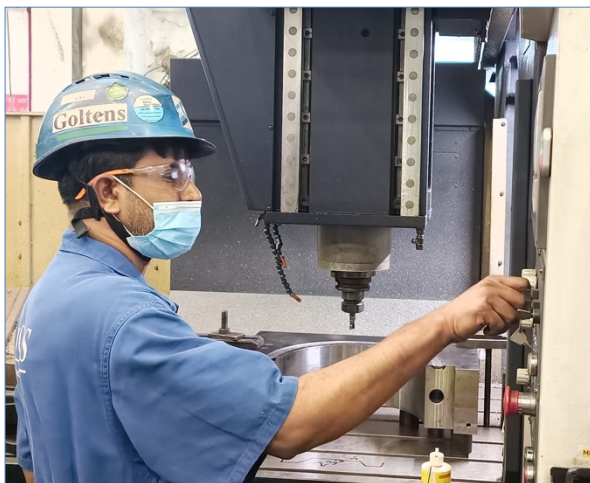
Machining of thrust collar

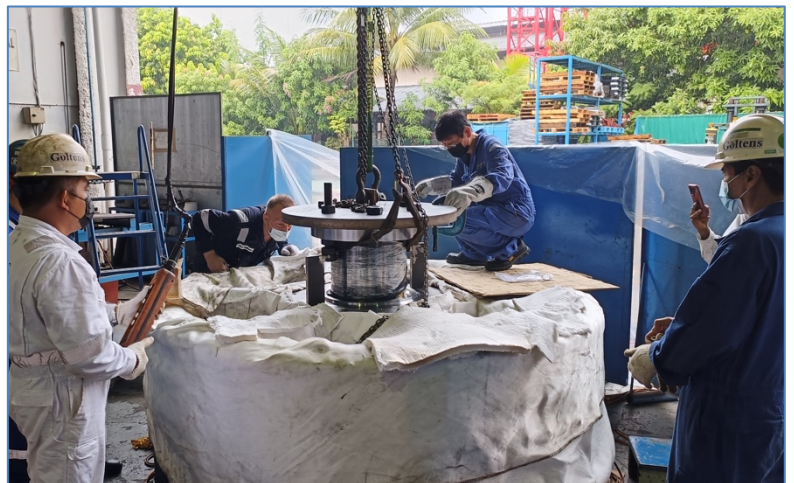
Installation of new Sprocket Shaft

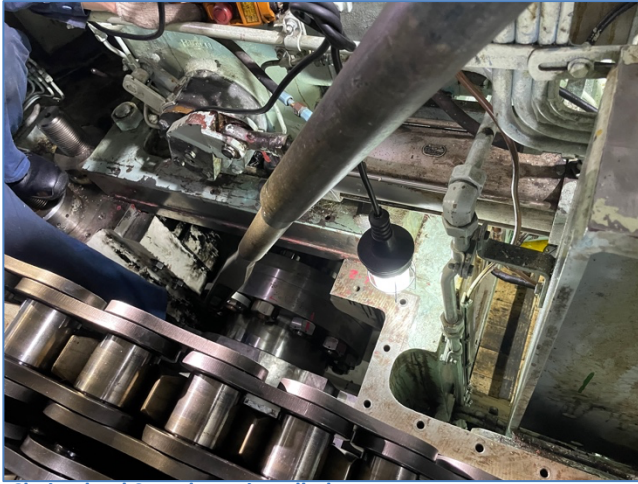
Chainwheel Sprocket reinstalled

The chainwheel and bearing housing were then returned aboard and installed with shaft alignment and recentering of the bearing housing to ensure failure doesn't recur. Bolt holes were reamed and fitted bolts installed before installing the chain linkage and adjusting the tension.

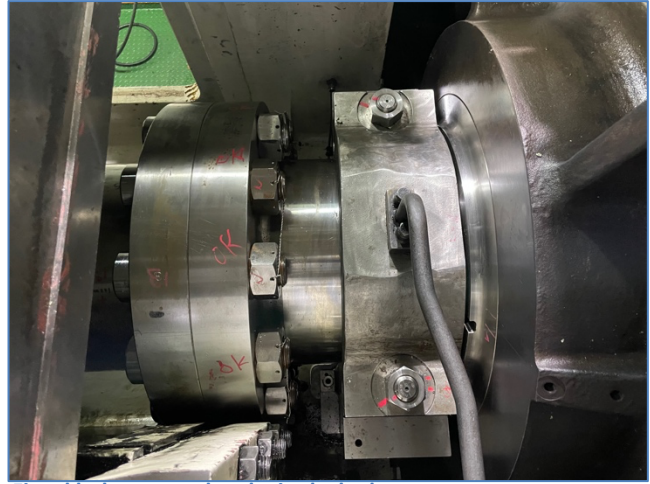
Fitted bolts torqued and wire locked

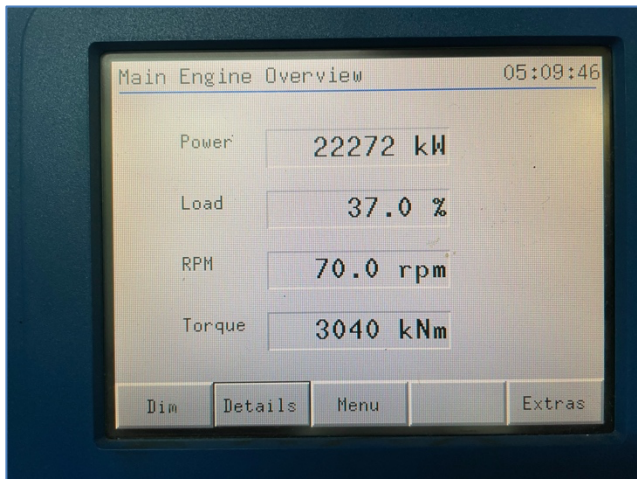
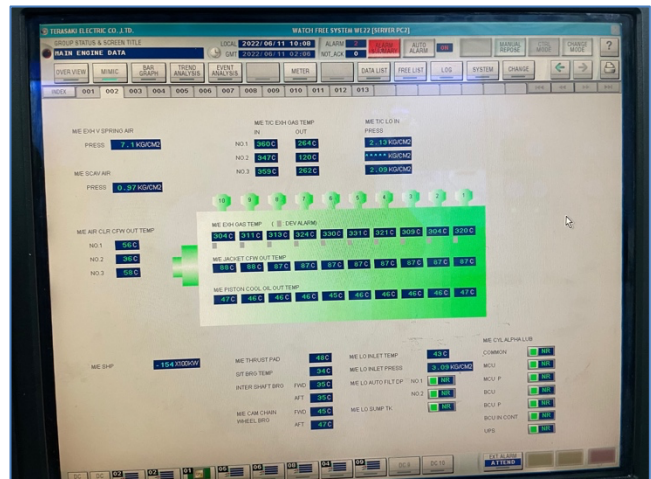
Satisfactory results from sea trial after repair completed
