BERGEN CRANKSHAFT REPLACEMENT ON GENERAL CARGO SHIP

MAIN ENGINE: BERGEN 32:40L9P

PROJECT FACTS: CRANKSHAFT RENEWAL

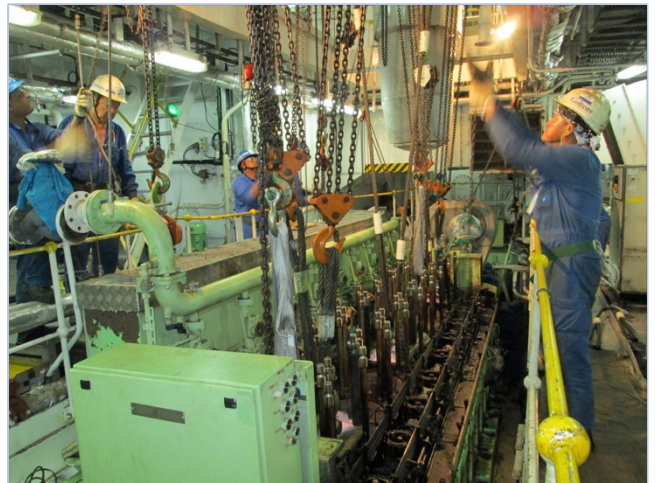
Lifting arrangements for block and crankshaft

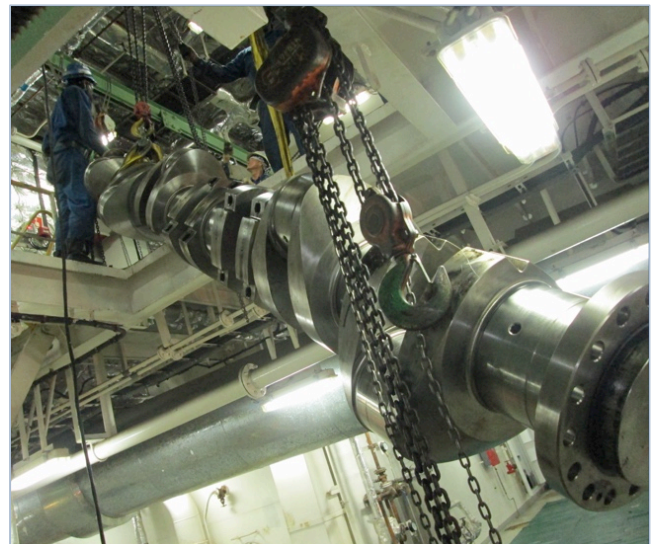
The cargo ship SE Cerulean suffered a major crankshaft failure on its port side main engine. As the maximum allowable undersize for this crankshaft was only 2.0mm, the owner decided to replace the crankshaft rather than try to salvage it by machining.

Rigging damaged crankshaft from the vessel
