IN-SITU ANNEALING SAVES MAK 8M32 CRANKSHAFT COSTLY CRANKSHAFT REPLACEMENT AND EXTENDED DOWNTIME AVOIDED

Caribe Mariner

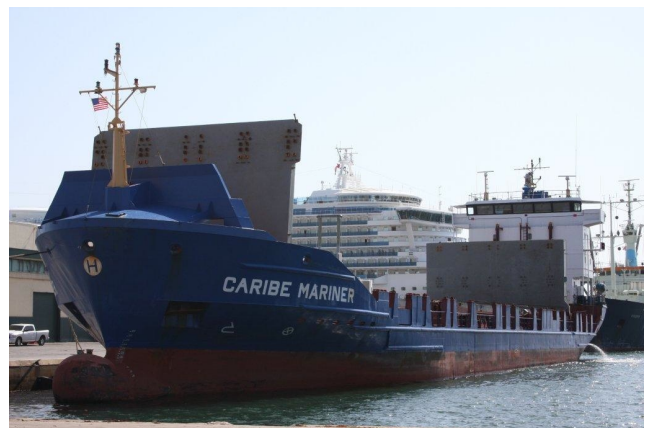
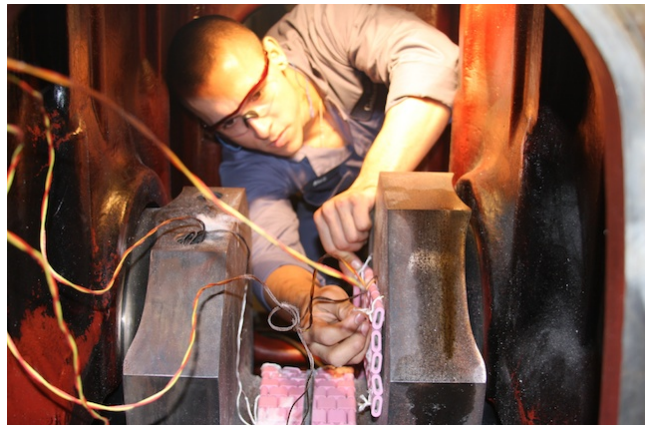
The inspection revealed the journal had 0.5mm Ovality, cracks on the bottom side of the pin, run-out of .03mm and areas of high hardness up to 650HB. Complicating this repair was the 280.00mm journal could only be reduced by a total of 3.00mm and remain within MaK specifications.

Goltens removed 1.0 mm and a full assessment showed that some cracks remained and hard spots remained above 600 HB. After a further 0.5mm, the remaining cracks were removed but the hardness had not abated.

- Removed 1.50 mm from crankshaft prior to annealing
- Annealed crankshaft to reduce hardness to a maximum of 308BHV, well within MaK limits
- Removed a final 0.5mm after annealing to finish the journal at 278.00mm (-2.00mm undersize)
- Superpolished crankpin journal to acceptable roughness limits
