SLIP RING IN-PLACE MACHINING RETURNS COAL FIRED STEAM TURBINES TO SERVICE

43-YEAR-OLD BBC TURBINE GENERATOR

PROJECT FACTS: SLIP RING MACHINING

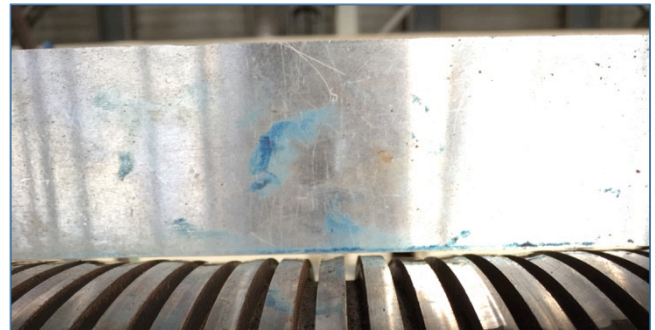
Goltens Rotterdam's in-place machining experts got the call to machine two sets of slip rings on a 43-year-old BBC generator with heavily worn slip rings. Evaluation with a straight edge showed a highly uneven wear pattern across the surface of the slip rings that required rectification.

Uneven wear surface on slip ring

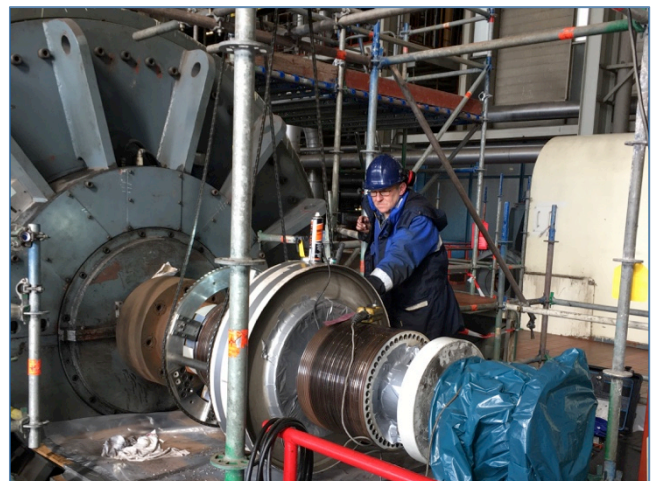
Machining slip ring with single point cutter

Goltens deployed its single point journal cutting tools to the site and began the process of returning the running surfaces to an even condition.

The two sets of slip rings had been subject to previous machining repairs and were of differing outside diameters before the repairs. Also, the extent of the wear on the slip rings was uneven and each set required a differing amount of material to be machined away to get to a clean, full contact surface.

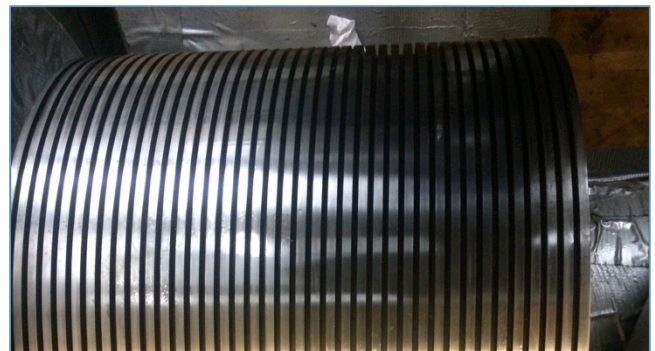
Final machined slip ring with finish of 1.0Ra

The entire repair was completed inside of 5 days onsite inclusive of waiting and staging. Both sets of slip rings were machined to a surface finish of 1.0Ra in accordance with the manufacturer's specifications and the turbine generator was returned to service.
