MECHANICAL & ELECTRICAL RESTORATION - FIRE DAMAGED CONTAINERSHIP

YANMAR 6EY26L AUXILIARY AND MAN 7L70MC-C MAIN ENGINE REPAIRS

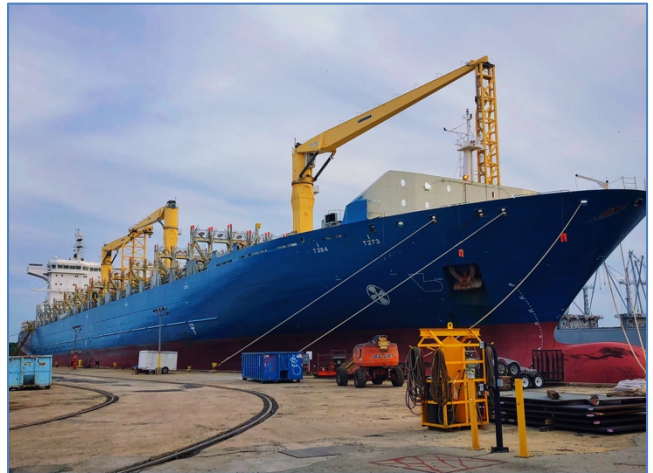
Figure 1: Fire damaged containership alongside in Philadelphia

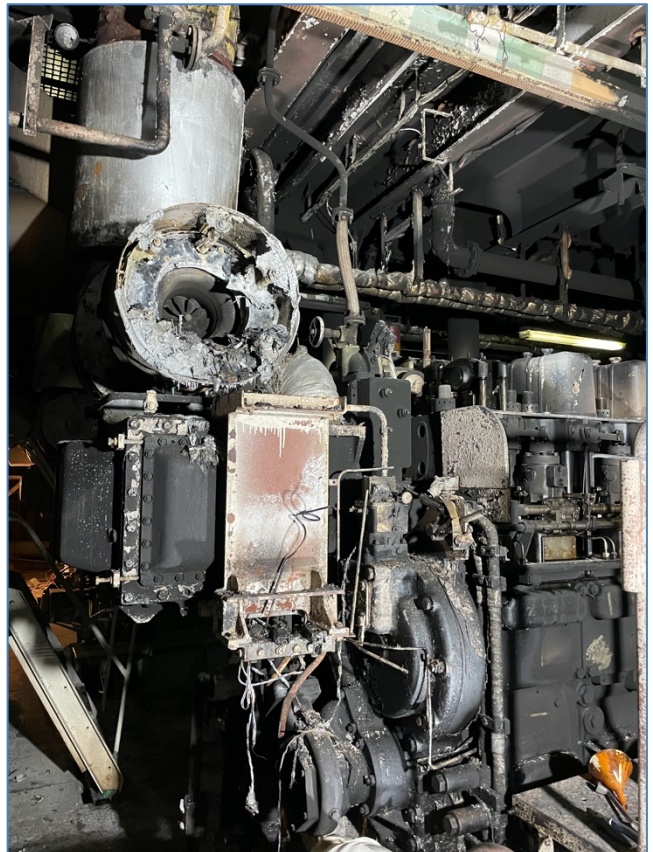
Figure 2: Extensive fire damage on DG#3

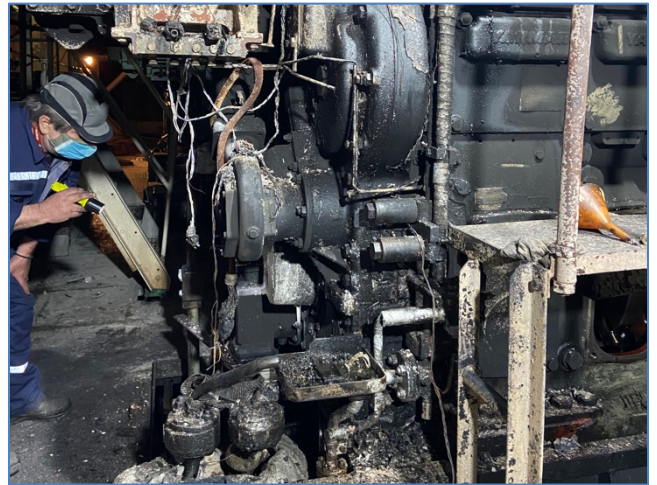
Figure 3: Inspection of DG#3 damage

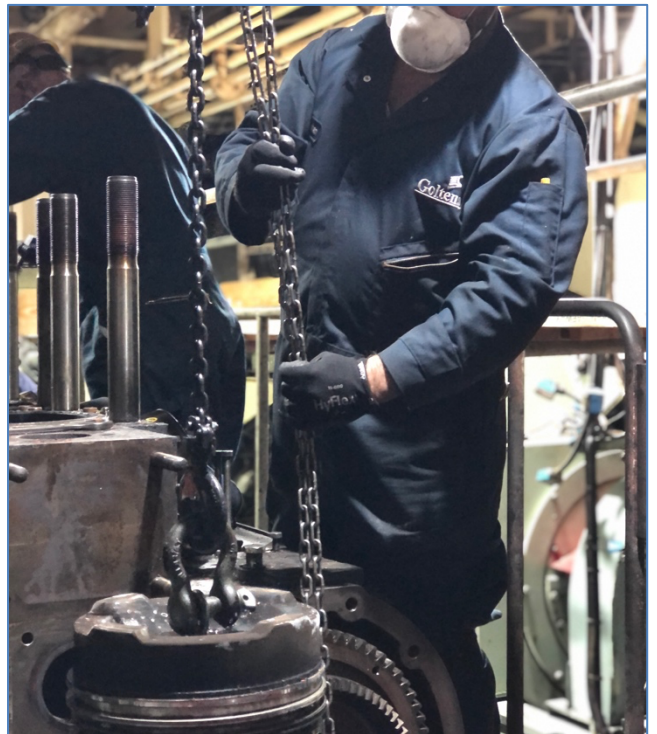
Figure 4: Removal of DG#3 pistons for calibration inspection

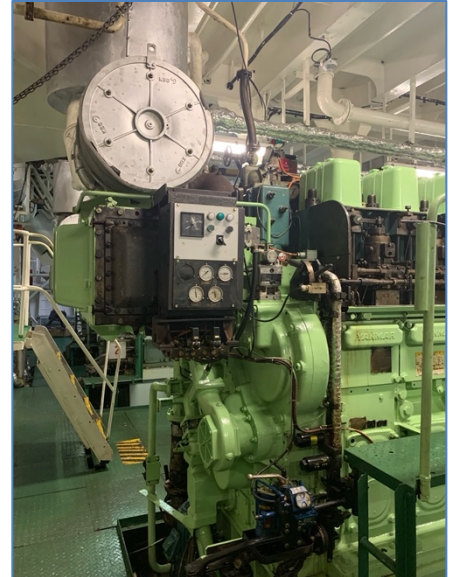
Figure 8: DG#3 after repairs completed

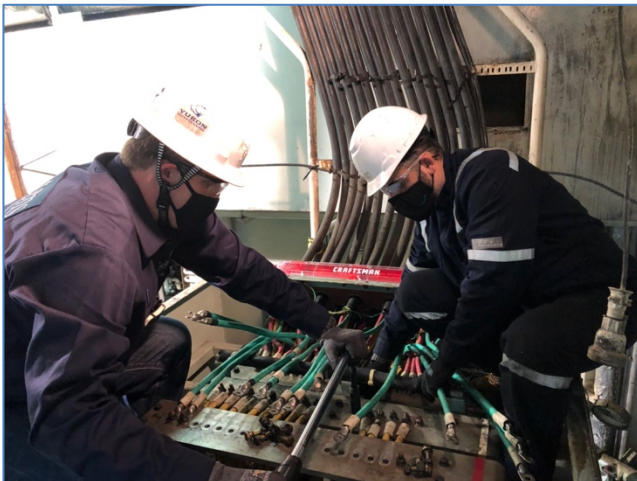
Figure 9: Hi-Pot testing of main cables
