## IN-SITU ANNEALING SAVES CRUISE SHIP CRANKSHAFT IN-SITU MACHINING AND ANNEALING SALVAGE SULZER 12 ZAV 40S CRANKSHAFT

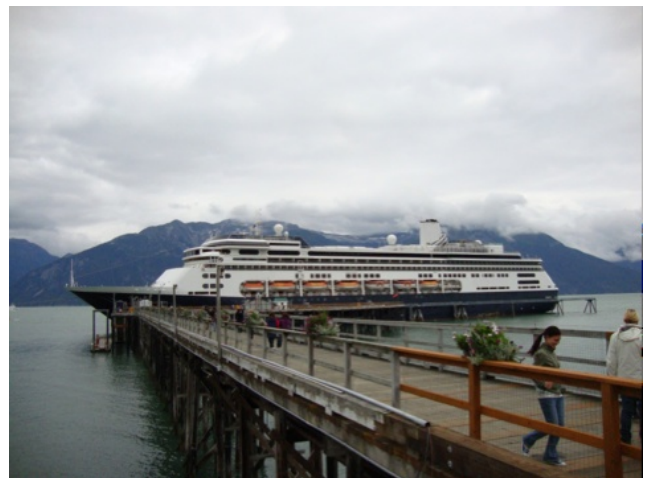
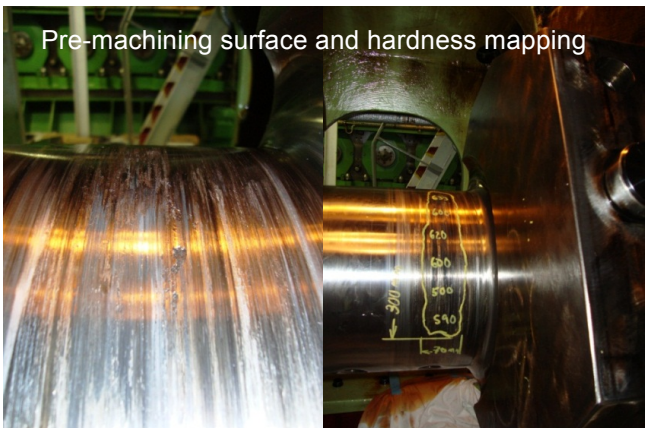
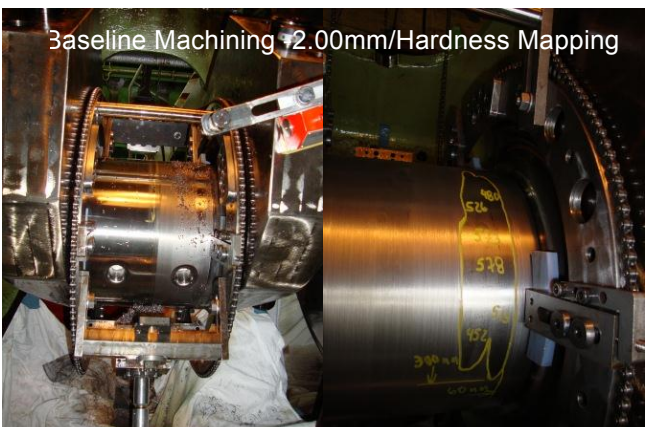
Inspection revealed that the crankpin journal was damaged all around the journal surface with scoring and bearing material. Additionally, technicians found a large area in the bottom side of the journal with hardness values above 600 HB. Run out measurements showed a maximum deficiency of 0.08mm.

After assessment, the journal was machined down -2.00mm (diameter 348.00mm) until the damaged journal surface was clean of foreign material and cracks. However, the high hardness values remained.

The customer decided to cut another -2.00mm to see if the hard area would get smaller and the hardness values would get lower. At diameter 346.00mm the hardness values and area were still out of the engine maker's specifications.

Goltens proposed performing its crankshaft annealing procedure to save the shaft within the maximum undersize diameter and hardness values given by the engine maker.

The annealing equipment was mobilized to Alaska and the engine was prepared for the annealing procedure. Once the annealing was completed according to the procedure submitted to the customer and Lloyds Register, the crankpin was machined to a final -5.00mm undersize (345.00mm). Post annealing hardness was measured under 300 Brinell.
