## IN-SITU MACHINING CRUISE SHIP CRANKSHAFT AFTER MAJOR CASUALTY

### RESTORATION OF SULZER 8 ZAL 40S CRANKSHAFT

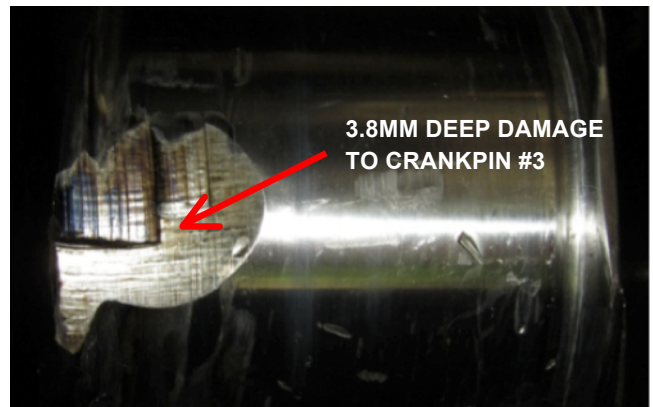
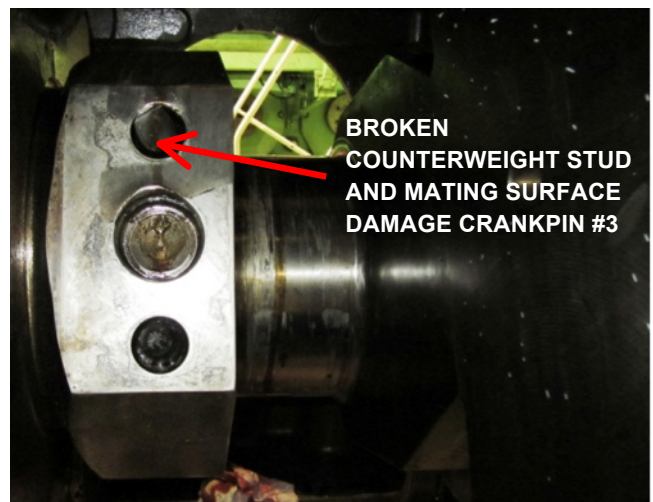
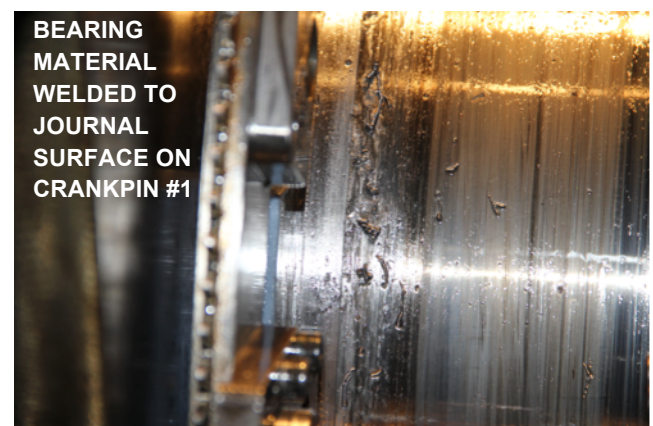
A Sulzer 8ZAL 40S Diesel engine aboard a cruise vessel suffered severe mechanical damage during an engine overspeed resulting in a broken counterweight stud, and severe damage to crankpin #3 and damage to crankpin #1 as well as major damage to the block.

Inspection revealed that the damage on journal #3 went all around the circumference of the journal #3 with severe damage to the radius and deepest damage measured at 3.8mm depth. Additionally, Goltens found a sheared counterweight stud and damaged mating surface for the counterweights.

- Machined new fillet radii on Crankpin #3 due to extensive damage to create clean reference surface.
- Machined -8.0 mm off the diameter of Crankpin #3 to finished diameter 342.00 mm
- Machined -3.0 mm off the diameter Crankpin #1 to finished diameter of 347.00 mm
- Lapped and blue fit journals with custom machined aluminum dummies and established a surface contact area and roughness (<0.4Ra)
- Final measurements found to be within Maker's specification including:
  - Hardness check
  - Crack test via Magnaflux
  - Full calibration of crankpin dimensions
  - Run-out Measurements
- Machine polished crankpins #2, #4, #5, #6, #7, #8
- Lapped and blued all above mentioned crankpins to achieve desired surface contact area as per engine maker specifications while maintaining within the standard size diameters as given by the engine maker.
