## **SULZER ZV40/48 ZGODA CRANKSHAFT REPLACEMENT & IN-PLACE MACHINING**

### **DIESEL OVERHAUL, LASER ALIGNMENT, LINE BORING, SURFACE MACHINING**

After a big end bearing failure on one of its Sulzer Z40/48 diesel generators, Tarlac Power Corporation in the Philippines, requested Goltens Singapore to do an inspection of the damage and propose a repair solution for the 18-year-old engine.

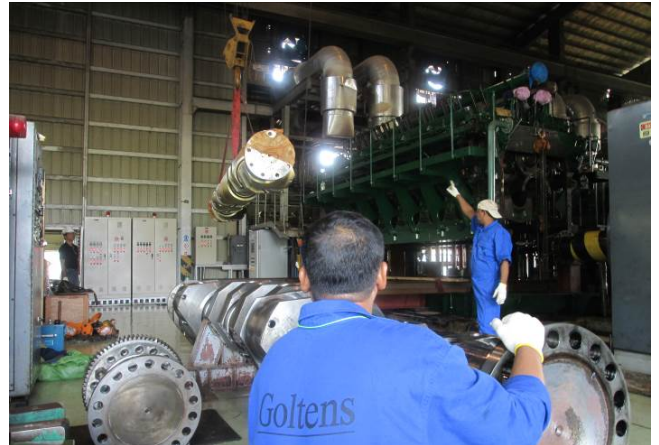
Rigging of the replacement crankshaft

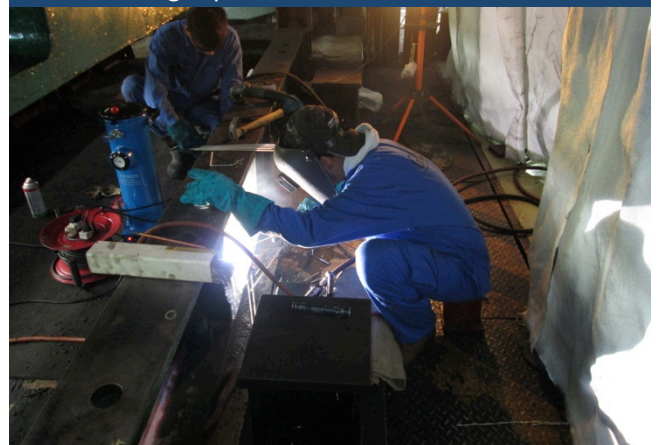
Additional inspection and laser flatness check of the engine block and foundation skids revealed that the skids were too stiff and had developed cracks. An evaluation of the plant layout and engineering was also performed to determine the best way to handle the logistics for the complex job.

#### **Cold welding repair on foundation skid**

- Disassembly & skidding of condemned crankshaft
- Cut and remove existing holding down bolts to facilitate milling of foundation skid.
- Repair cracks on foundation side by gouging, cold welding and peening to relieve stress.

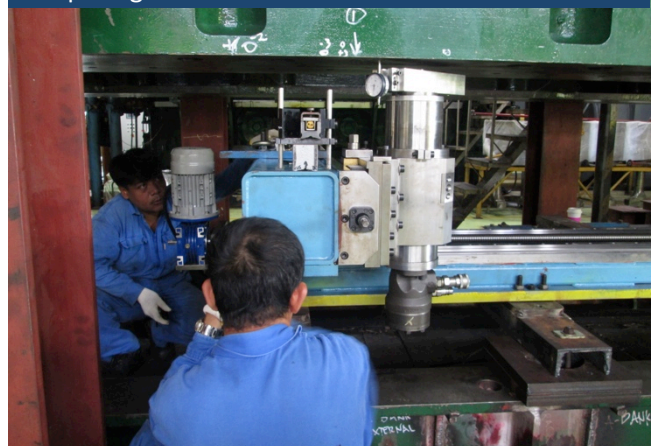
Once dismantled, laser checks were performed on the foundation skids, lower engine mating surface to foundation skid and main bearing pockets. The skids, mating surface and main bearing pockets were found to be distorted and the surfaces would require in-place machining and the engine would need to be line bored.

#### **Preparing to machine the lower block surface**

- Align X-Y-Z milling machine and carry out in-situ milling of foundation skid and underside of engine block to achieve flatness.
- Perform laser alignment for flatness checks on foundation skid top face and engine block underside surface.

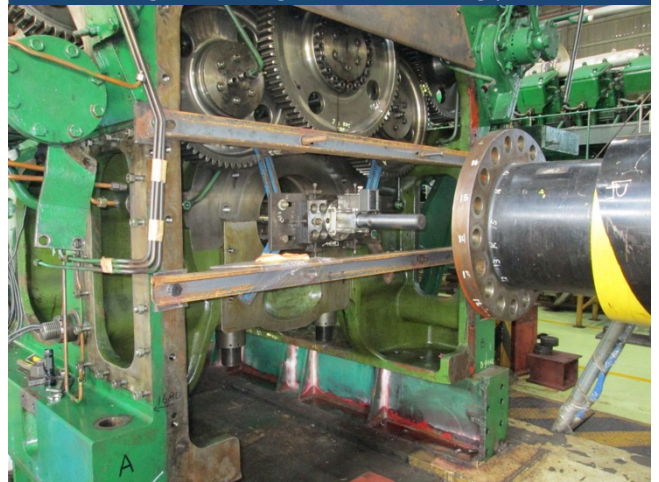
**Line boring of the engine main bearing pockets**

- Lower engine block into place for line boring
- Line boring of main bearing pockets and post-boring calibration and alignment check by laser.
- Remove saddle and jack up engine block to facilitate replacement of crankshaft.

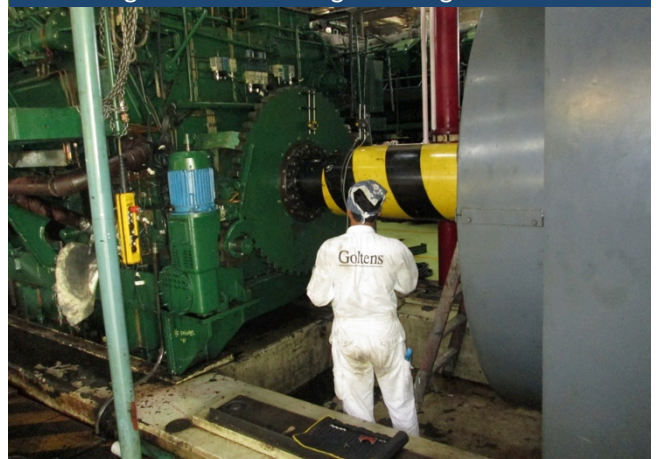
**Laser alignment of the engine and generator**

After the in-place machining works were completed and the replacement crankshaft installed, the engine could be rebuilt and the engine realigned properly to the generator using laser alignment tools.

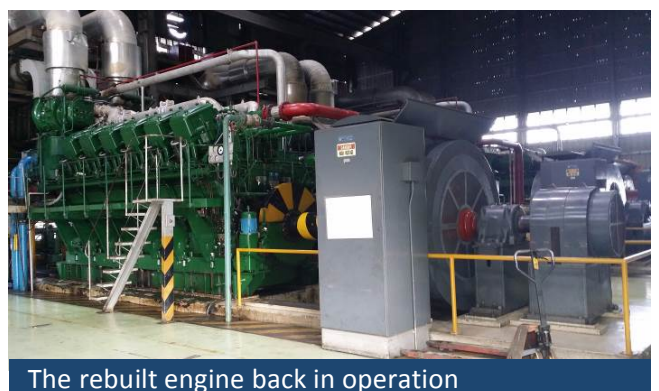
**The rebuilt engine back in operation**

After flushing of the engine lubrication system, Goltens' team proceeded with the commissioning of the engine performing satisfactory load tests up to 100% of load.
