## METAL STITCHING REPAIRS STRENGTHEN RELATIONSHIP METAL STITCHING REPAIR SAVES TIME FOR DREDGING COMPANY

### PROJECT FACTS: Metal Stitching Repair

Vessel Type: Heavy Duty Cutter Suction Dredger  
Engine Type: MAN B&W  
Surface Stitched: 1.45 meters (57").

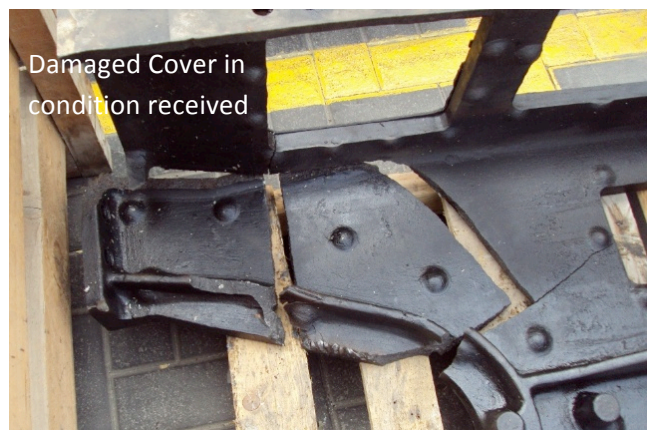
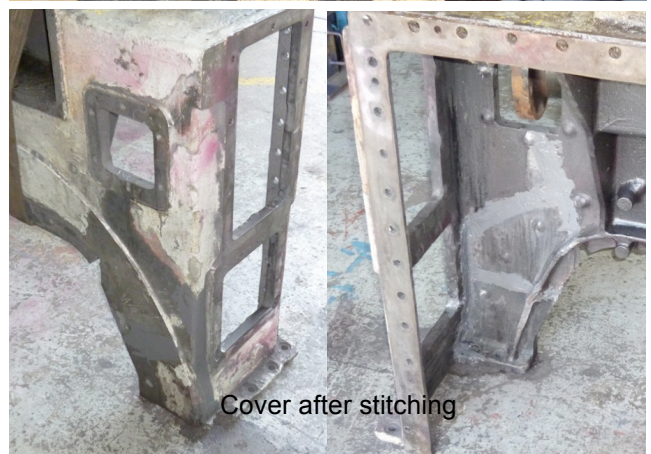
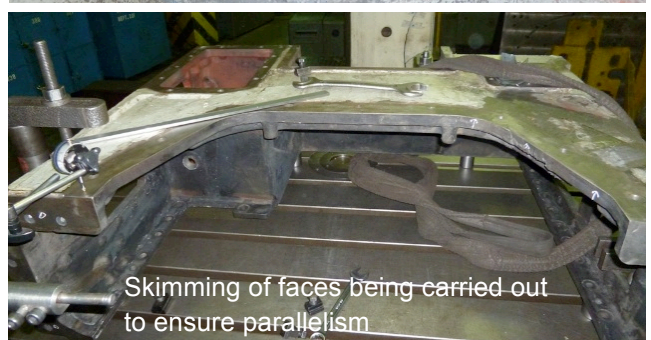
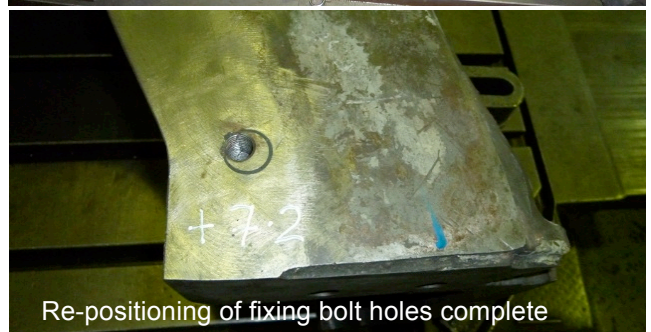
Goltens received an enquiry from a local dredging company in Mussafah Abu Dhabi, to repair a badly damaged vibration damper cover on an MAN engine from a heavy-duty cutter suction dredger in the company's fleet. The cover had been inspected by the engine maker and deemed to be beyond repair and advised the cover be scrapped.

The damaged cover was inspected and Goltens reported the results of its findings and proposed a repair procedure to metal stitch the cover.

Goltens' In-Situ specialists started by joining the larger parts together prior to metal stitching along the full length of the cracks. The finished stitching covered a length of 1.45 meters (57"). The stitching was then coated with a layer of Belzona to ensure the integrity of the unit.

With the stitching complete, the cover was delivered to Goltens' machine shop to check the dimensions after repair. The cover was mounted on a horizontal boring machine and dial gauges were used to check flatness and parallelism. The inspection showed the repair had left the cover slightly twisted with the hole pitches not matching the mating flange. The cover was skimmed on all machine faces to ensure parallelism and all the fastening holes were plugged and re-drilled and tapped.

- Metal stitching 1.45 meters of damaged cover and surface coating repair with Belzona
- Plugging and re-drilling of fastening holes
- Finish machining to ensure parallelism and flatness
