DUAL FUEL MODIFICATION & INSTALLATION OF 80 TONNE WARTSILA 18V46GD BLOCK DIESEL AND IN-SITU MACHINING SERVICES COUPLED TOGETHER FOR MAJOR PROJECT

PROJECT FACTS: COVANTA ENERGY

Engine Type:	Wartsila 18V46
Bore and Stroke:	460 / 580 mm
Length and weight of block:	12.3 M / 82 MT
Max Power and RPM:	18,900 KW / 514 RPM

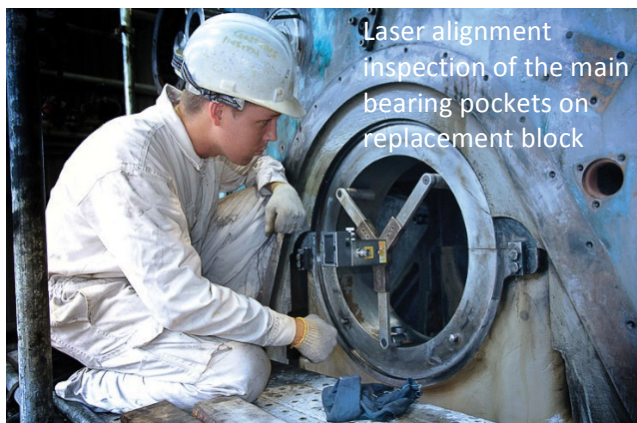
Laser alignment inspection of the main bearing pockets on replacement block

- Laser alignment and full calibration on all main bearing pockets.
- In-Situ grinding of all liner landing surfaces.
- In-Situ machining of 3 lower liner landing surfaces
- Fabrication of new bushes, shrink fitting and securing of new bushes for the lower liner landings.
- In-situ machining of all fuel pump bores to accommodate the gas fuel pump body design.
- Honing of all crankpins and main journals
- Milling counterweight contact landings
- In-Situ milling of locating key way and in-situ drilling of location pinhole for new fuel pump design.
- Full blasting and painting, under paint manufacturer supervision and procedures.

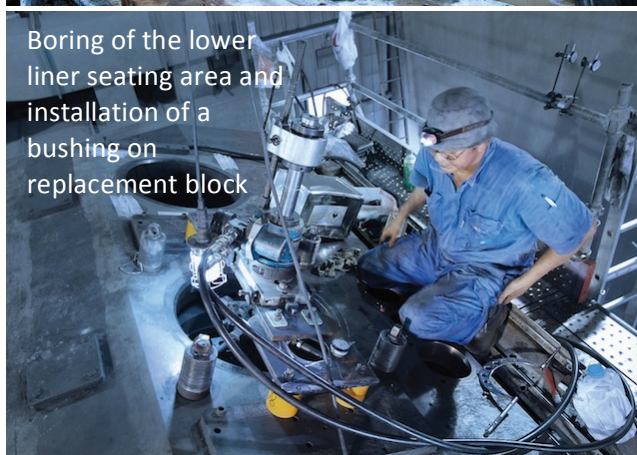
Boring of the lower liner seating area and installation of a bushing on replacement block

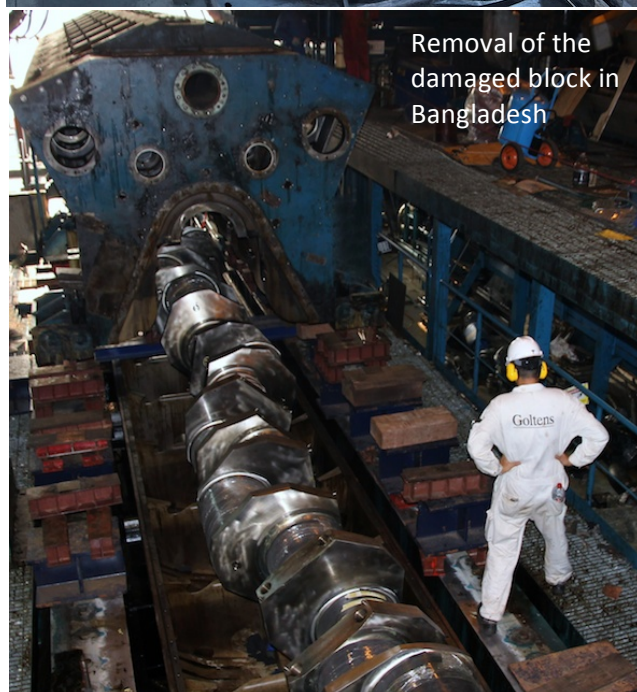
Removal of the damaged block in Bangladesh

Goltens' specialists dismantled the existing engine, jacked up the damaged engine block from its original position and shifted the crankshaft aside. A full inspection of the existing crankshaft was carried out on-site, resulting in honing of the crankpins and main journals, as well as milling counterweight contact landings.

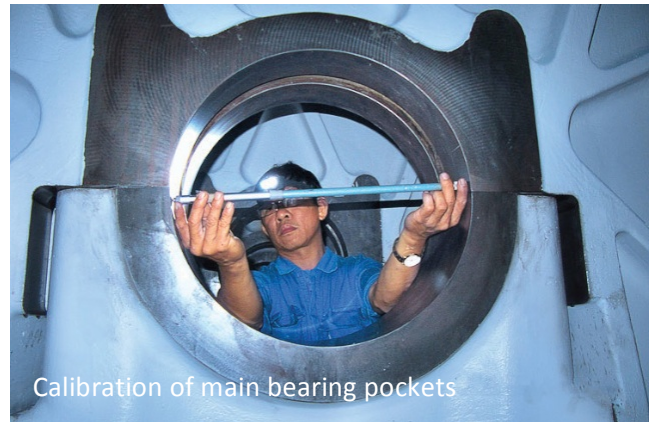
Calibration of main bearing pockets

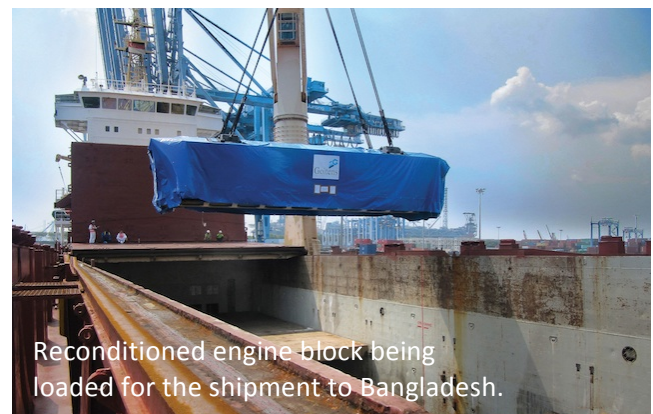
Reconditioned engine block being loaded for the shipment to Bangladesh.

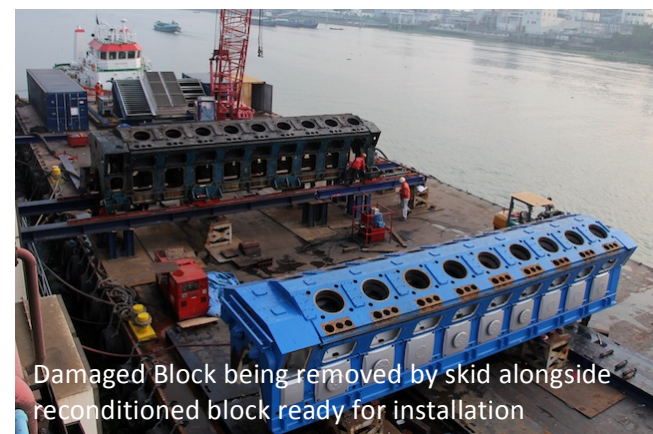
Damaged Block being removed by skid alongside reconditioned block ready for installation

A delicate skidding operation was then performed whereby the existing engine block was removed and replaced by the reconditioned block. Goltens' diesel team then rebuilt the engine culminating in successful commissioning and handover to the customer.

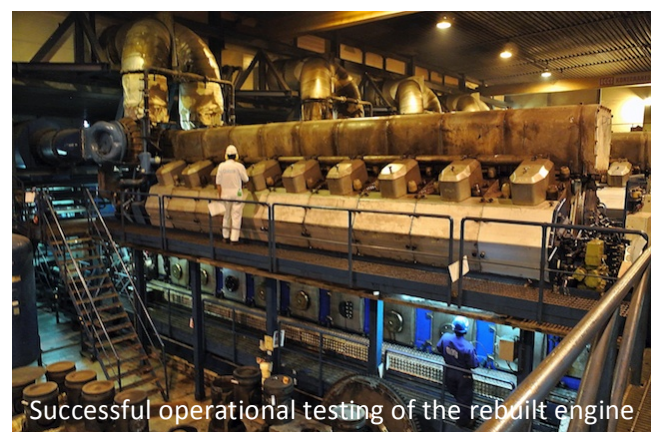
Successful operational testing of the rebuilt engine

Although the diesel and machining work performed was largely routine for Goltens, the complex logistics surrounding the project in 3 countries made it a very challenging assignment. All operational tests were successful and the engine was turned over to Covanta.
