SHIPYARD FLANGE FACING IN SITU MACHINING ON NEW BUILD NAVAL VESSEL

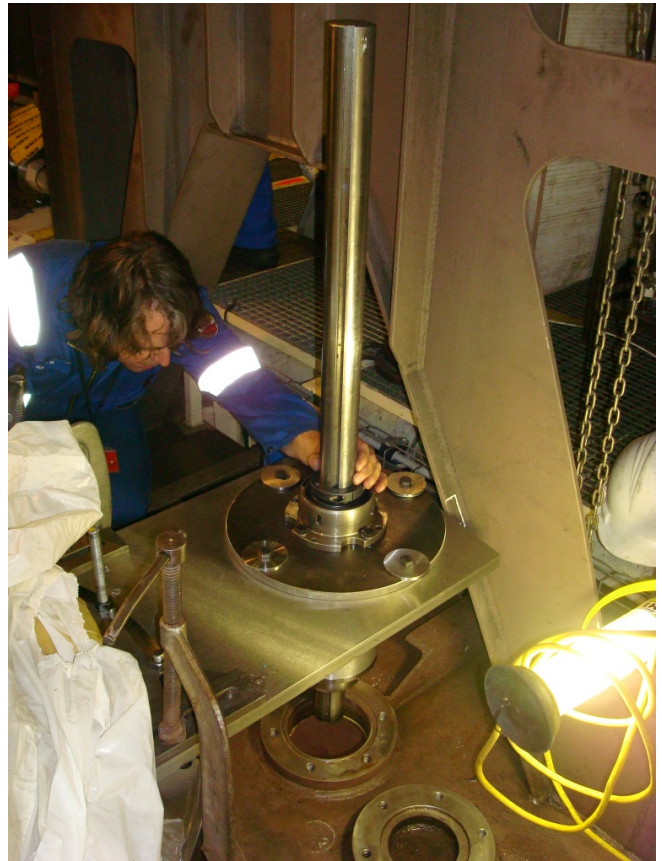
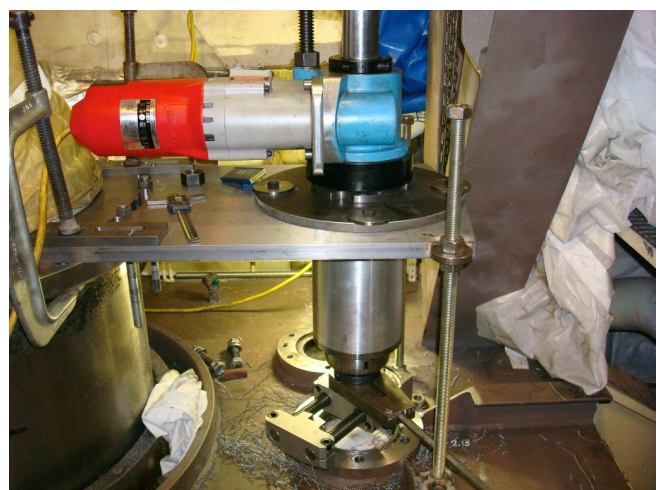
Goltens arrived onboard to evaluate the extent of the alignment issues and determined after clocking, that the deck-mounted flanges were as much as 2.5mm out of alignment. Having no reference other than the flange for the unit itself, Goltens fabricated a custom steel jig to mount to the flange that provided a true reference over the flanges 500mm away.

- Alignment inspection
- Fabrication of a machine mounting jig and bearings
- Machining of 4 deck mounted flanges – removing a maximum of 2.5mm from the faces of the flanges
- Renewed interior recess to original 4.8mm depth X 5.0mm wide

All 4 flanges were machined within 2 days to meet the manufacturer's requirements. Results were inspected and accepted by the equipment manufacturer and installation of the retractable propulsion units continued.
