GENERAL ELECTRIC 7LM6000 GAS TURBINE POWERPLANT REPAIR IN PALEMBANG, INDONESIA

ELECTROPLATE REPAIR OF GEARBOX TEETH AND LASER ALIGNMENT

PROJECT FACTS: GAS TURBINE GEAR REPAIR

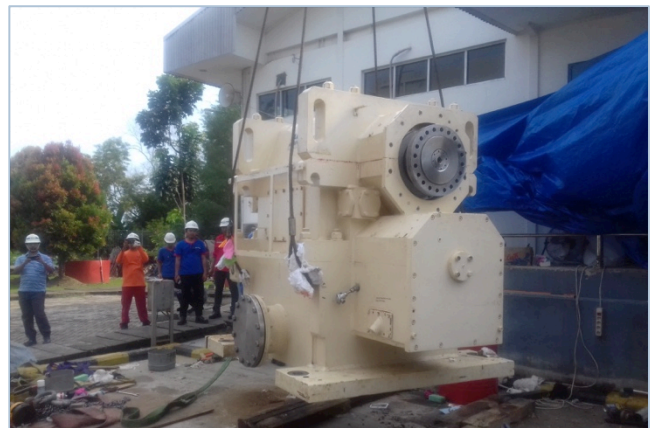
Rigging gear box out of powerhouse to work area

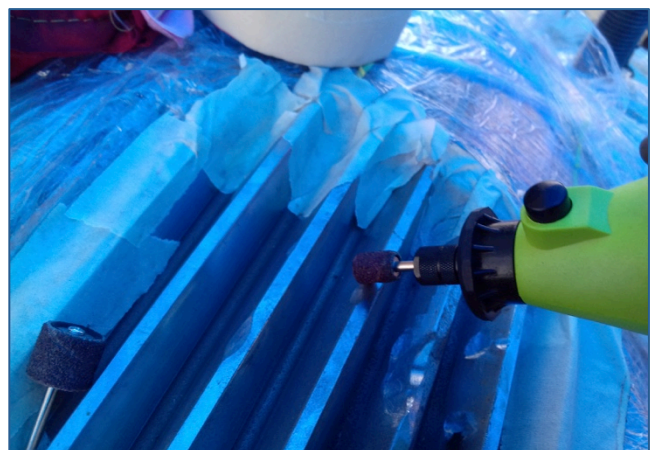
Goltens' specialists dismantled the gearbox and performed a thorough visual inspection and range of non-destructive tests. The gears were determined to have chipped teeth that would have to be repaired. Rather than incur the cost and delays of transporting the large gearbox to a workshop, Goltens deployed the required tooling and in-place machinists to do the work onsite.

Pre-machining chipped gear teeth

Once the gearbox was moved to a safe work area and the gears were secured, Goltens machined the damaged areas on the gear to ready the surface for repair. Technicians then applied selective electroplating to the damaged gear teeth using nickel and cobalt acid.

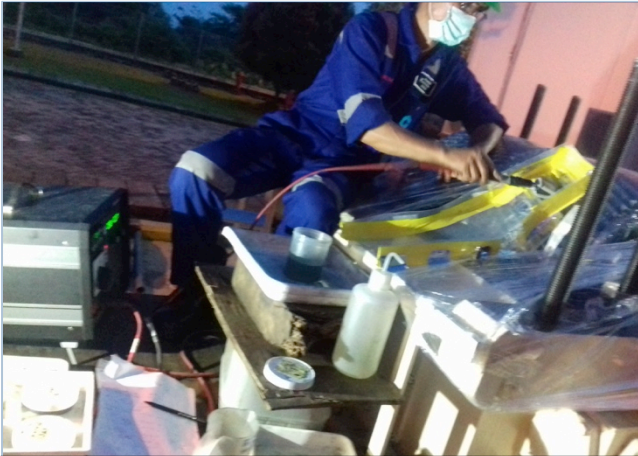
Selective electroplating damaged gear teeth

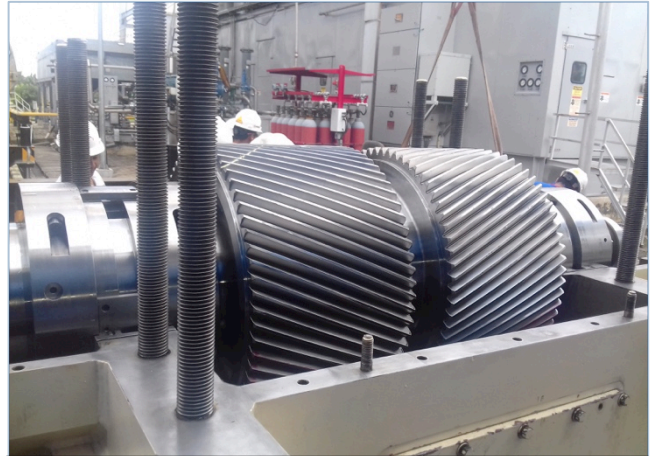
Gear teeth after repairs completed

Once the gears were inspected and the repair approved, Goltens reassembled the gearbox and laser aligned it to the gas turbine.

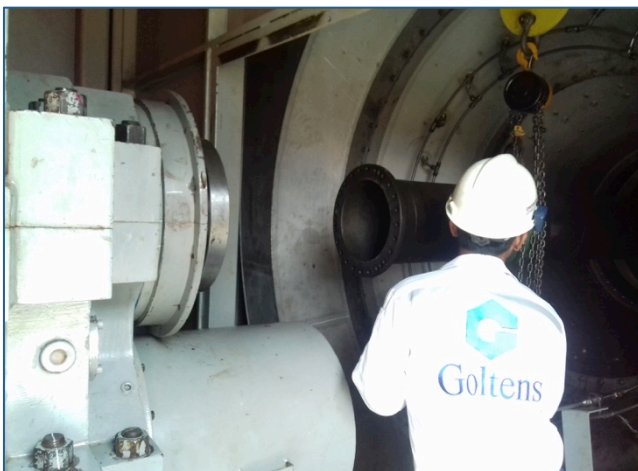
Installation of shaft between gearbox and turbine

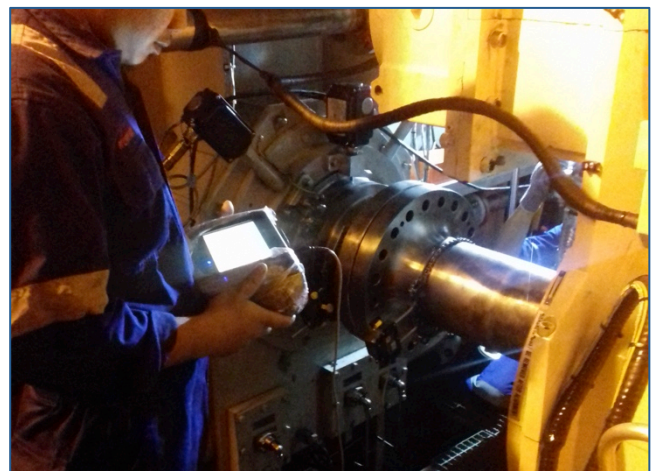
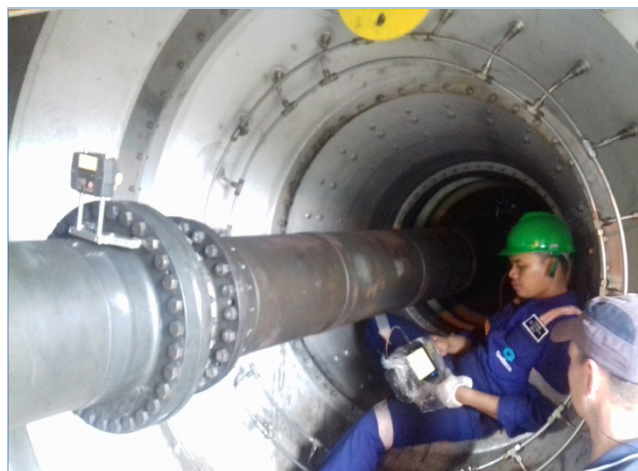
Laser alignment of generator to gearbox

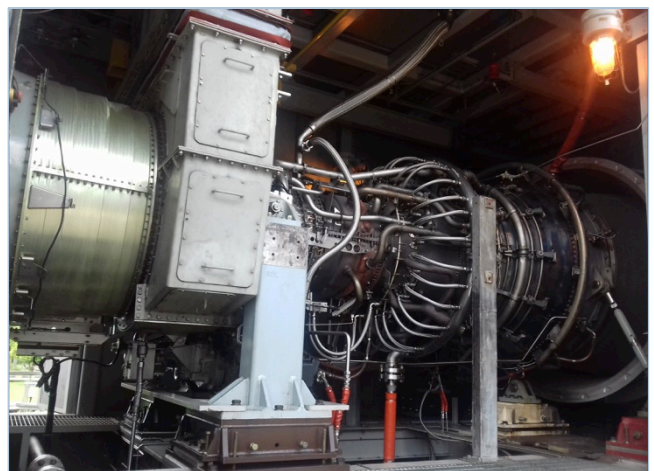
Commissioning tests were successfully performed on the engine with the output reaching 34.5MW at 10,366 RPM with vibration of 0.06-0.09.

Engine testing / commissioning
