HIMSEN 6H25/33 CRANKSHAFT REPLACEMENT - SINGAPORE

CRANKSHAFT REPLACEMENT AND FULL ENGINE REBUILD IN ONLY 5 DAYS AT ANCHORAGE

PROJECT FACTS: CRANKSHAFT REPLACEMENT

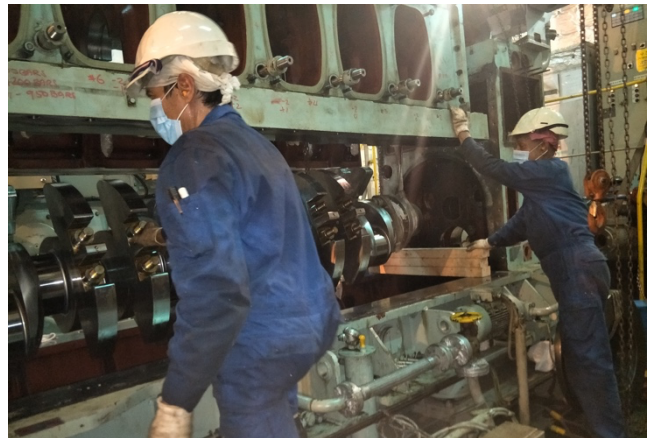
The ship's crew performed an initial inspection of the engine and found that the #5 crankpin had seized during the overspeed and subsequent shutdown. Further inspection revealed that the crankpin journal was badly damaged beyond the repair limits and the crankshaft was condemned.

Figure 1: Block lifted, removing condemned crankshaft

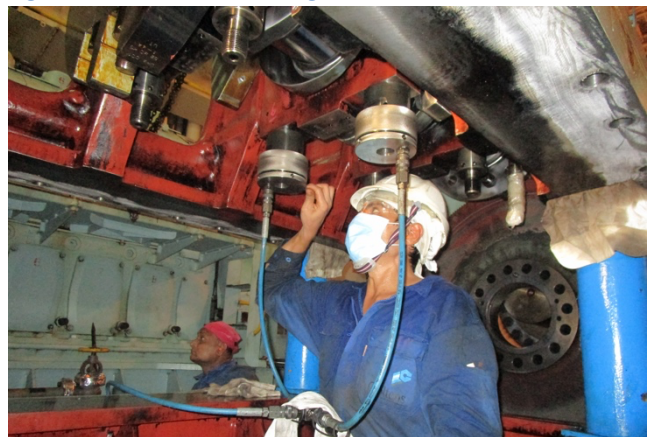
Figure 2: Hydraulic tensioning main journal bearing caps

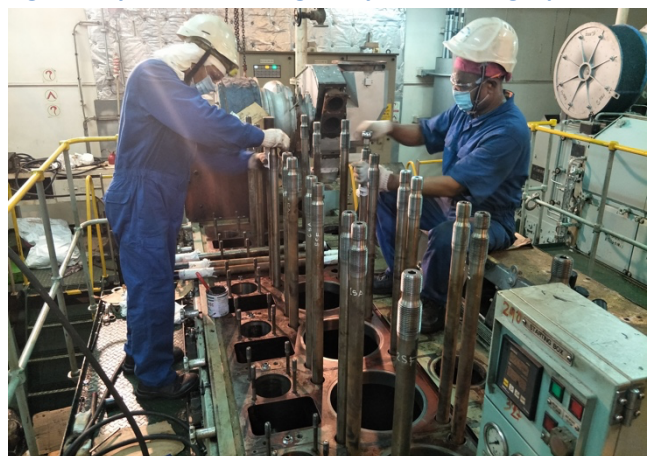
Figure 3: Torqueing of cylinder head studs

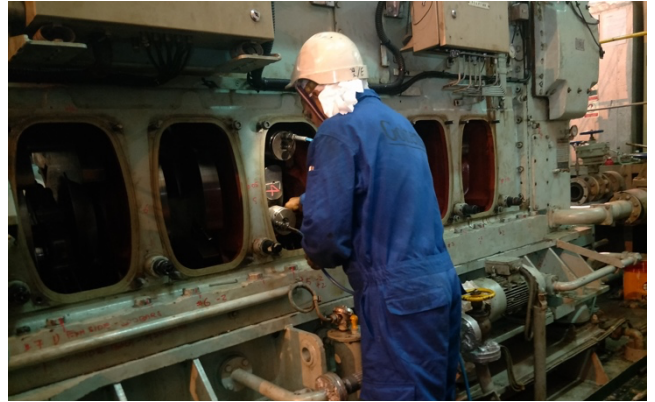
Figure 4: Hydraulic tensioning big end conrod bolts

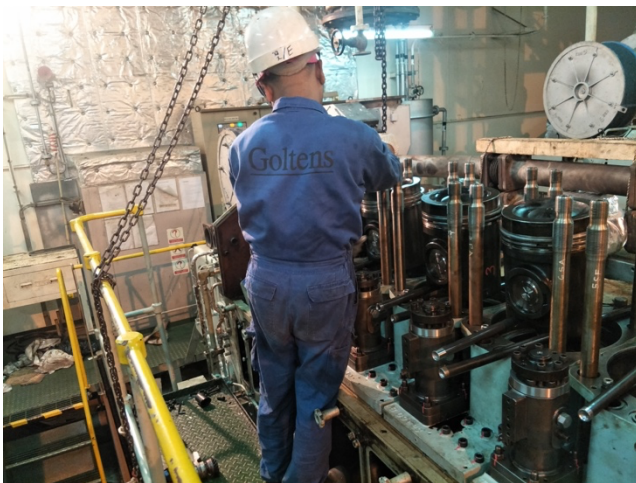
Figure 5: Calibrated pistons positioned for installation

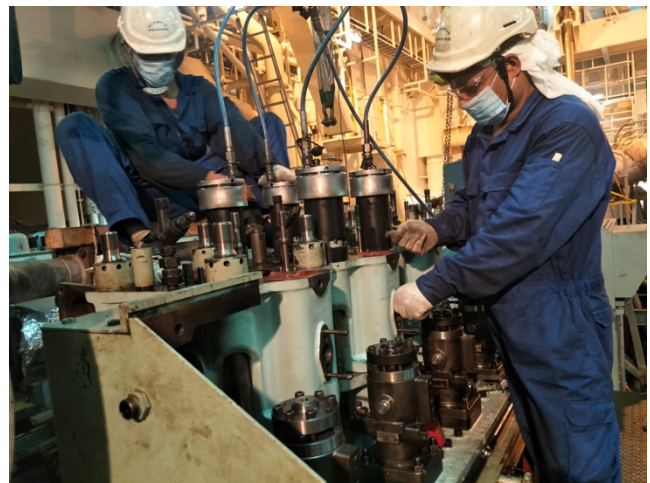
Figure 6: Hydraulic Tensioning of cylinder head studs

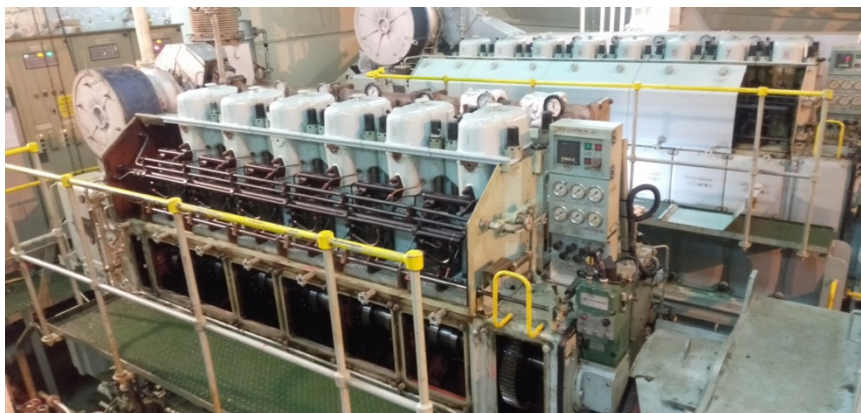
Figure 7: Engine reassembled with exception of gallery covers
