IN-PLACE MACHINING MINIMIZES COST AND DOWNTIME FOR TANKER ENGINE REPAIR

TWO GOLTENS STATIONS TEAM UP TO COMPLETE THE REPAIR AND RESTORE THE ENGINE TO SERVICE

Description: MAN B&W HUYNDAI 7L23/30H

Location: Portugal – US (under voyage)

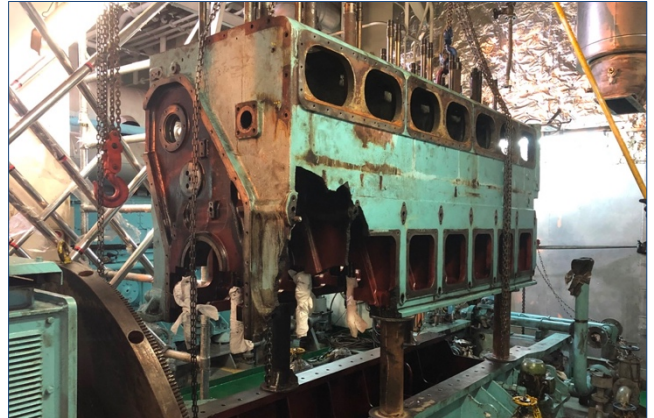
Goltens Dubai, received an emergency call to mobilize to Portugal to evaluate a major casualty on an MAN B&W Hyundai 7L23/30H on an oil tanker. The team evaluated the damaged engine and determined that the engine block and crankshaft were beyond repair and required replacement. Further, the bedplate had suffered major impact damage from the broken connecting rod and piston and its salvage was questionable.

Figure 1: Damaged engine disassembled and jacked

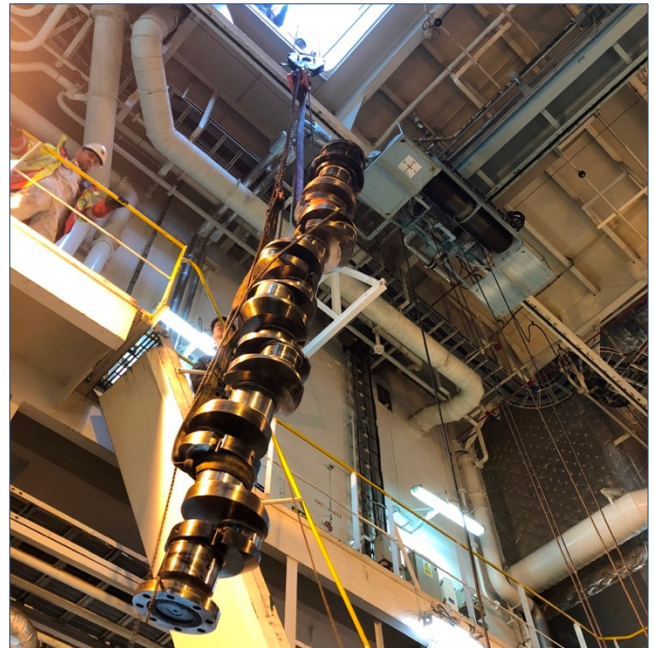
Figure 2: Rigging condemned crankshaft from engine room

Goltens dismantled the engine and rigged the condemned block and crankshaft from the engine room to the upper deck while the vessel was on voyage. They also rigged the damaged alternator which needed to be sent ashore for repair.

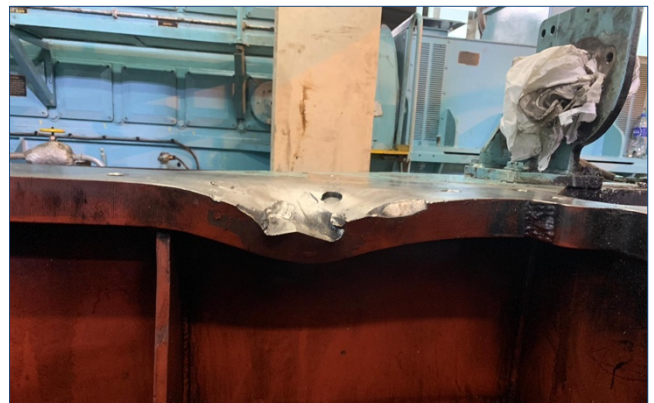
Figure 3: Bedplate damage from component impact

Despite heavy damage to the bedplate, Goltens advised that it could be salvaged with an in-situ repair while the vessel was sailing, minimizing the costs to the owner, the degree of disruption and the downtime of the generator. Goltens Miami's in-place machining team came on board at the Louisiana anchorage in the USA to carry out the repair work of the bedplate while the vessel continued sailing.

To effect the repair, Goltens' In-situ machinists milled the damaged area to 20mm depth and inserted a 22mm thick plate which was fastened to the bedplate with CSK headed screws. The excess material was milled to match the original surface of the bedplate. The repair process and all materials were approved by DNV class surveyor prior to undertaking the repair as well as the completed repair.

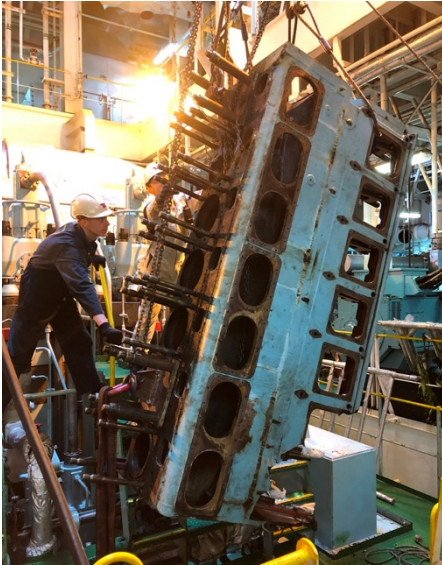
Figure 4: Rigging of engine block

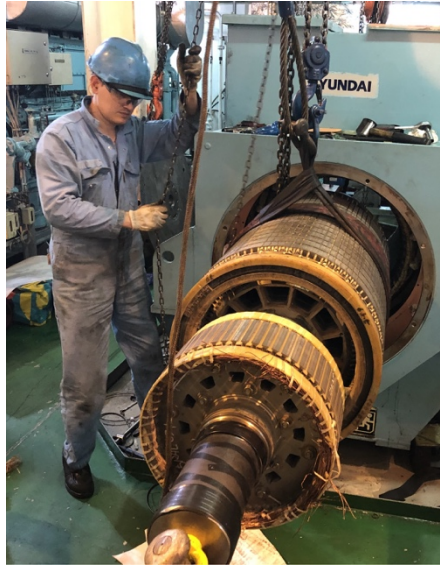
Figure 5: Rigging damaged alternator

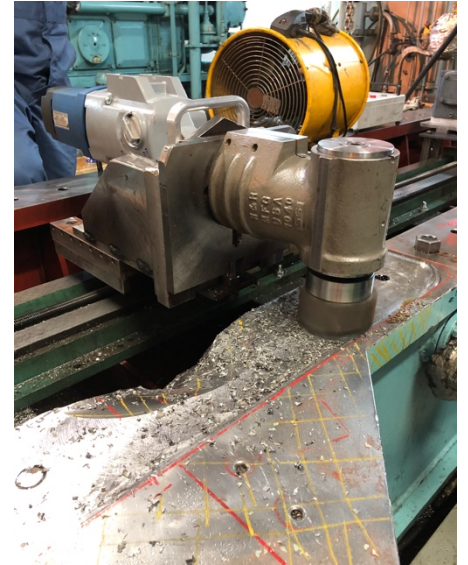
Figure 6: Milling damaged area

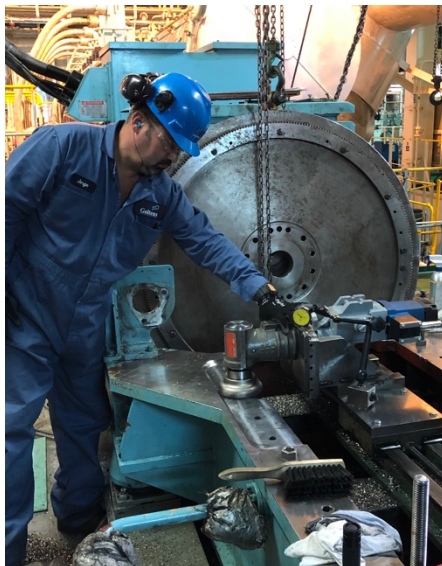
Figure 7: Finish milling recess in bedplate

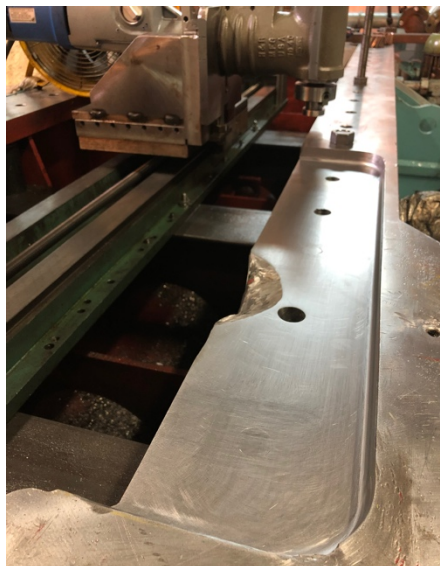
Figure 8: Recess ready for insert

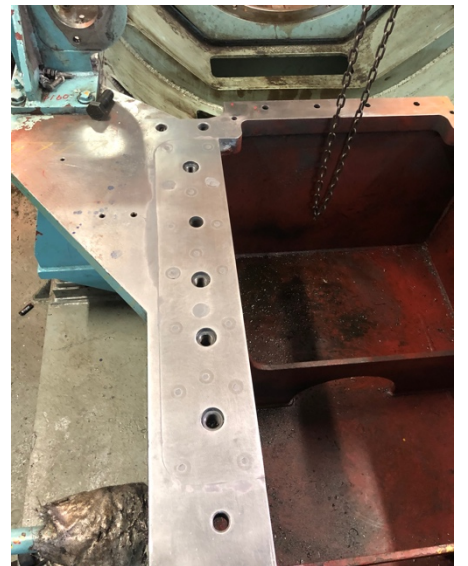
Figure 9: Bedplate repair complete

Post machining, the new block and crankshaft were installed, the block and bedplate foundation bolt holes were re-drilled and threaded and the alignment and flatness were rechecked and found to be acceptable.

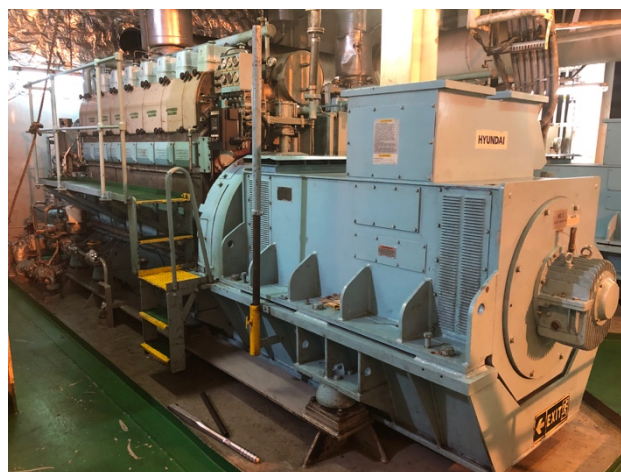
Figure 10: Engine rebuilt and returned to full service

All salvageable engine components were overhauled onboard and Goltens Dubai's riding squad completed the rebuild with new pistons, connecting rods and other components that could be reused. Goltens completed the engine alignment and full load tests prior to turning the generator back over to ship's crew.
