IN-PLACE MACHINING SOLUTION RESOLVES SHAFTING ISSUE

LINE BORING AND FLANGE FACING RESOLVES SHAFT ALIGNMENT ISSUE FOR SHIPYARD

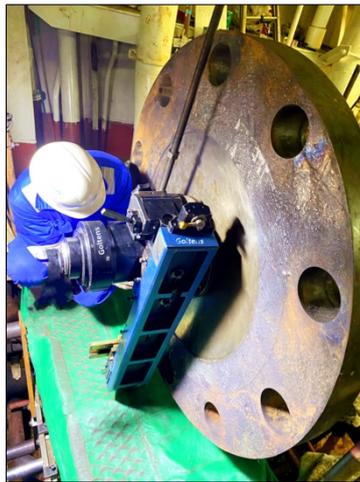
Figure 6: Damaged flange face

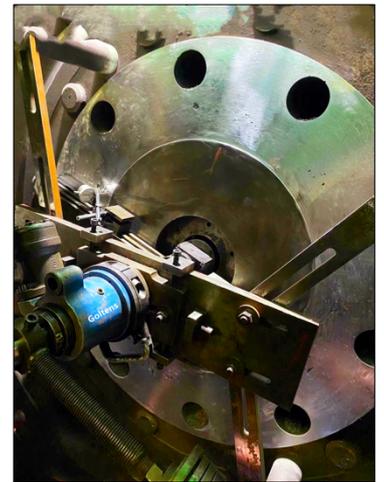
Figure 7: Flange post machining
