LINE BORING OF BRACKETS HOLES FOR OCTAGONAL FDPSO NEW BUILD PROJECT FAIRLEADER BRACKET HOLES ALIGNMENT AND BORING

PROJECT FACTS: Octagonal FDPSO N262

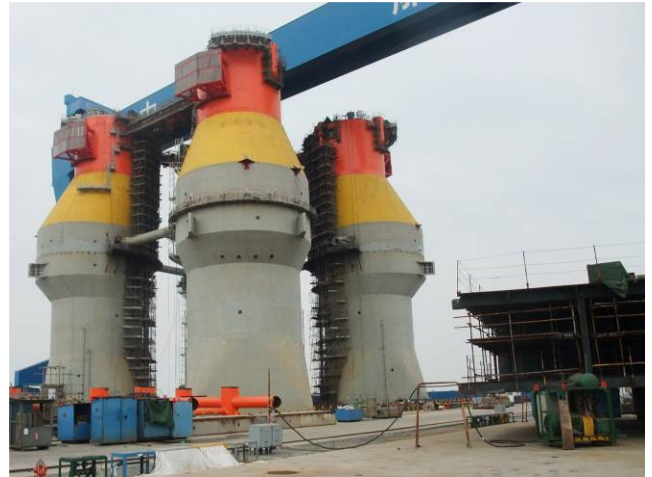
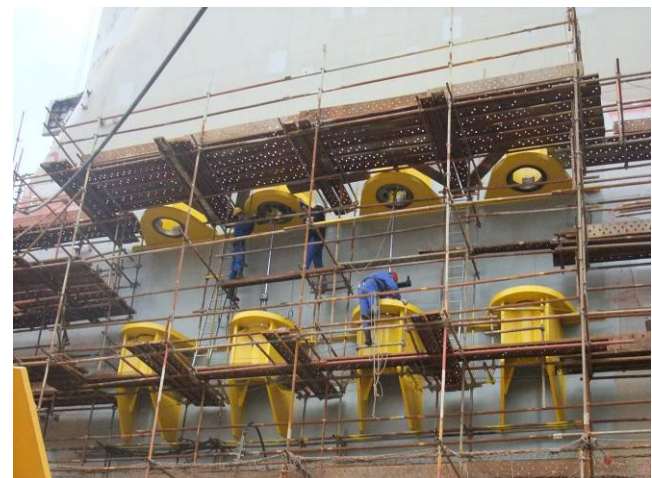
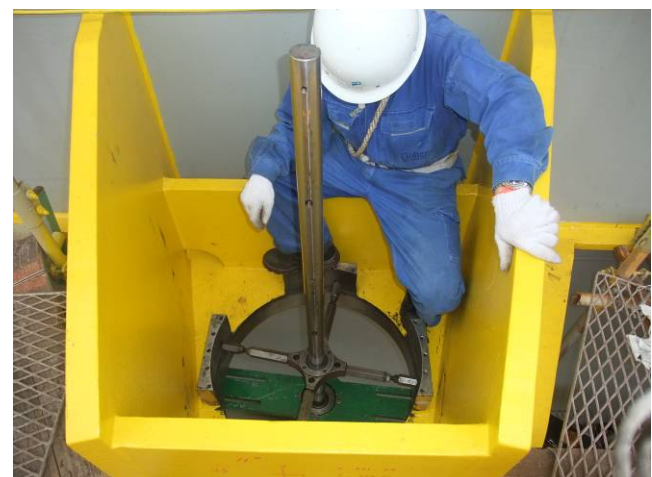
Goltens discovered that during installation of the fairleaders, welding had caused a misalignment of the centerline and distortion of the brackets. In Situ line boring would be required to realign the 13 sets of bracket holes to a suitable condition.

- Alignment checking of 13 sets of 651mm diameter upper and lower bores concentric with taper holes of bearing bracket
- Line-boring of 13 sets of 3 fairleader holes to the dimension of Maker's specification (652.5mm finished diameter)
- Post boring alignment check to verify accuracy of boring
- Application of surface preservative/protective oil
