IN-SITU ANNEALING & MACHINING RESTORES US NAVAL VESSEL MAIN ENGINE TO SERVICE

USS PEARL HARBOR (LSD-52) COLT PIELSTICK PC2.5 V16 BEARING FAILURE

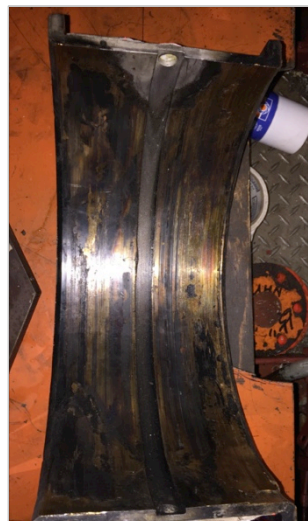
A US Navy amphibious vessel, the USS Pearl Harbor (LSD-52) experienced a bearing failure on main journal 0 on one of its four 16 cylinder Colt Pielstick PC 2.5 main engines. The failure was significant in that it introduced excessive hardness in the main journal and adjacent thrust faces.

Damaged Bearing

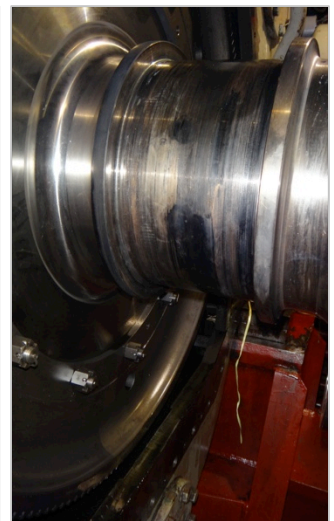
Goltens was engaged by the engine manufacturer to complete an inspection of the damage and propose a possible in-place machining repair for the bearing. Inspection revealed run out measurements were normal but confirmed that the surface of the journal had cracks and excessive hardness. Goltens mobilized tools and technicians to begin machining of the crankshaft and remove the surface cracks.

Damaged Main Journal

At -2.00mm the surface was determined to be clear of cracks but excessive hardness remained in large areas on the shaft. Goltens proposed utilizing its class approved annealing process to restore the crankshaft within manufacturer's limits. Once the procedure was reviewed and approved by the manufacturer, Goltens mobilized its annealing equipment to complete the repair.

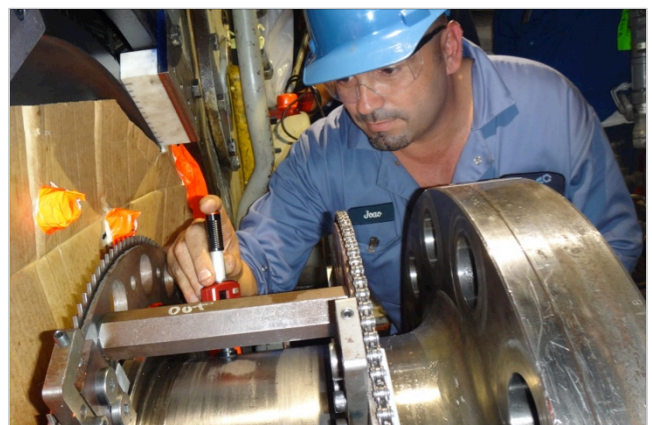
Hardness checks during pre-annealing machining

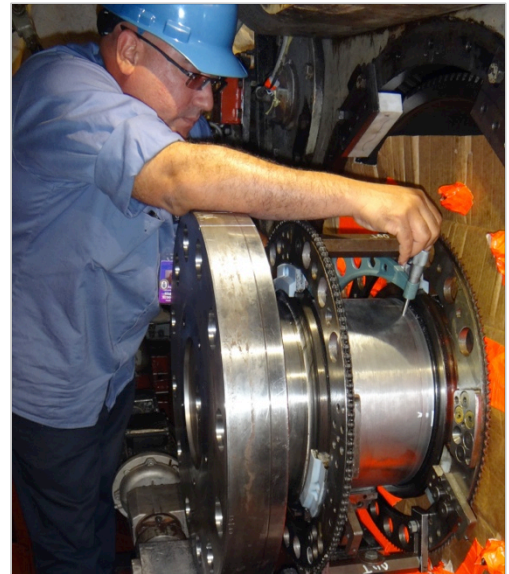
Checking shaft diameter pre-annealing

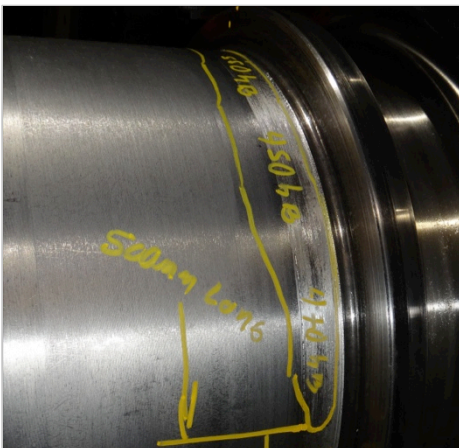
Surface hardness at -2.00mm

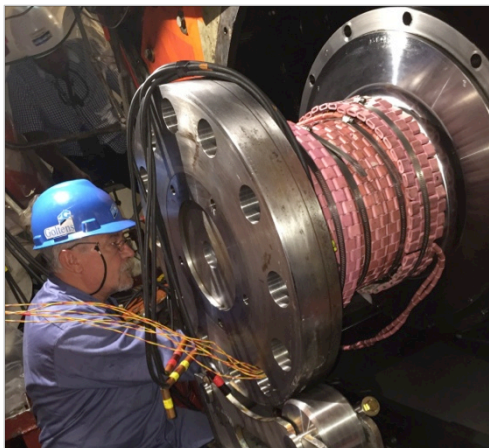
Annealing equipment installed on shaft

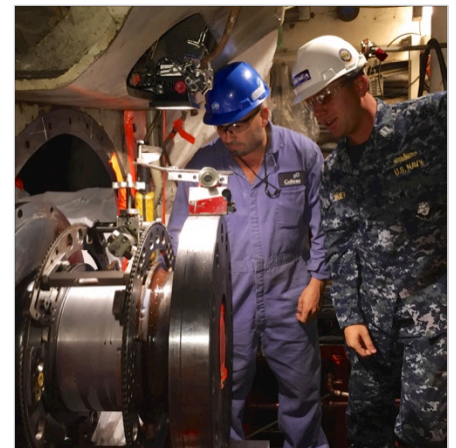
Machining of Thrust face

The main journal was finished at a final diameter of -3.00mm and both thrust faces were machined to -1.00mm (the first undersize).

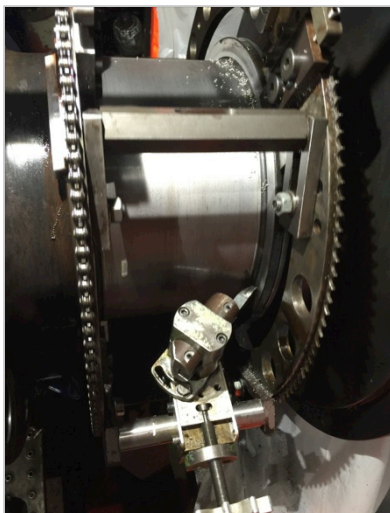
Machining of thrust face

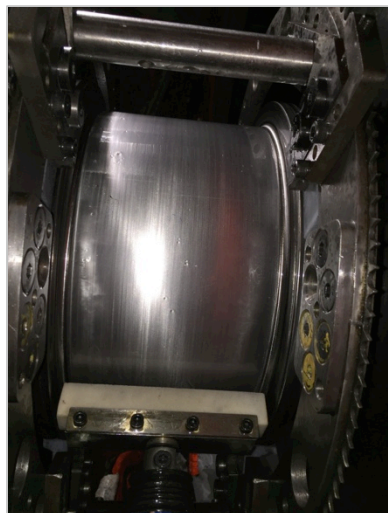
Finish honing of main journal

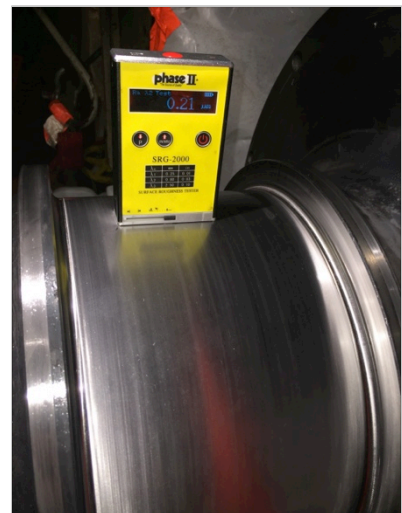
Finished surface at 0.21 Ra
