## IN-SITU CRANKSHAFT MACHINING RESTORES BULK CARRIER CRANKSHAFT

### MITSUI B&W 5L42MC MAIN ENGINE FAILURE - TAIWAN

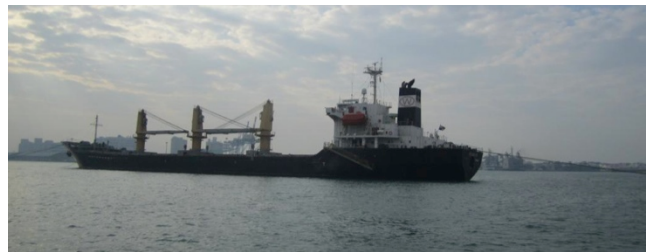
Once onboard the vessel the crankshaft journal surface was found to be full of cracks and the fillet radii were also found to be damaged. Goltens advised that new fillet radii be machined to provide a true reference for the journal machining and that the journal surface be machined clean to evaluate the extent of the damage.

After the new radii had been machined, Goltens' in-situ machinists machined the crankpin to  $-4.00\text{mm}$ . At this point crack tests still showed several small cracks. Local grinding was performed to determine the depth of the cracks.

Surface cracks visible during crack tests

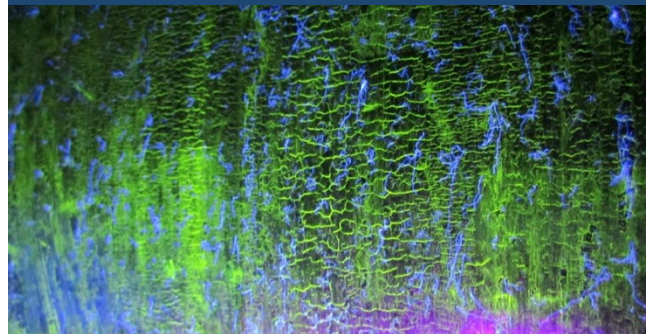
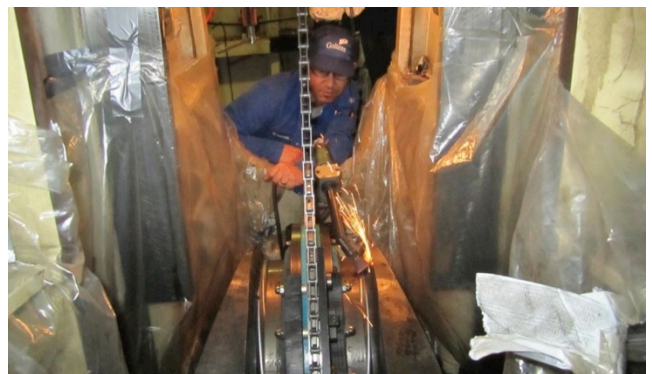
Machining of new fillet radii

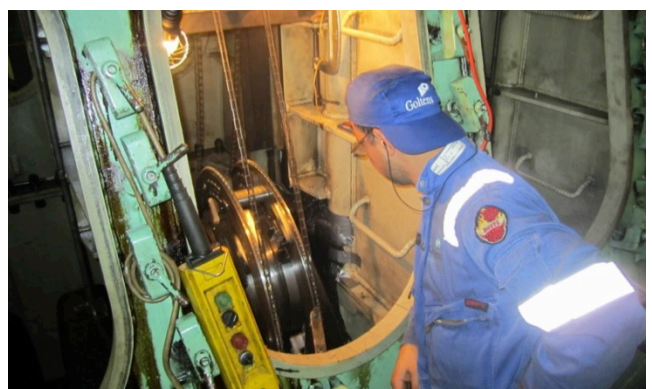
Goltens advised the client that the crankpin journal would be free of cracks and hardness at  $-6.00\text{mm}$ .

Machining damaged journal surface to  $-6.00\text{mm}$
