## IN-SITU SHAFT MACHINING RESTORES FULL CAPACITY OF DUTCH POWERSTATION IN ONLY FOUR DAYS

### MACHINING AND HONING OF STEAM TURBINE GENERATOR ROTOR SHAFT

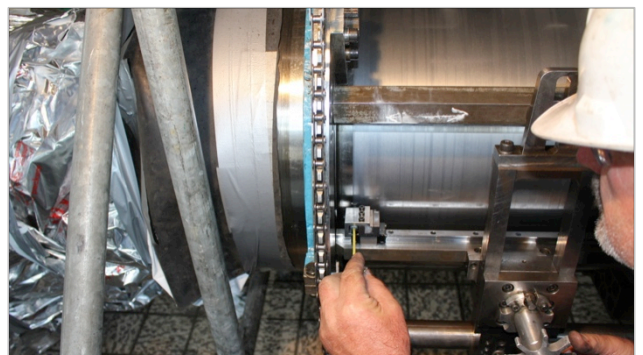
Adjusting in-situ journal machining tooling

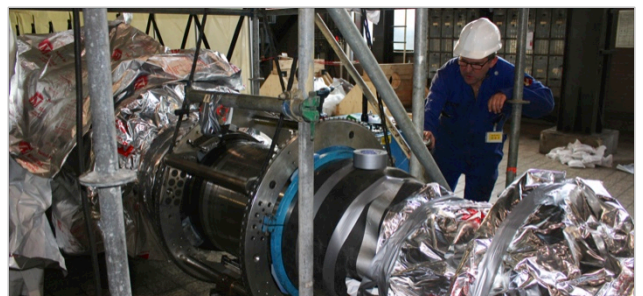
Machining of the damaged rotor shaft in progress
