## IN-SITU MACHINING EIGHT CRANKPINS IN 14 DAYS ON CANADIAN FERRY

### 24/7 REPAIR EFFORT RESTORES MIRRLEES KVSS M16 V-TYPE MAIN ENGINE

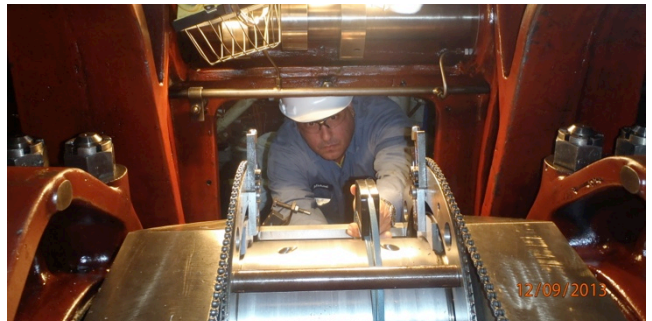
Checking the journal diameter during machining

- Performed Magnaflux crack test and hardness tests on all crankpins
- Performed run out and ovality checks on all crankpin journals
- Machined 8 crankpin journals to a finish diameter of 265.18mm and machined new fillet radii on all crankpins
- Super polished all journals to a finish of 0.15-0.18Ra

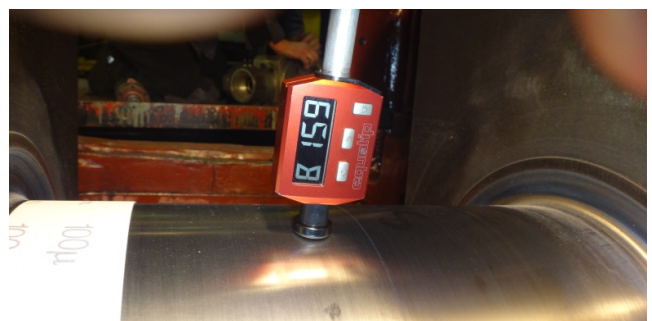
Goltens performed a full inspection of the crankshaft and determined that the running surfaces of the crankpin journals were in very poor condition from years of wear. As no casualty had occurred, shaft straightness and hardness were both found to be within acceptable tolerances. Inspection of the main journals also revealed no damage.

Performing hardness checks on damaged journal

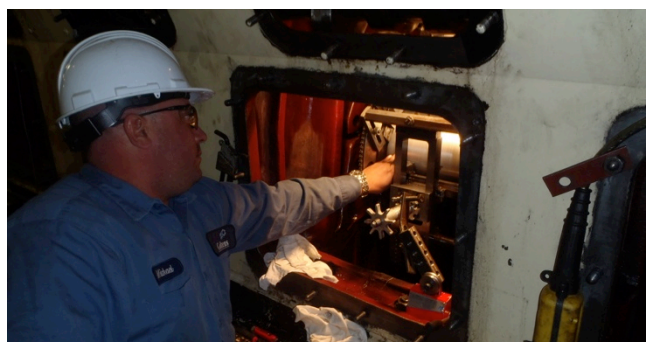
Adjusting Goltens' Single Point Cutting Tools

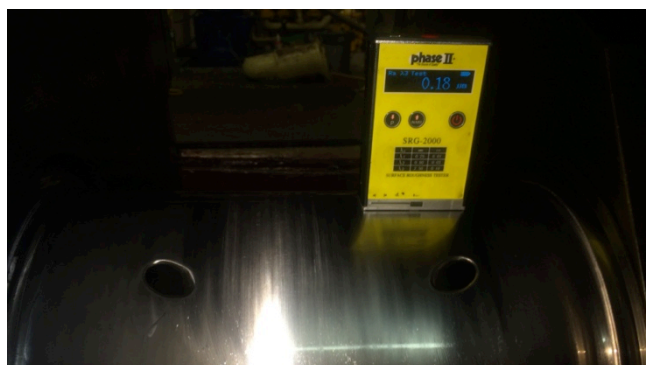
Finished journal surface at 0.18Ra
