IN-SITU ANNEALING AND MACHINING RESTORES PANAMANIAN POWERPLANT WARTSILA W18V46 GENERATOR

PROJECT FACTS: Panamanian Power Plant

Engine Make/Model:	Wartsila W18V46
Engine Output:	10,000 HP
Crankpin Dia. Pre machining:	450.00mm
Crankpin Dia. Post machining:	447.00mm
Distance between Webs:	450.00mm

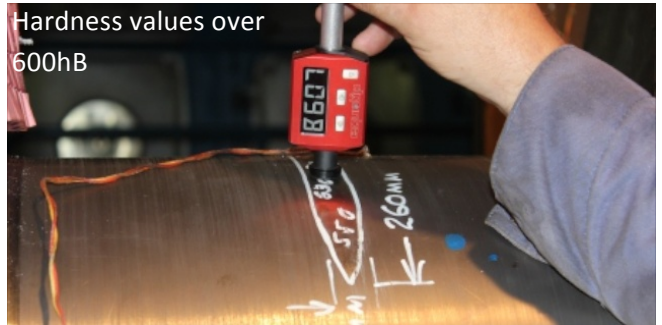
Goltens In-Situ specialists evaluated the extent of the casualty, checking the crankpin for cracks and hardness and determined that surface cracks were present and that hardness values over 600 Brinell were present. Additionally, grooves and white metal from the bearing were welded crankpin journal's surface.

Hardness values over 600hB

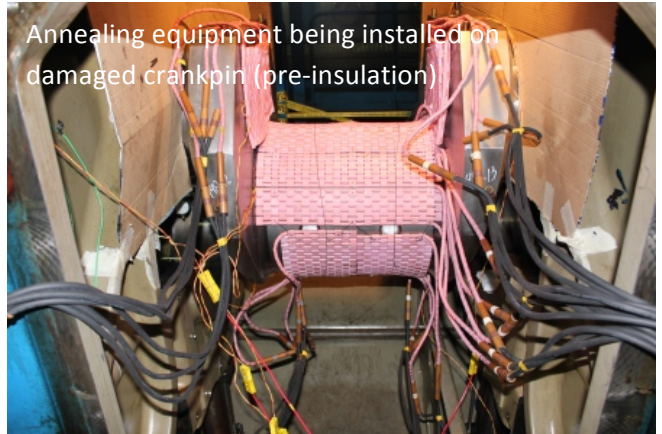
Annealing equipment being installed on damaged crankpin (pre-insulation)

Goltens' machinists removed 2.00mm from the diameter to eliminate the surface cracks but found the hardness was not reducing significantly. Based upon the extent of the hardness, Goltens estimated that it could extend as deep as 8.00mm or more. In order to salvage the crankshaft at the largest possible diameter Goltens recommended annealing (heat treatment) of the journal to reduce the hardness to acceptable levels and finish machine at a much larger diameter.

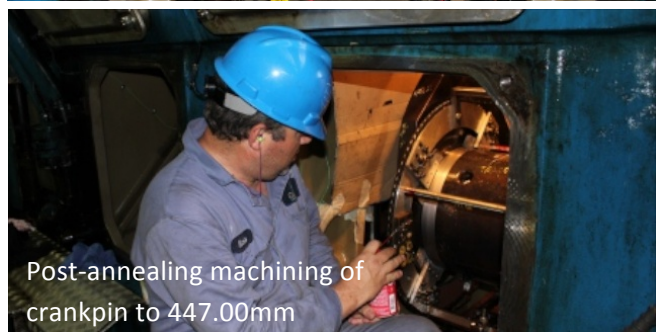
Post-annealing machining of crankpin to 447.00mm

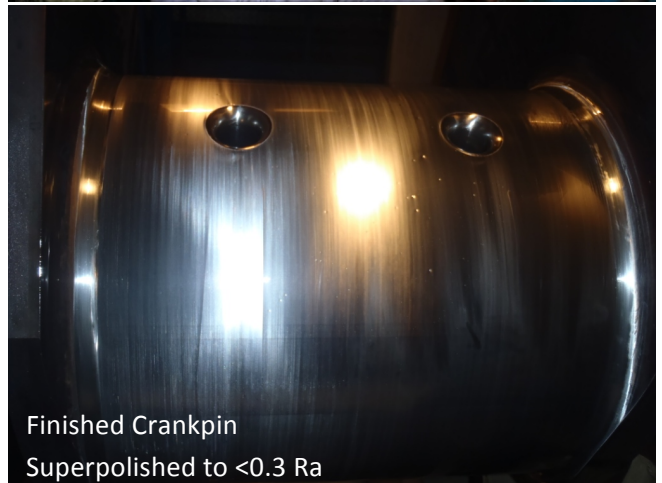
Finished Crankpin
Superpolished to <0.3 Ra
