IN-SITU MACHINING REMOVES TAILSHAFT AND FLYWHEEL BOLTS

MAN B&W 5S60MC MAIN ENGINE

PROJECT FACTS: Bulk Carrier Bolt Removal

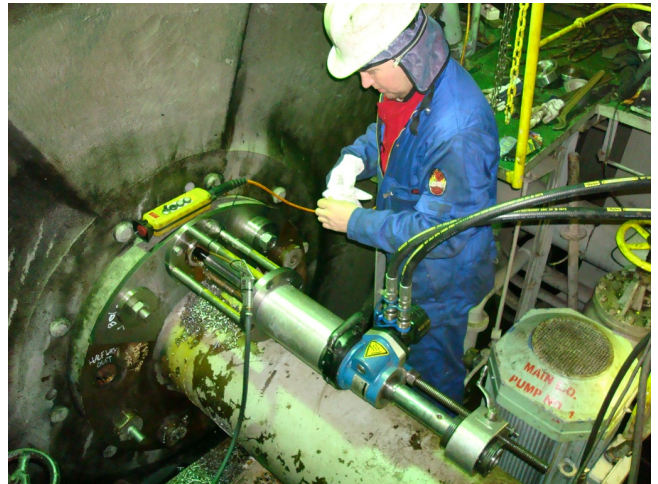
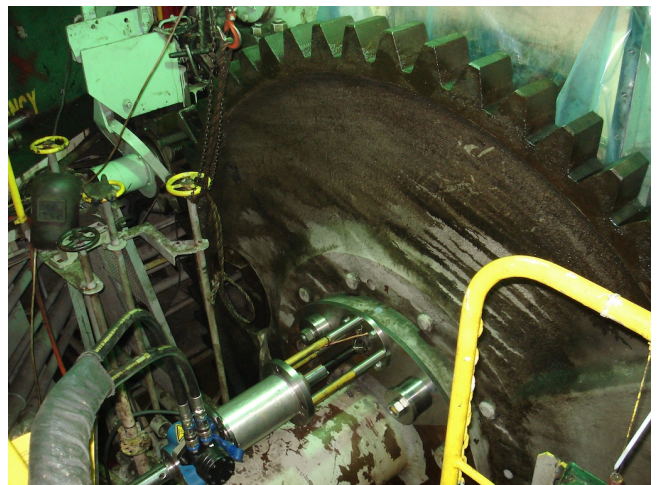
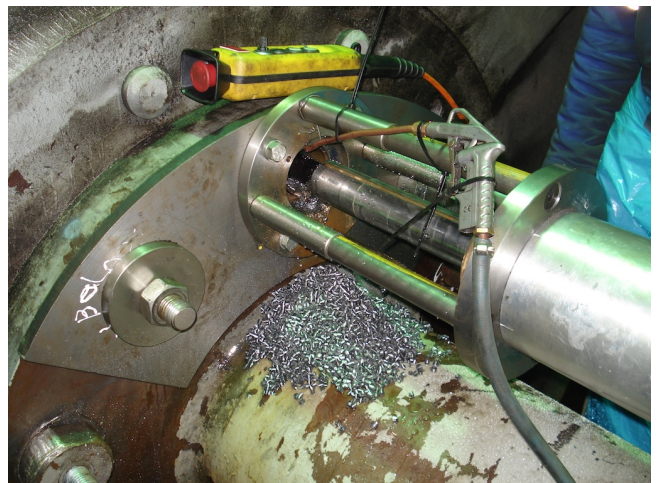
While preparing for a tailshaft removal on a 15 year old, 73,390 DWT Bulk Carrier in a Polish shipyard, the yard discovered the tailshaft and flywheel bolts were frozen in place. Using a 100 ton hydraulic jack, they had damaged 8 of 10 tailshaft bolts holes and 2 of 10 flywheel bolt holes. Goltens was asked to repair the damaged bolt holes by machining them to oversize and to remove the remaining flywheel and tailshaft bolts without damaging the bolt holes.

Goltens bored the damaged bolt holes to 1.00mm oversize and then fabricated a special bracket for the MAN B&W 5S60MC which allowed for quick alignment of boring rig over the remaining bolts and extremely accurate drilling of the bolts.

Each of the bolts was 335mm in length and 80mm in diameter. Goltens In-Situ machinists drilled each of the remaining bolts to 78mm allowing for easy removal without damaging the bolt holes.

- Manufactured a custom bracket to mount Goltens' boring/ drilling rig to the Flywheel and Tailshaft flanges
- Bored 8 tailshaft and 2 flywheel bolt holes to +01.00mm oversize at 81.00mm
- Drilled out 2 tailshaft and 8 flywheel bolts (bore hole dia. 78.00mm) to facilitate easy removal without damage to the holes.
- Performed light honing of bolt holes after removal
