IN-SITU LASER CLADDING AND MACHINING RESTORES CHINESE CHEMICAL PLANT TO OPERATION

LARGE MULTI-AXIS COMPRESSOR SLIDE BEARING HOUSING REPAIR IN ONLY 4 DAYS

Bearing Housing Repair

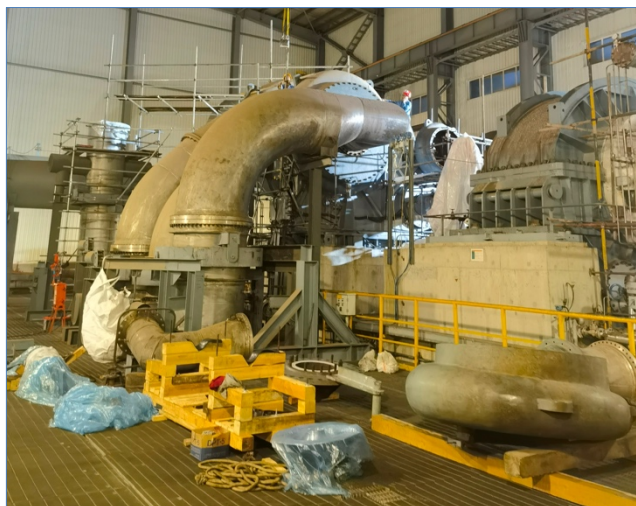
Large multi-axis compressor

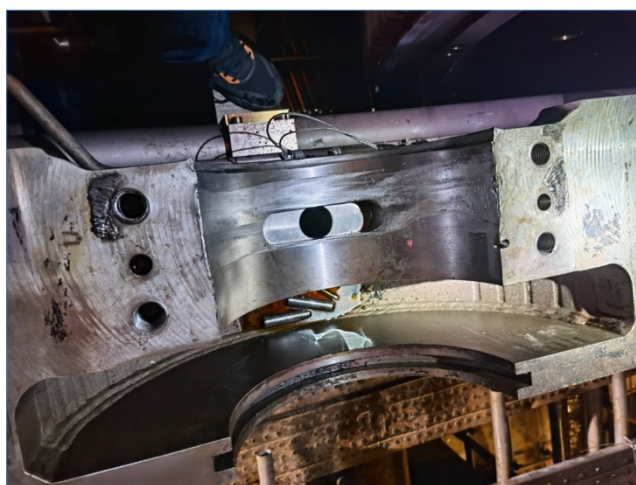
Unfortunately, when the compressor was disassembled, the main bearing was found severely damaged due to overheating. The compressor OEM immediately contacted Goltens for a solution that would repair the bearing housing and return it to original dimensions. Understanding the urgency, Goltens deployed an In-Situ specialist and, after inspection, advised the OEM and plant the housing could be repaired on-site with laser cladding and machining.

Damaged slide bearing housing

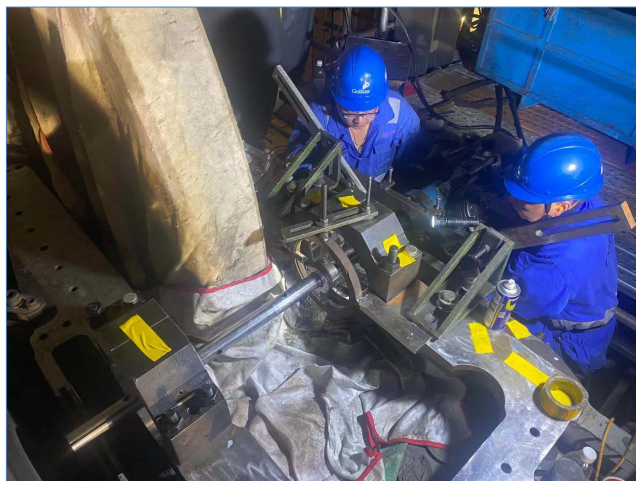
Pre-laser cladding machining of damaged housing

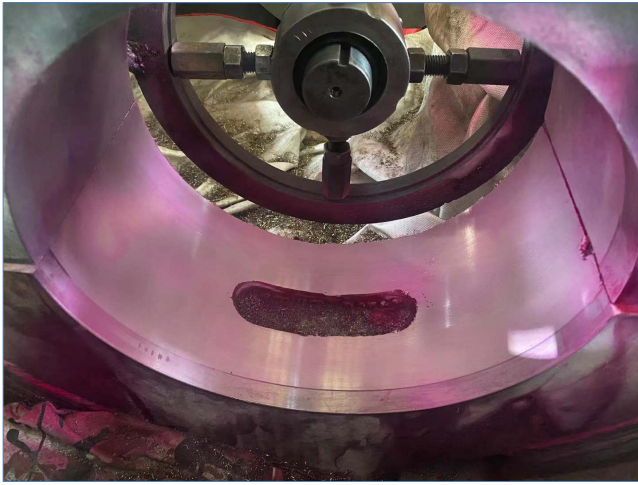
Dye-check of bearing housing inner surface before laser cladding

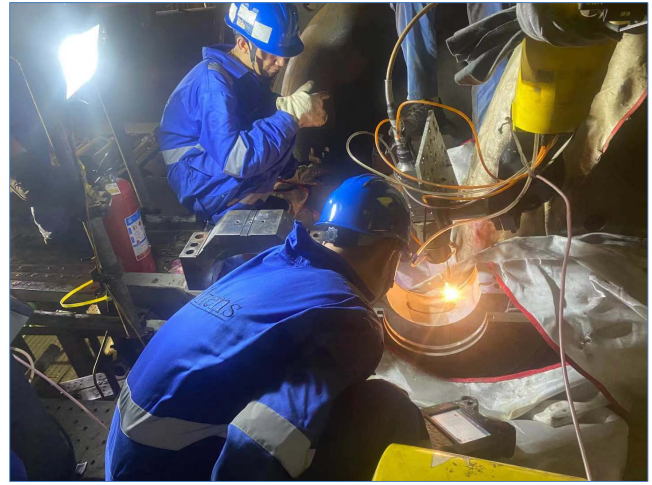
Laser cladding of bearing housing

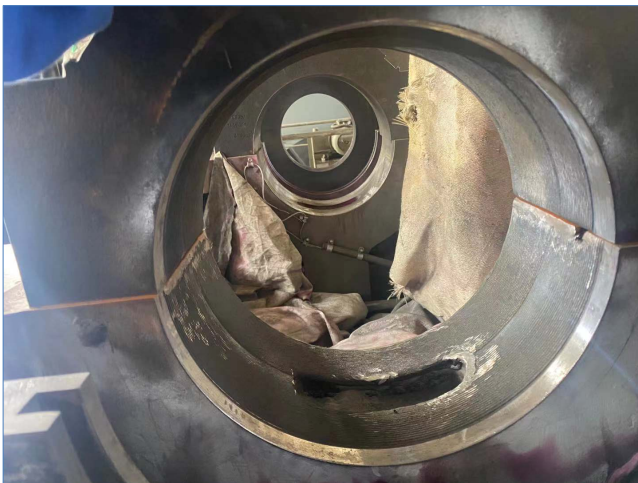
Inner housing surface after laser cladding

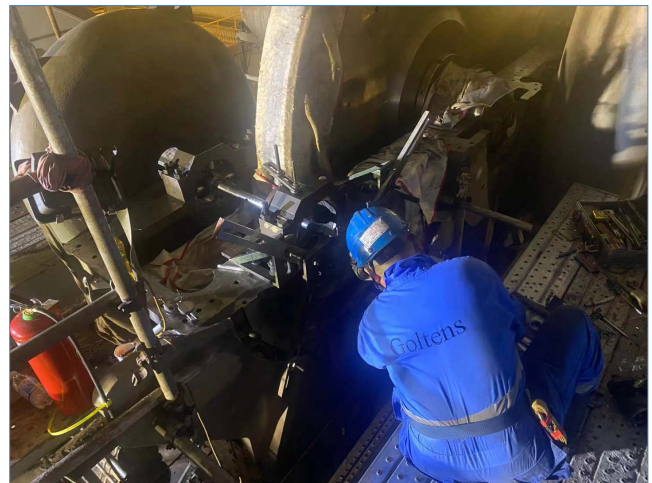
In-Situ line boring of bearing housing to original diameter

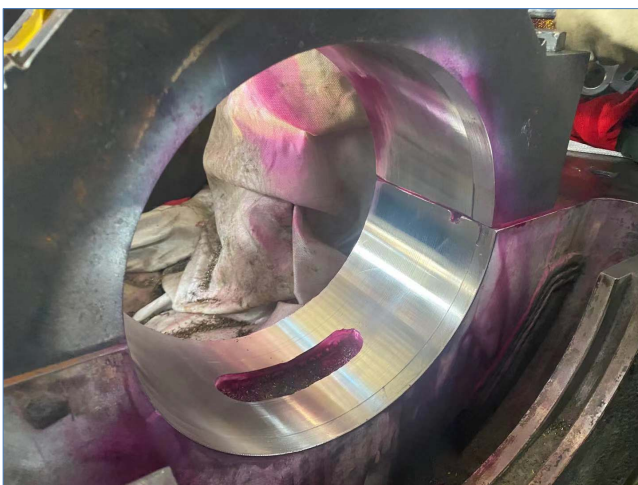
Bearing housing after line boring to original diameter

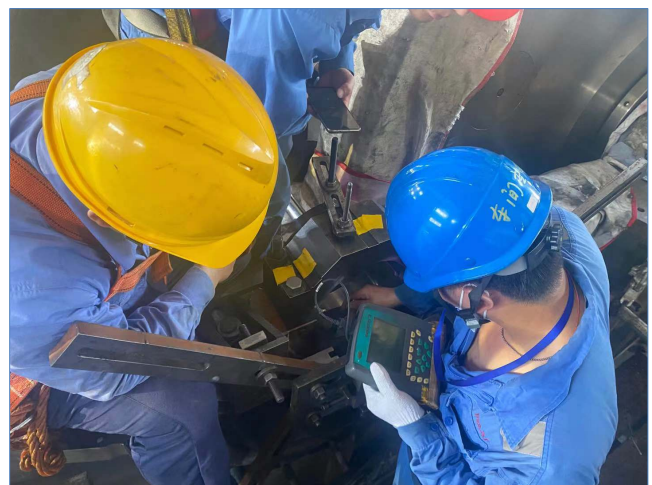
Hardness and calibration checks after machining
