IN-SITU BORING

CYLINDER LINER LANDING SURFACE REPAIR SULZER 16ZAV40S

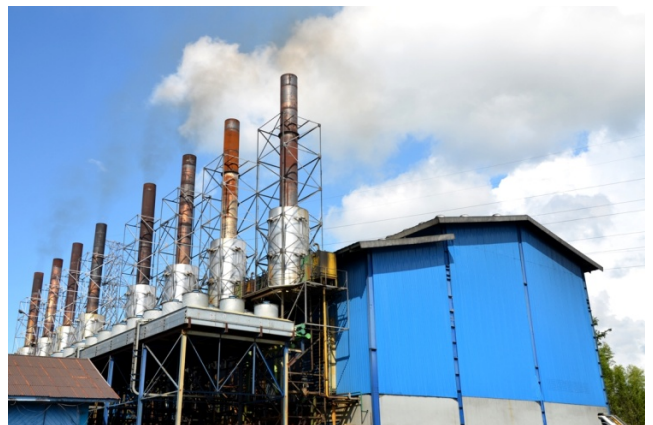
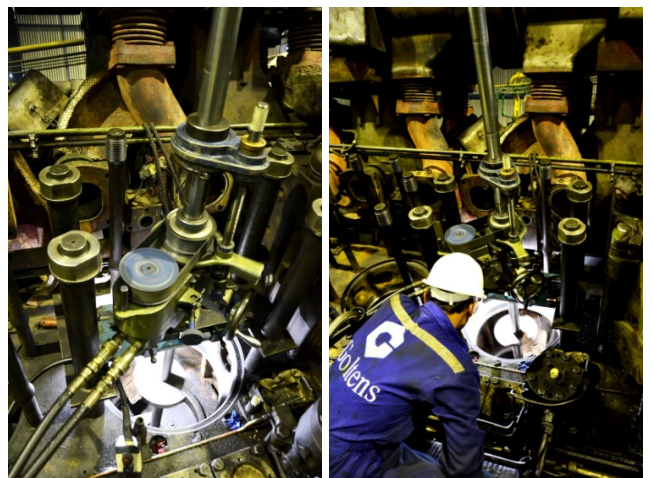
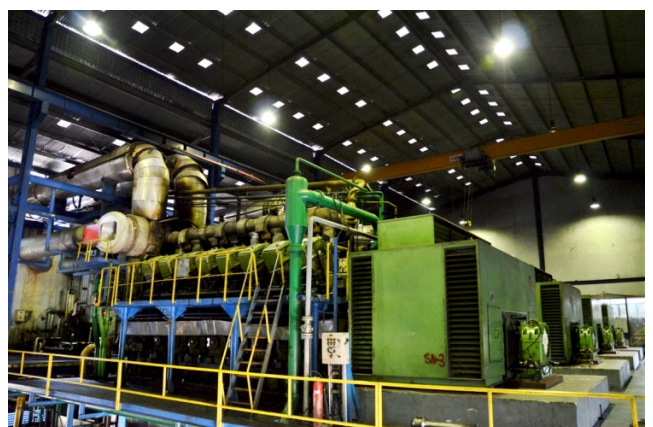
An Independent Power Producer (IPP) company operating in Makassar Sulawesi, Indonesia experienced cooling water leaks in one of their eight Sulzer 16ZA40S generators. As the company supplies power to the main power grid, downtime was a critical issue. Goltens immediately responded by dispatching an In-situ machining specialist and line boring tools along with a specialist Diesel Service Team to assess the root cause and determine the scope of repair work. Inspection determined that the cooling water leakage problems were caused by corrosion in the lower liner landing surfaces of eleven of the 16 cylinders.

To minimize the downtime at the plant, Goltens immediately began machining the 11 liner bores and fabricating ring inserts to restore the bores to original diameter. The pockets were bored, rings inserted and engine rebuilt and restored to operation.

- Dismantling of cylinder head, piston and connecting rod, cylinder liner and accessories to provide access for In-Situ Line Boring machinery
- In-situ machining of 11 liner landing surfaces
- Fabricating and installing the insert bush to restore the cylinder pockets
- Reassembly of all engine components, commissioning and operational testing
