HYUNDAI MAN B&W 6L28/32H CRANKSHAFT REPAIR AND REPLACEMENT

BENT CRANKSHAFT REPAIRED IN WORKSHOP

PROJECT FACTS: CRANKSHAFT REPLACEMENT

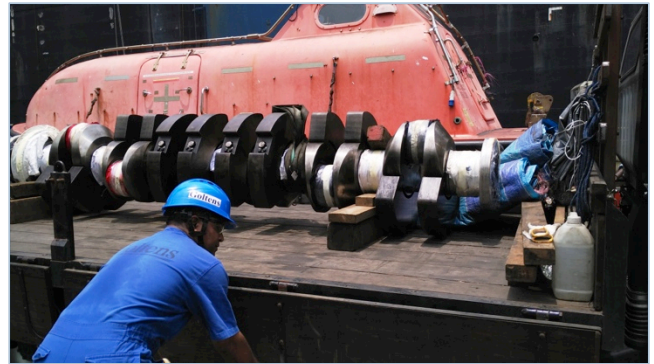
Upon inspection of the damage, Goltens' specialist determined that the bend in the crankshaft was too large to remove by in-place machining. Goltens advised that the crankshaft needed to be removed and taken to Goltens' facility for straightening and journal repairs. Goltens reviewed the repair procedure with the attending superintendent and mobilized teams to the vessel to begin the job.

Damaged crankshaft rigged for transport to shop

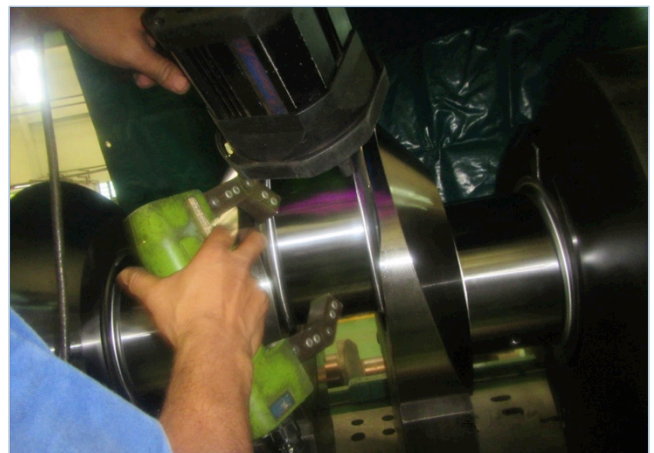
MPI crack tests performed on all journals

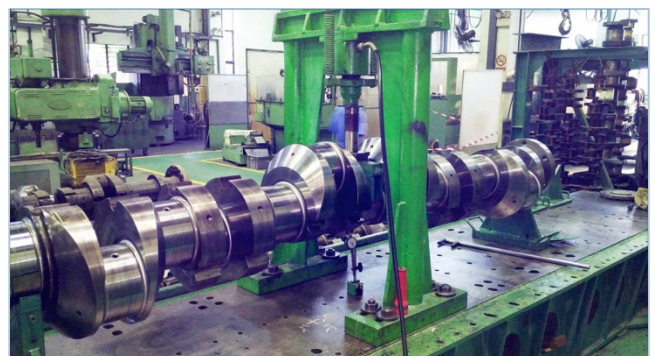
Straightening of crankshaft in Goltens' workshop

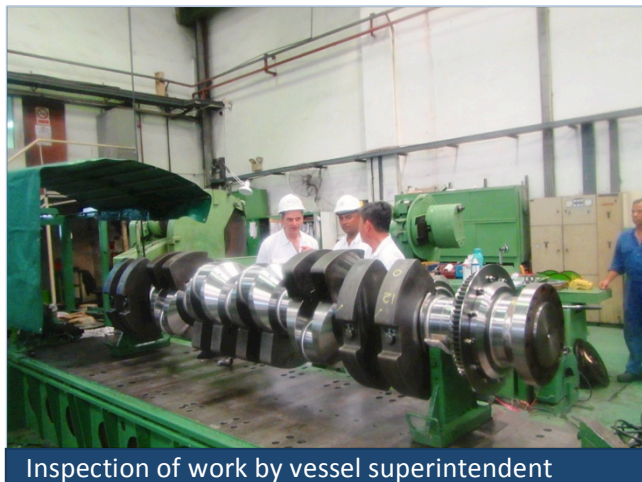
Inspection of work by vessel superintendent

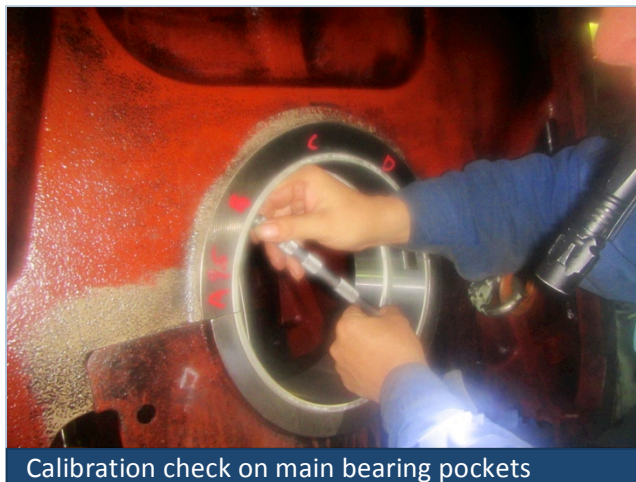
Calibration check on main bearing pockets

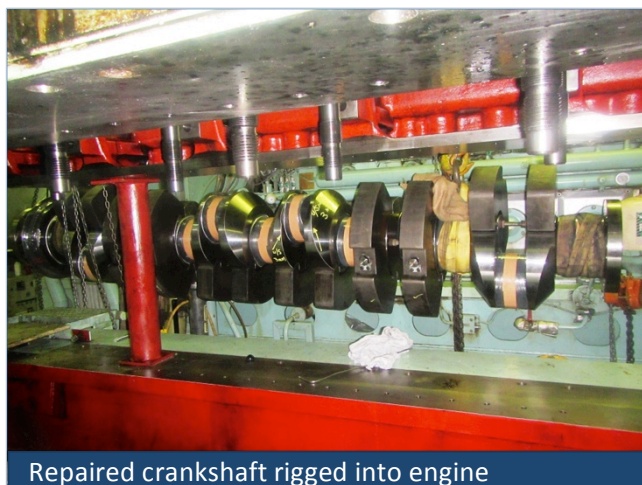
Repaired crankshaft rigged into engine

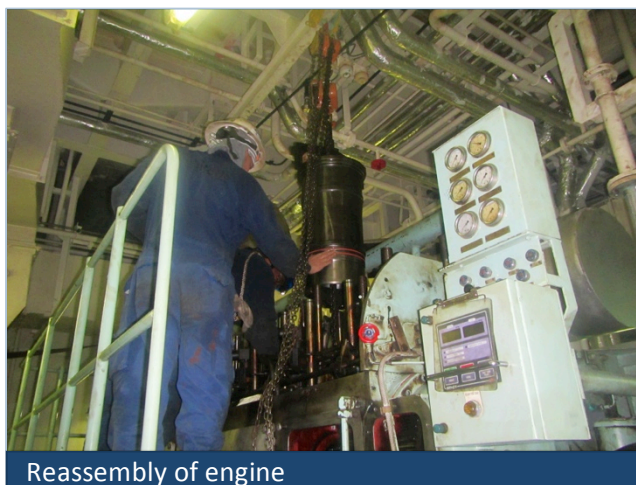
Reassembly of engine

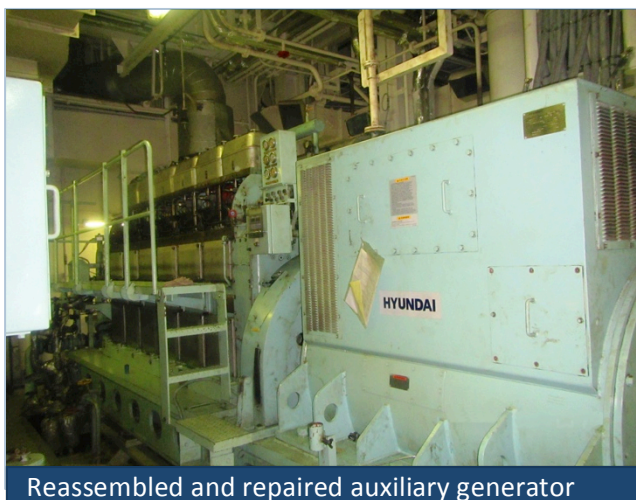
Reassembled and repaired auxiliary generator
