IS A REPAIR EVEN POSSIBLE?

LASER SCANNING, METAL STITCHING AND IN-SITU MACHINING ON MITSUBISHI-MAN 6L 40/45 MAIN ENGINE AFTER CATASTROPHIC FAILURE

PROJECT FACTS: METAL STITCHING REPAIR

Engine Type:	Mitsubishi MAN 6L40/45
Location:	United States
Engine Output:	3,310 kW (4,500 hp)

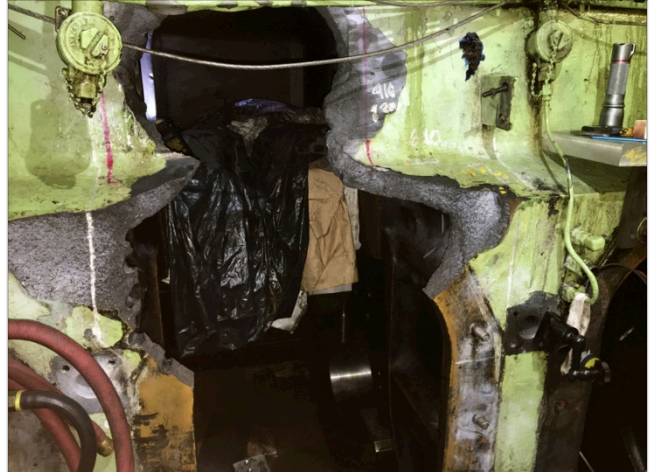
Goltens was called to answer these questions, when this nightmare turned reality aboard a 34-year-old rail vehicles carrier. Goltens specialists surveyed the engine and discovered, in addition to the large hole in the engine block, damage to the lower liner-landing surface, the crankpin, the counterweight-mating surface and bolt as well as the oil sump. Under other circumstances, the engine block may have been replaced. However, because of the age of the vessel, absorbing the massive cost of a replacement block was not an economically viable solution for either the owner or the insurer. Goltens’ proposal and demonstrated engine repair capability gave the owner the confidence to move forward.

Extensive damage to crankcase from casualty

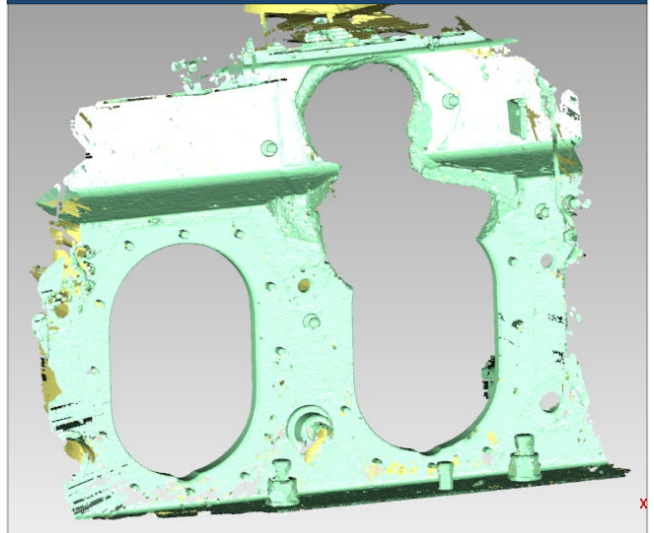
Cast metal repairs are a routine job for Goltens but due to the size of the hole and the angular or “stepped” surface of the block, Goltens performed 3-D laser scanning to provide the exact dimensions of the damaged area and performed extensive crack testing to ensure there was no damage extending farther into the crankcase. Drawings were then generated from the scan data and the large section was cast and milled along with an identical wooden dummy.

3D Laser Scan of damaged area

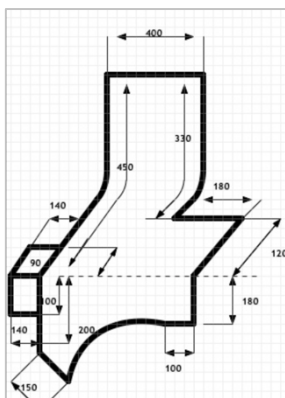
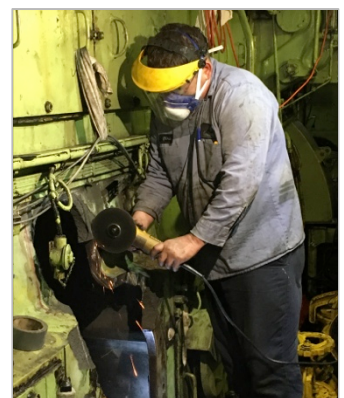
Cast model design and cropping damaged section

While waiting for the cast piece to be fabricated, Goltens technicians cropped out the damaged section of the block to create smooth surfaces along the edges suitable for metal stitching. As the cast metal section was quite heavy, the wooden dummy was cut and shaped into the exact dimensions of the cropped section and used as a template to machine the cast section.

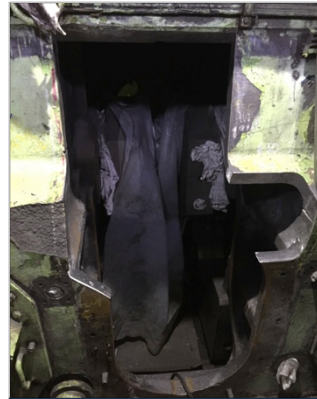
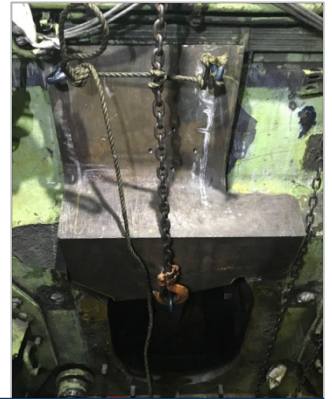
Insertion of cast piece into cropped section

Once machined, the piece was rigged into place and Goltens' In-Situ machinists began the long process of drilling and tapping the metal stitching pins along the long seams, drawing the mated surfaces together. Once this was completed, precision hole patterns were drilled and locks were inserted across the stitched joint line to reinforce the repair and distribute load stress away from the failure point.

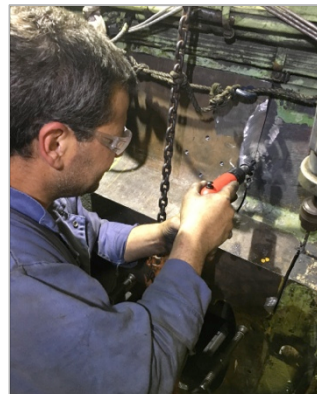
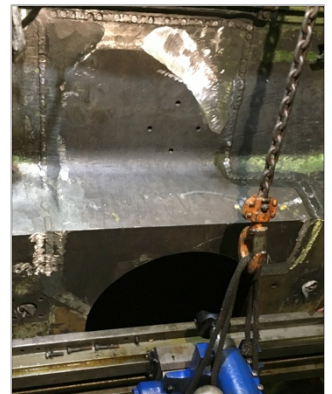
Metal Stitching the mated seams

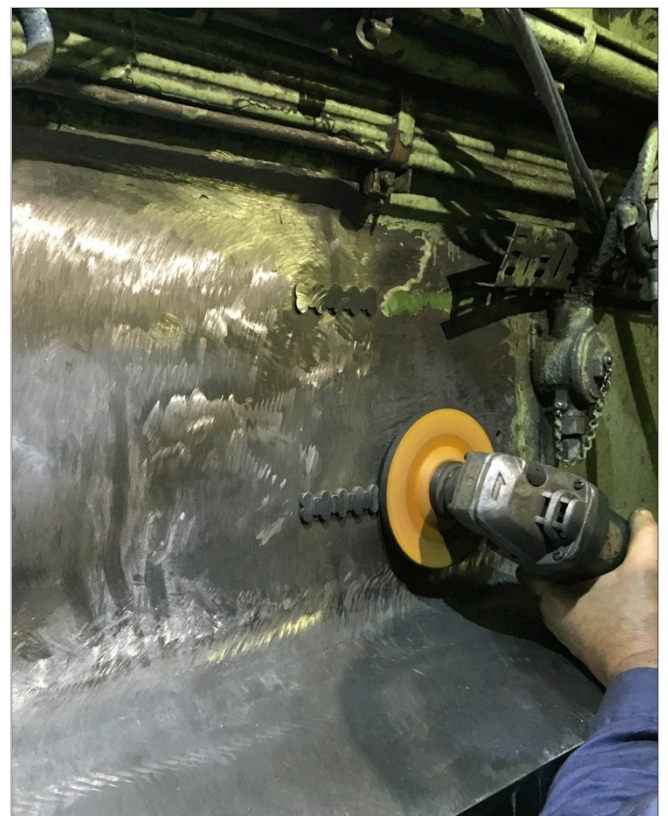
Finish grinding after locks were inserted
