MAJOR INSPECTION/OVERHAUL FOR GAS TURBINE PLANT IN BANGLADESH

GE FRAME 6B GAS TURBINE WORK RESULTS IN MAJOR IMPROVEMENT IN CAPACITY

PROJECT FACTS: FRAME 6 GAS TURBINE

Customer:	Bangladesh Power Development Board (BPDB)
Location:	Sylhet, Bangladesh
Plant:	Fenchugonj Combined Cycle
Turbine Brand:	General Electric
Turbine Type:	PG 6581 B, GE Frame 6B, DLN 1
Output Power:	35.700 kW

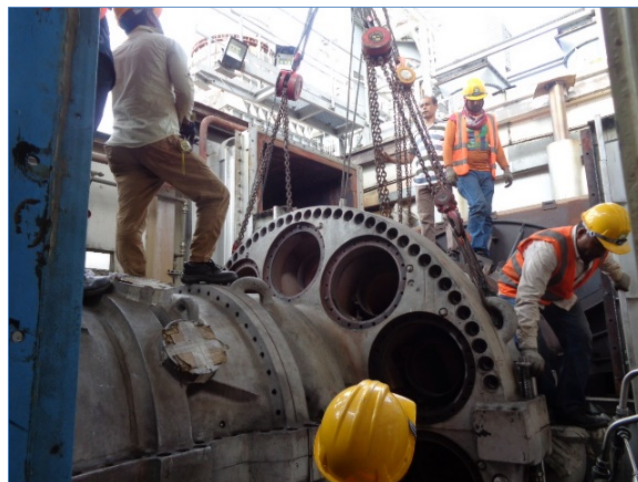
Figure 2: Removal of Turbine casing

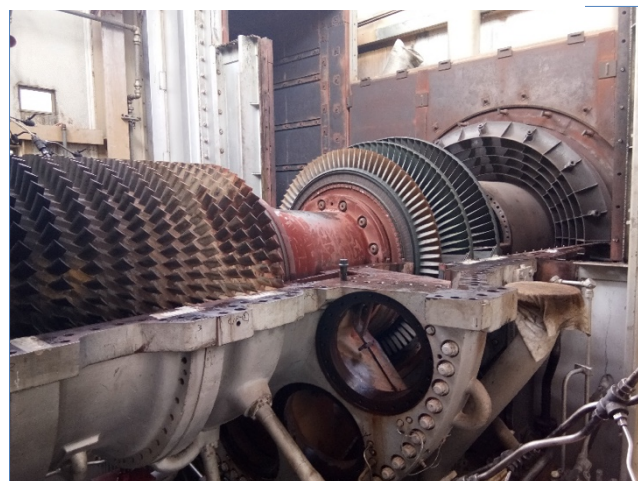
Figure 3: Turbine casing removed

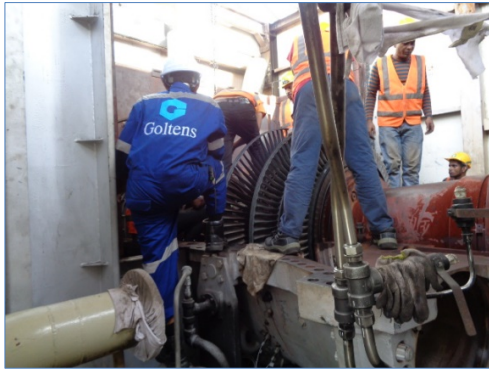
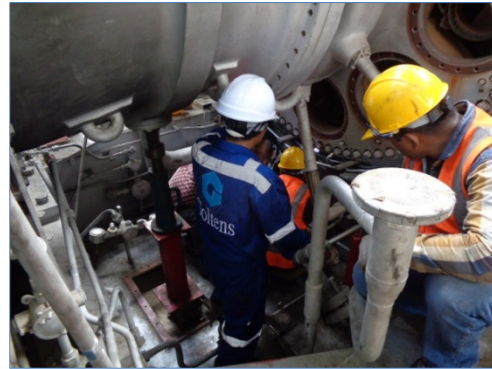
Figure 4-5: Dismantling turbine and accessories

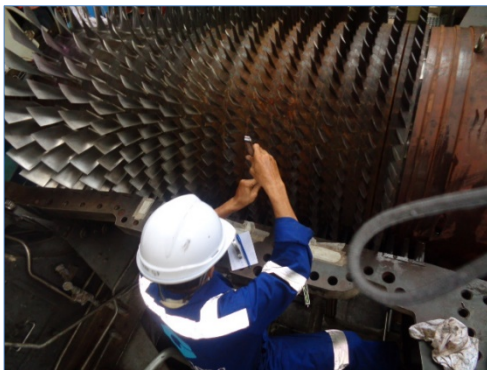
Figure 6: Positioning Turbine for clearance readings

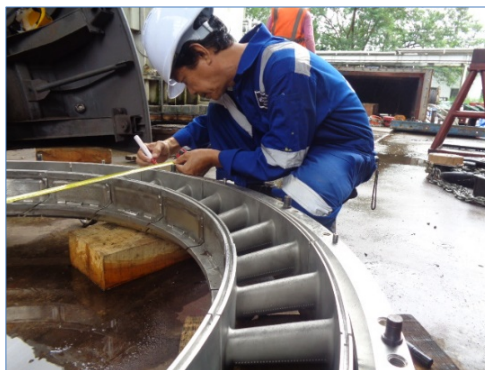
Figure 7: Recording clearance data

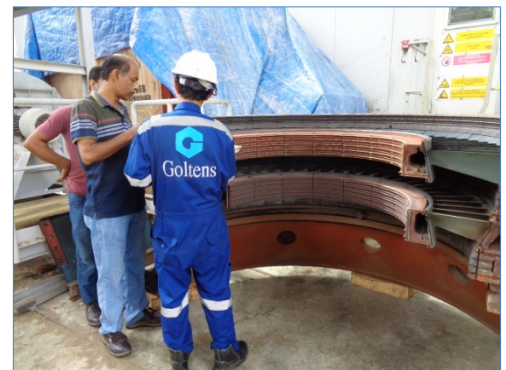
Figure 8: Inspection of turbine components

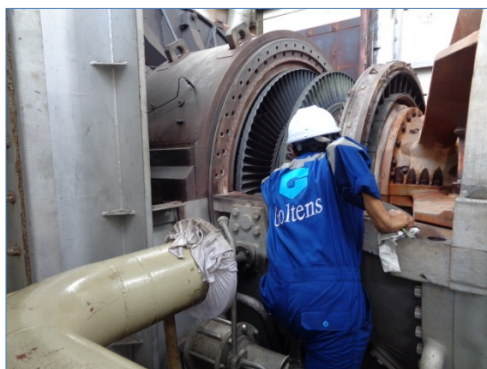
Figure 9: Inspection of turbine components

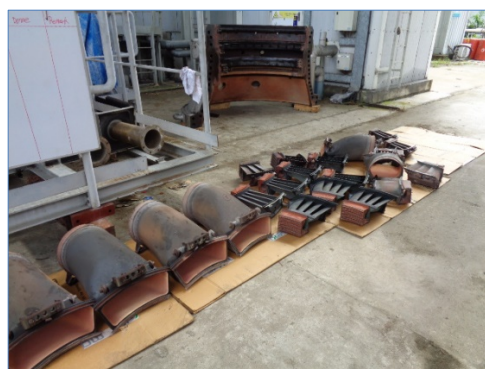
Figure 10: Cleaning of turbine components

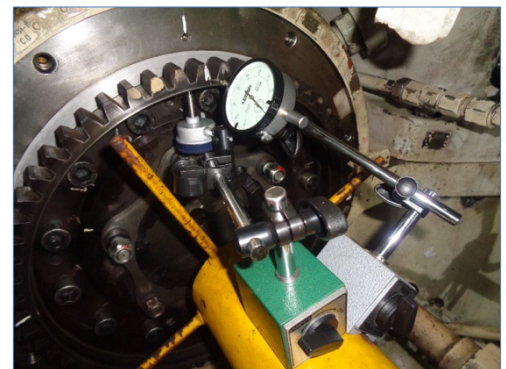
Figure 11: Turbine Shaft alignment check

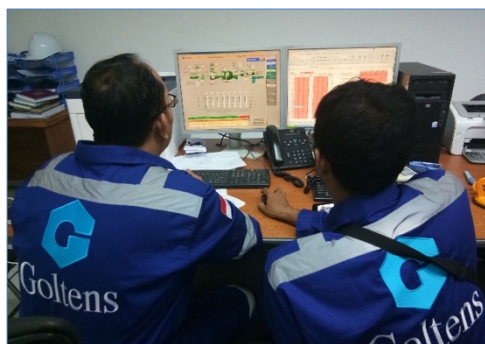
Figure 12: Mark VI Distribution Control System Inspection
