5 DAY TURNAROUND ON YANMAR METAL STITCHING & CRANKSHAFT GRINDING

CONNECTING ROD FAILURE ON BULK CARRIER'S YANMAR 6N18-UN AUXILIARY

PROJECT FACTS: MV VTC OCEAN

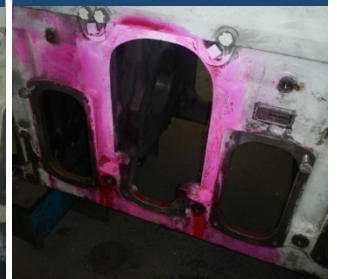
Damaged edges cleared

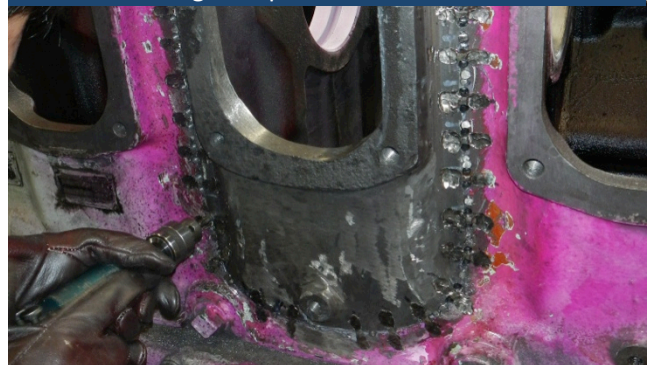
Metal stitching of replacement door to block

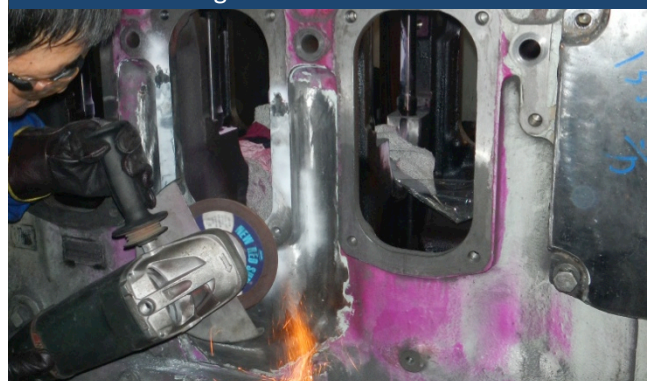
Finish machining of the metal stitched block

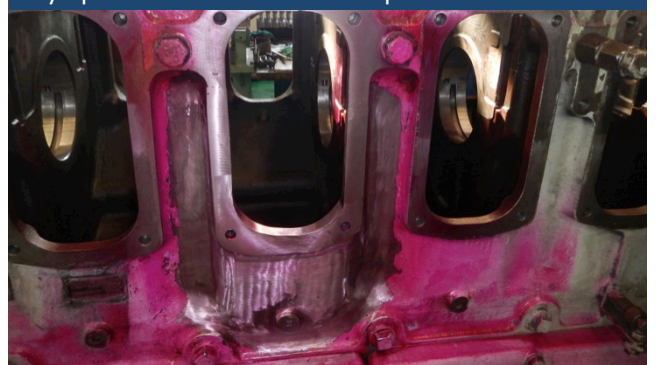
Dye penetrant crack test of repaired block
