## METAL STITCHING REPAIR SALVAGES BADLY DAMAGED MAK 12M282 ENGINE BLOCK

### CONNECTING ROD FAILURE ON OFFSHORE SUPPLY VESSEL'S MAK 12M282 GENERATOR

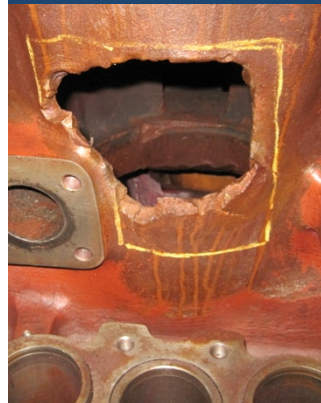
A highly specialized offshore vessel in the US Gulf suffered a catastrophic failure on one of its MaK 12M282 generators. The connecting rod broke away from the crankshaft and broke through the block of the engine.

Initial block damage

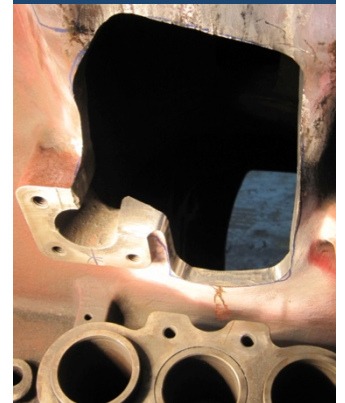
Damaged section removed

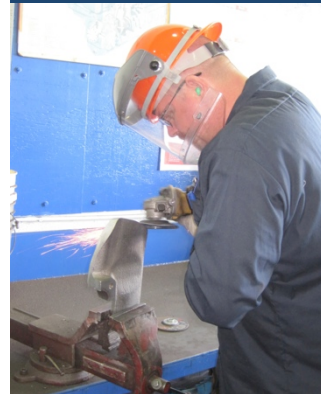
Shaping the patch piece

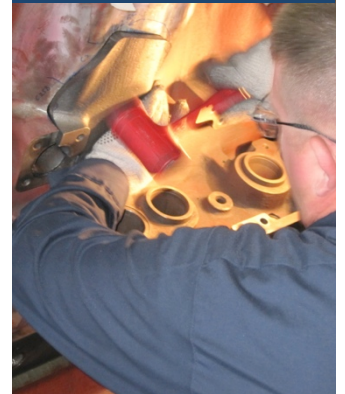
Inserting the patch

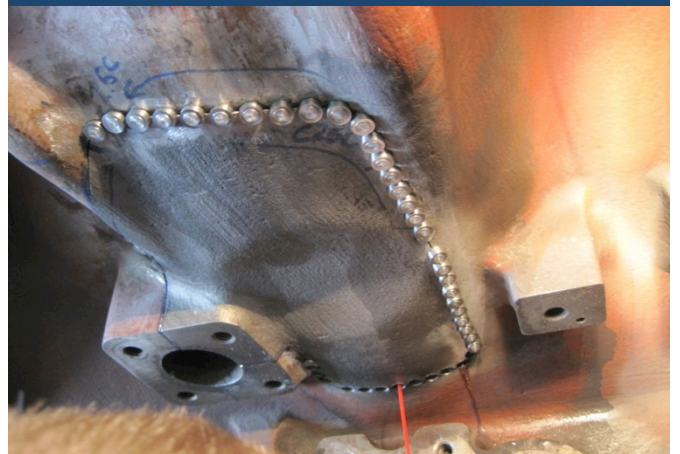
Stitching bolts in place along the seam

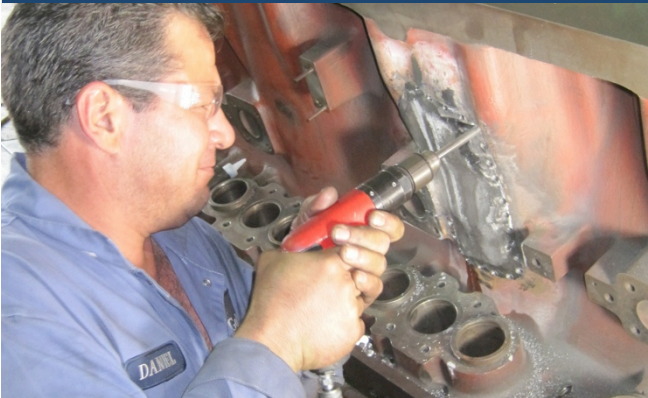
Finishing up with the stitching of the patch

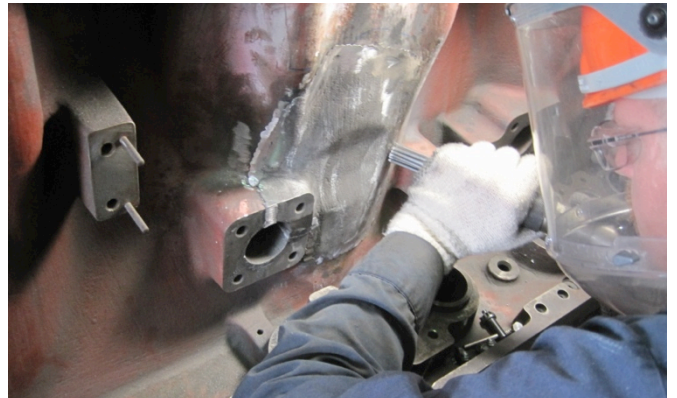
Finishing the completed stitch and preparing for the lock

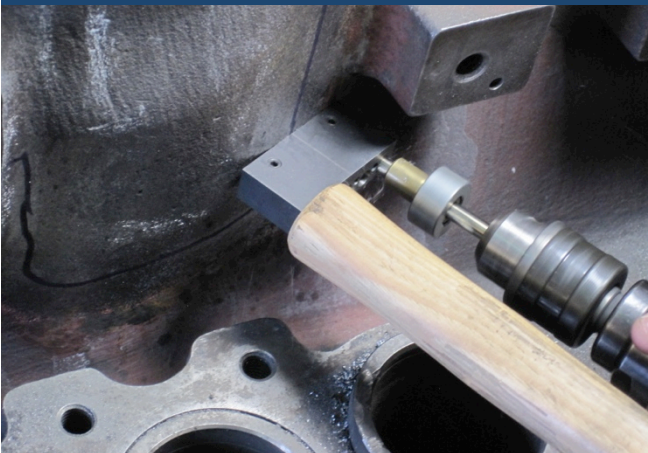
Drilling the hole pattern for the lock insert

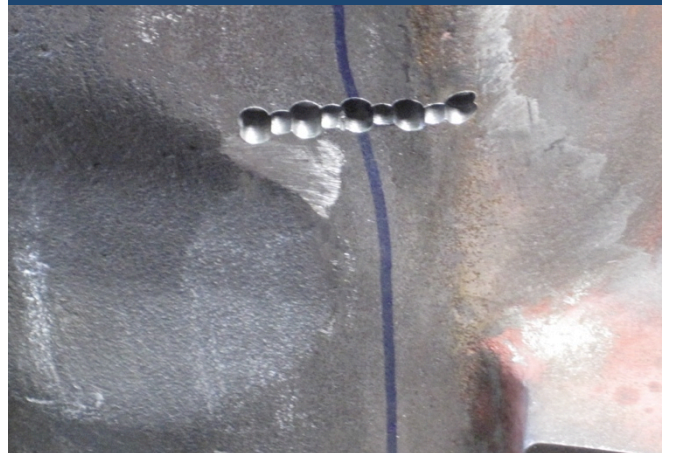
Hole pattern complete – ready for lock insertion

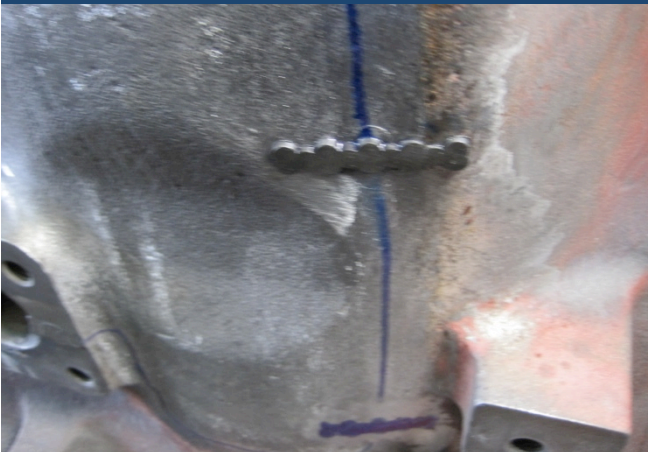
Lock hammered into position

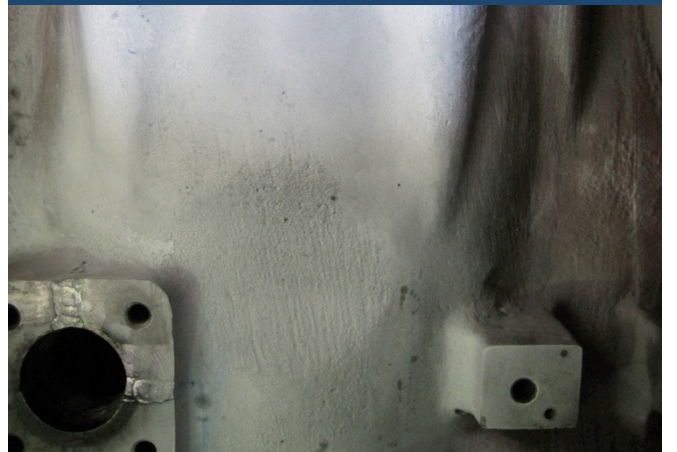
The repair was reviewed and accepted by class and the engine was ready to be rebuilt and put back into service on the vessel. Goltens' metal stitching repair avoided a costly purchase of a replacement block and enabled the owner to repair the engine in a much more cost effective manner.

Completed repair – no cracks present
