IN-SITU X-Y MILLING ON BADLY DAMAGED MAIN ENGINE GUIDE RAILS MITSUBISHI 6UEC52LA CASUALTY RESTORED IN ONLY 10 DAYS

PROJECT FACTS:	HAI FENG 618
Vessel type:	Refrigerated Cargo Ship
Tonnage:	7,934 DWT
Main Engine:	Mitsubishi 6UEC52LA
Power:	7,061 KW

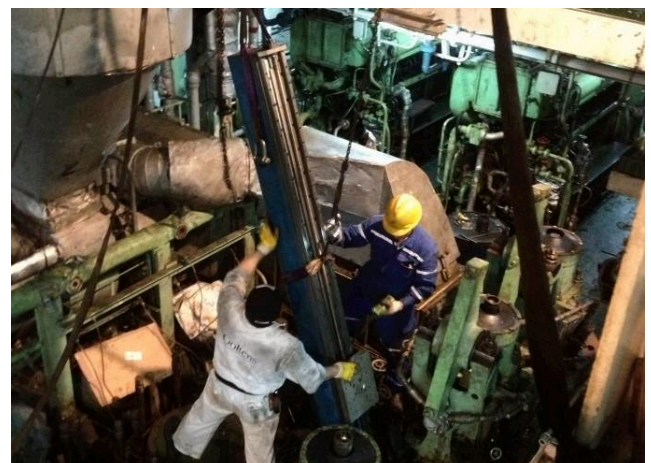
X-Y Milling Machine being rigged into the engine

Goltens' In-Situ specialists modified their in-situ X-Y milling machinery in their workshop to fit within the engine crankcase. After modification at Goltens workshop, the tools were immediately transported to vessel engine room where Goltens' diesel specialists had dismantled the damaged cylinders.

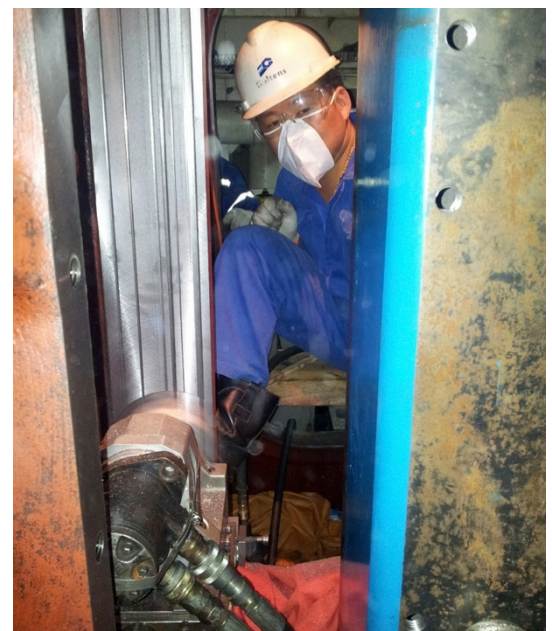
At the ship manager's request, Goltens immediately dispatched their In-Situ Machining Supervisor together with their Technical Manager to check the main engine guide shoe condition. Goltens' inspection revealed severe and deep scoring all along the length of the guide shoe support rails on 3 cylinders as well as serious damage to the guide bearings.

Milling in process on damaged guide rail

- Machining Cylinder No. 1 FWD & AFT guide rail port side to -2.50mm undersize and starboard side to -0.75mm undersize;
- Machining Cylinder No. 2 FWD & AFT guide rail port side to -1.50mm undersize and starboard side to -1.00mm undersize;
- Machine polishing Cylinder No. 3 FWD & AFT guide rails for Port side and STBD side;
- Rebabbiting of the 12 guide shoes for Cylinders 1 and 2
- Rebuilt Cylinder Numbers 1, 2 and 3 after machining
- Commissioning test and successful sea trial
