## IN-SITU MACHINING RESTORES EL SALVADOR POWERPLANT GENERATOR WARTSILA VASA 18V32 PISTON FAILURE

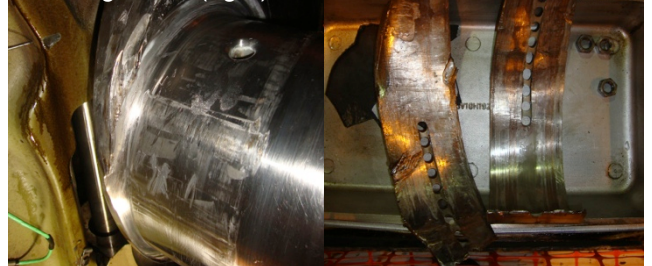
Nejapa Power, a powerplant in El Salvador suffered a major casualty to one of its Wartsila VASA 18V32 generators. As a result of a piston failure, the generator suffered a broken counterweight, sheared counterweight bolts, badly damaged crankpin bearings, a damaged crankpin journal and damaged fillet radii along with damage to other engine components.

Damaged crankpin journal (left) and crankpin bearing shells (right)

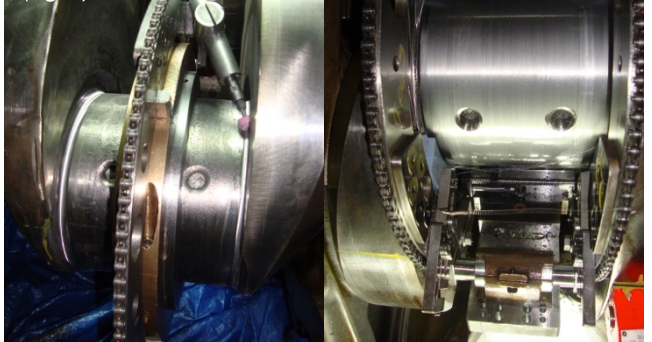
Machining of fillet radii (left) and Crankpin journal (right)

- Machining new fillet radii
- Machining and superpolishing crankpin journal #6 to -3.00mm undersize with finish <math><0.2R\_a</math>
- Removal of sheared counterweight bolts
- Fabrication of a custom jig and surface machining of counterweight mating surface on crankshaft

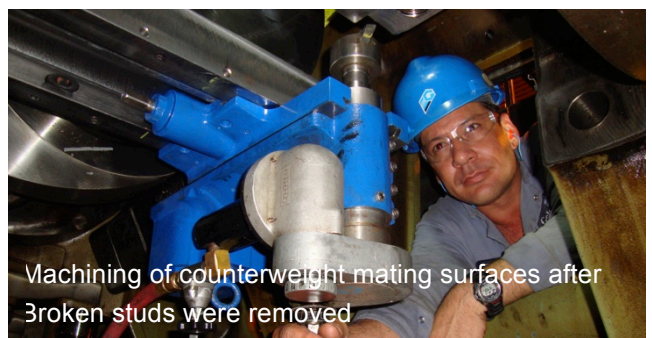
Machining of counterweight mating surfaces after broken studs were removed

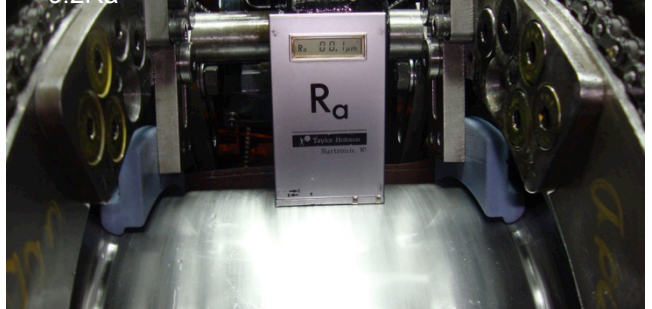
Completed crankpin journal with surface finish <math><0.2R\_a</math>
