ANNEALING AND SINGLE POINT CUTTING SAVES MAK 16CM32 CRANKSHAFT

STATIONARY POWERPLANT - NICARAGUA

PROJECT FACTS: CENSA Nicaragua

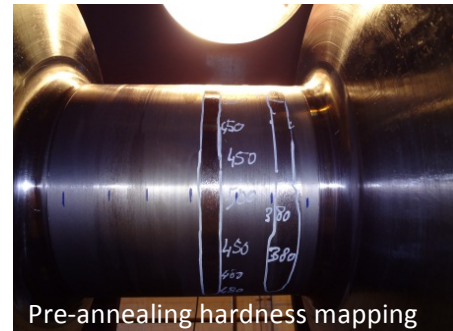
As the pin had already been machined down to 278.5mm, pre-machining was not required prior to annealing. Goltens verified that the crankpin was free of surface cracks and performed a hardness mapping of the crankpin. Hardness values over 500 hB (hardness Brinell) were discovered in spots around the crankpin surface, well above the manufacturer's acceptable limits for hardness.

Pre-annealing hardness mapping

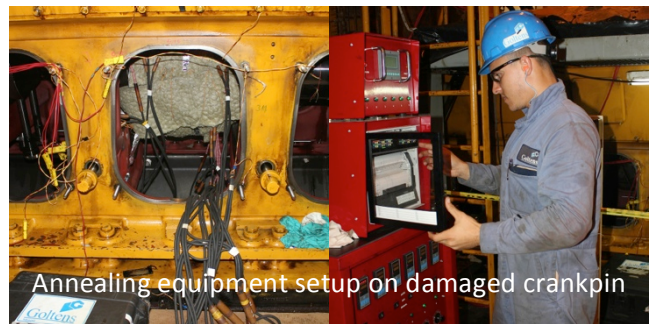
Annealing equipment setup on damaged crankpin

Goltens installed the annealing equipment and performed the annealing process after which the hardness values were brought to within acceptable parameters and the crankpin was finish machined and honed to a final diameter of 278mm.

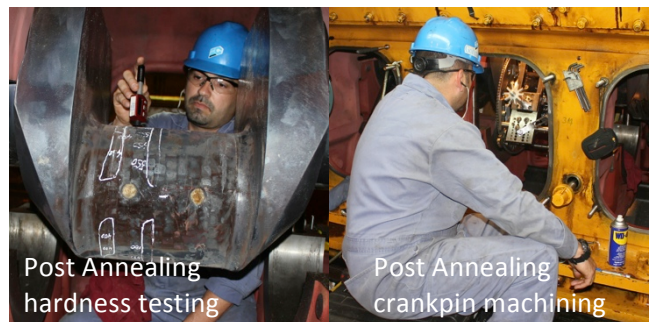
Post Annealing hardness testing

Post Annealing crankpin machining

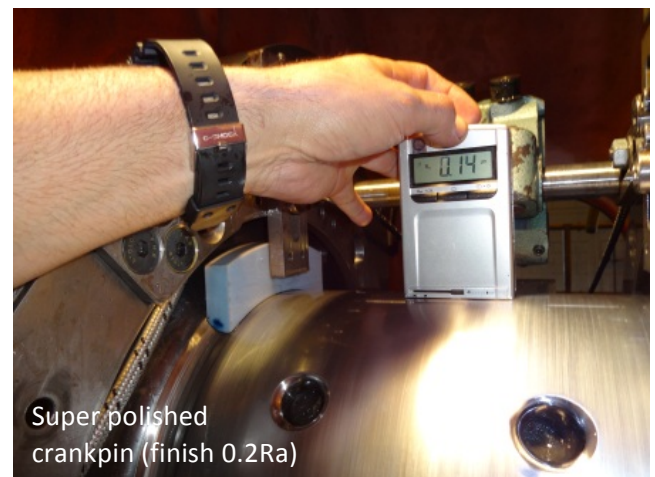
Super polished crankpin (finish 0.2Ra)
