FAST RESPONSE, ON-SITE FLANGE FACING FOR DECK CRANE PEDESTAL FLANGE

CRANE POST FLANGE SURFACE RENEWAL FOR BULK CARRIER IN CHINA

CAPETAN VASSILIS

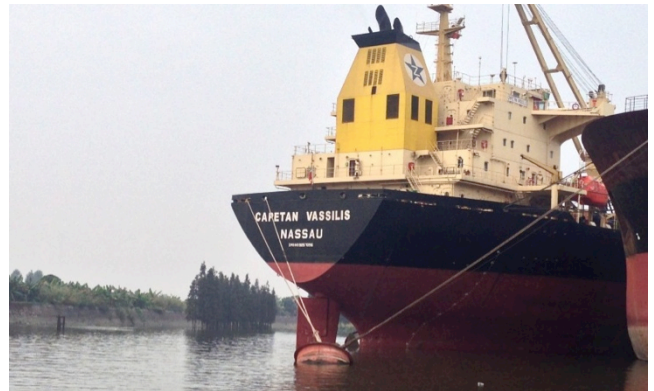
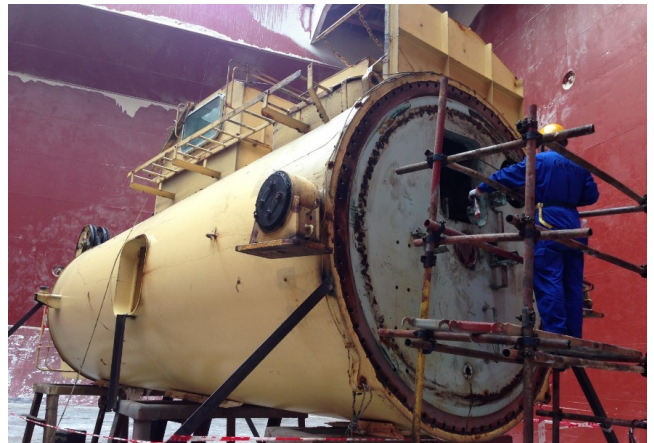
During a short, scheduled dry-docking at COSCO Guangzhou in China, the operator of the Capetan Vassilis, a 10-year-old bulk carrier, encountered unforeseen damage on one of the deck crane pedestal's 2.75-meter diameter flanges.

Inspection of damaged crane pedestal flange

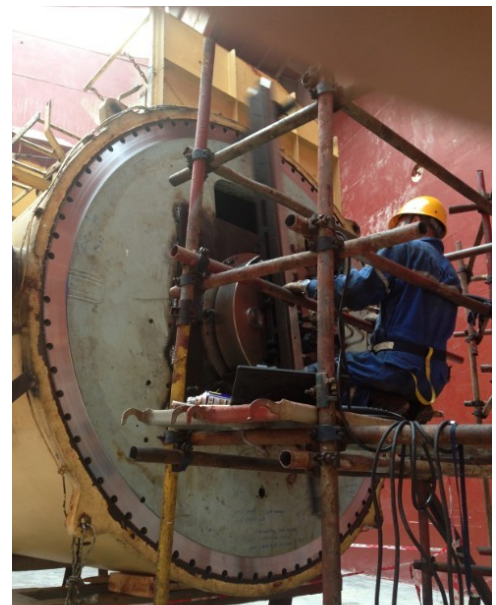
2.75 meter flange facing in progress

- Performed laser flatness checks on crane post flange number 2
- Performed vertical on-site flange facing machining 3.5mm from the crane pedestal flange surface
- Performed post-machining laser flatness checks confirming flatness within 0.15mm.
