IN-SITU ANNEALING & MACHINING RESTORE NAVY FLEET REPLENISHMENT OILER TO SERVICE IN JAPAN

PIELSTICK 10PC4.2V MAIN ENGINE CRANKPIN

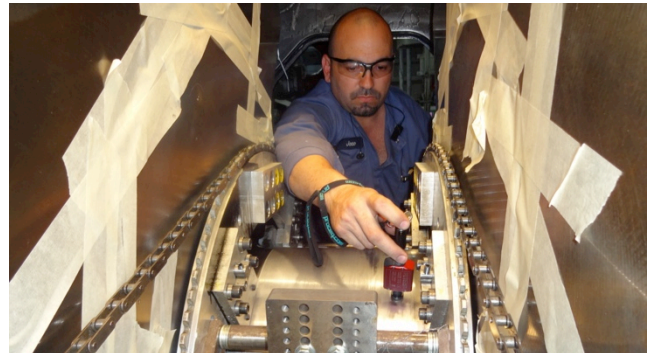
Checking hardness at -0.40mm

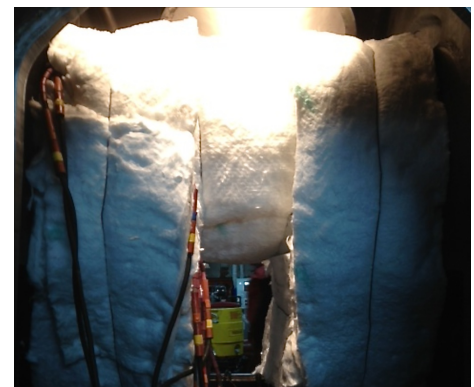
Annealing equipment mounted

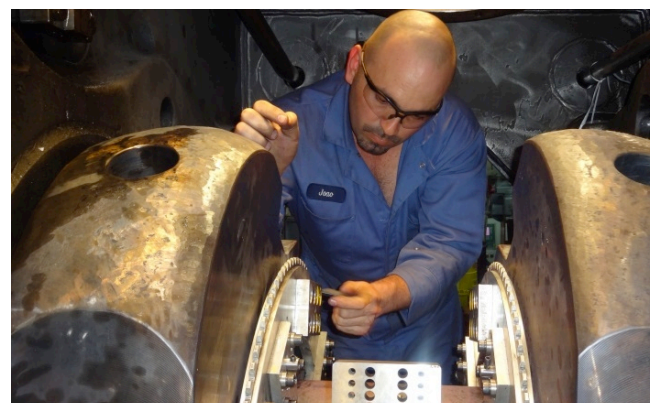
Setting up tooling for post annealing machining

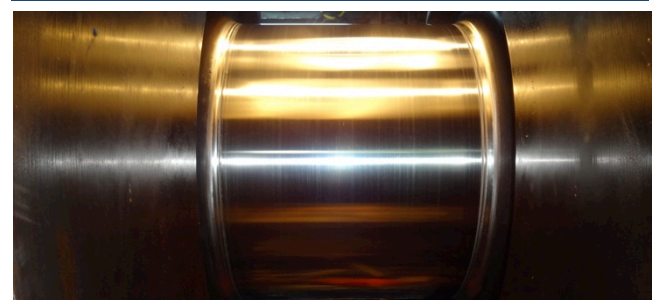
Completed crankpin after polishing (0.4Ra finish)
