## FAST RESPONSE AND COMPREHENSIVE REPAIR FOR ARIZONA NUCLEAR POWER PLANT

### METAL STITCHING BLOCK REPAIR, LINE BORING AND CRANKSHAFT REPLACEMENT FOR EMERGENCY DIESEL GENERATOR

#### PROJECT FACTS:

Plant:	Palo Verde III
Engine Make:	Cooper Bessemer
Engine Model:	KSV-20-T
Rating:	5,500 KW / 600RPM

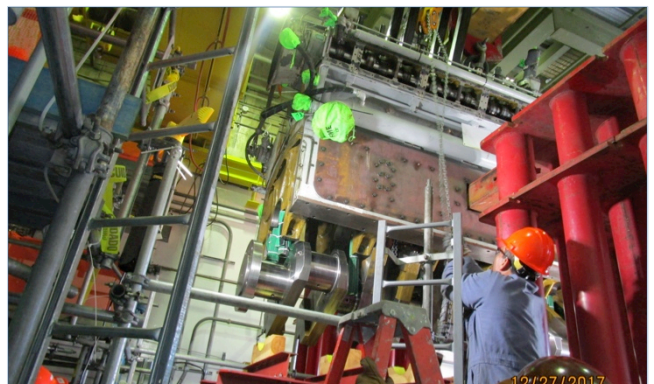
Lowering crankshaft onto skid for removal

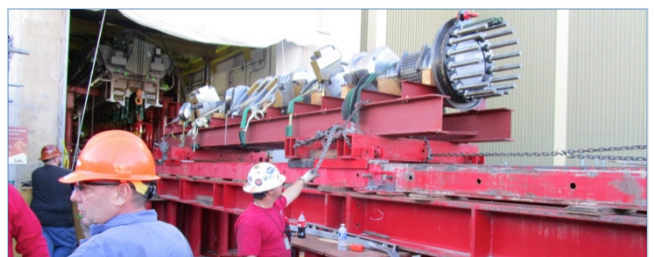
Removal of damaged crankshaft from plant

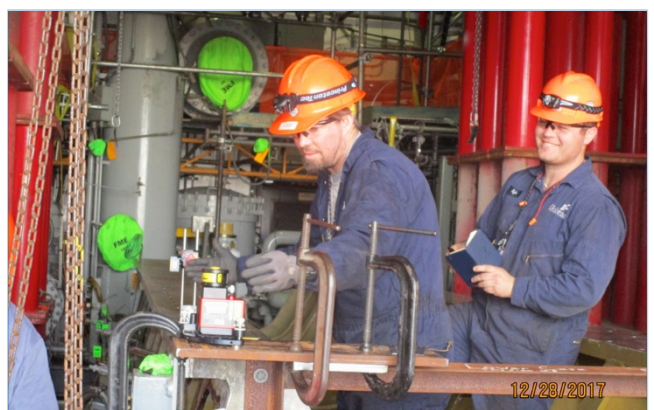
Laser flatness checks on base frame

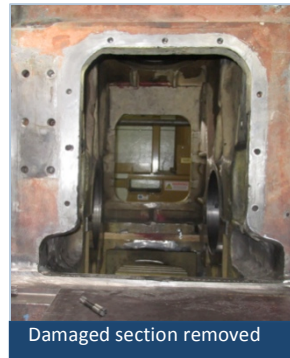
Damaged section removed

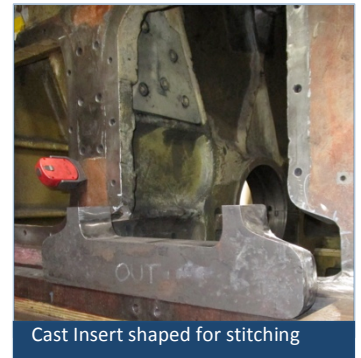
Cast Insert shaped for stitching

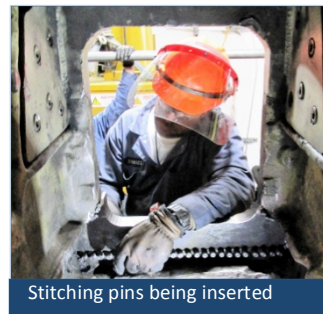
Stitching pins being inserted

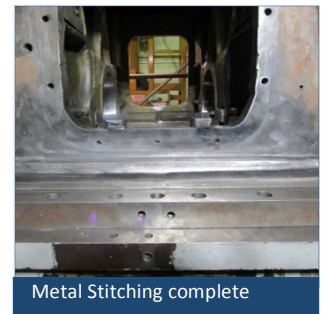
Metal Stitching complete

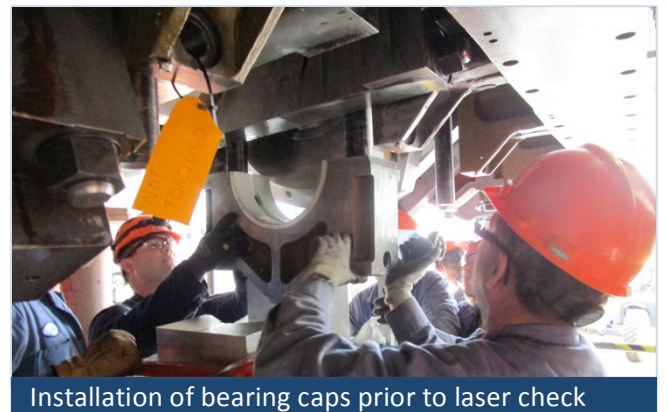
Installation of bearing caps prior to laser check

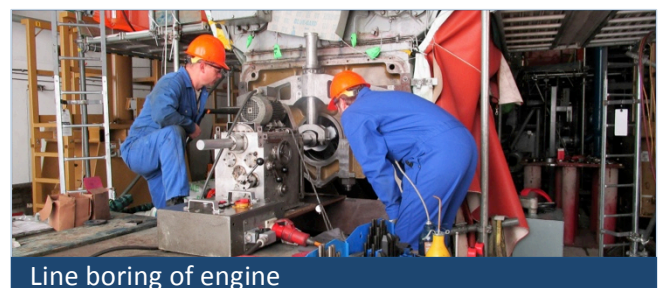
Line boring of engine

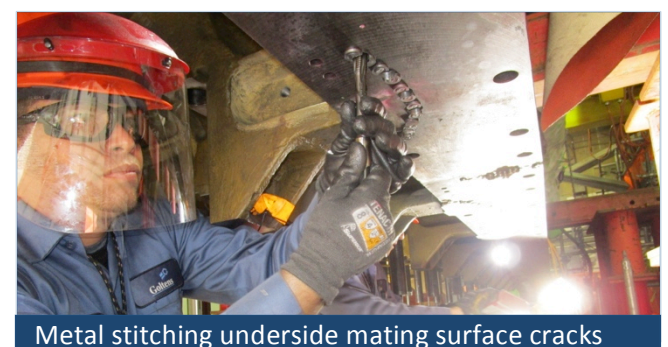
Metal stitching underside mating surface cracks

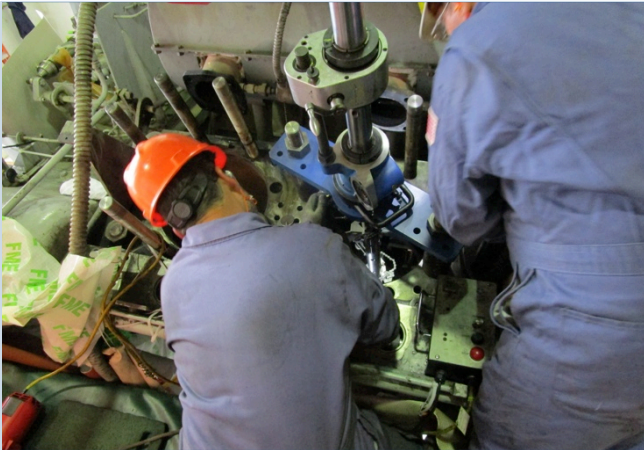
Boring lower liner landing after metal stitching

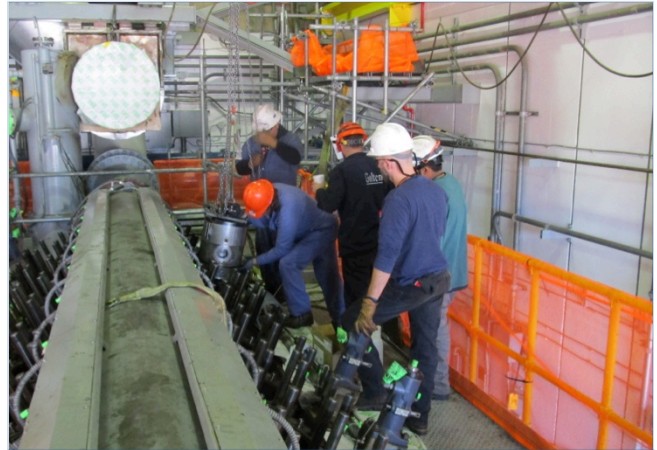
Reinstallation of power packs

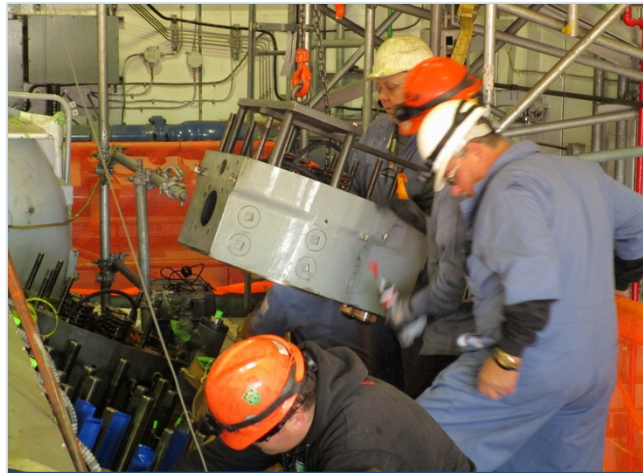
Installation of cylinder heads prior to testing
