## CRANKSHAFT REPLACEMENT, LINE BORING & REBUILD FOR WARTSILA 12V46 ENGINE

### CAREFUL PLANNING AND EXECUTION ALLOWS FOR UNINTERRUPTED OPERATION ONBOARD ROYAL CARIBBEAN CRUISE SHIP

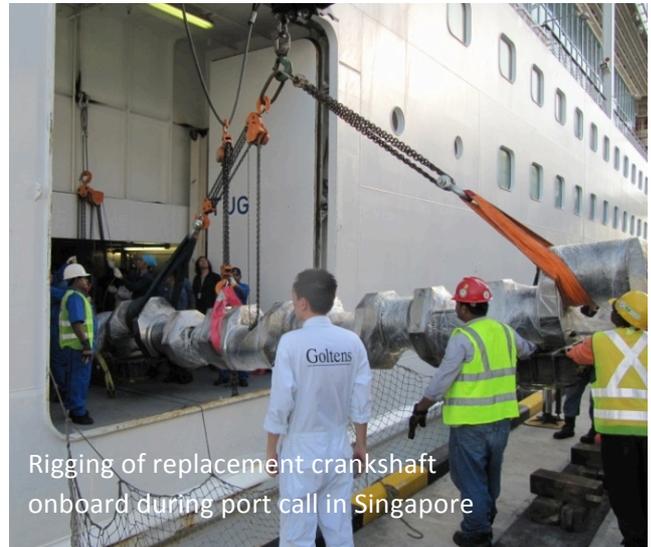
Rigging of replacement crankshaft onboard during port call in Singapore

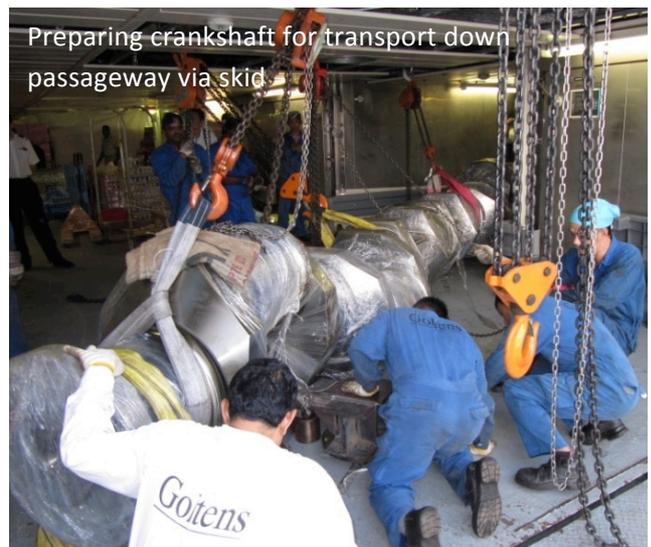
Preparing crankshaft for transport down passageway via skid

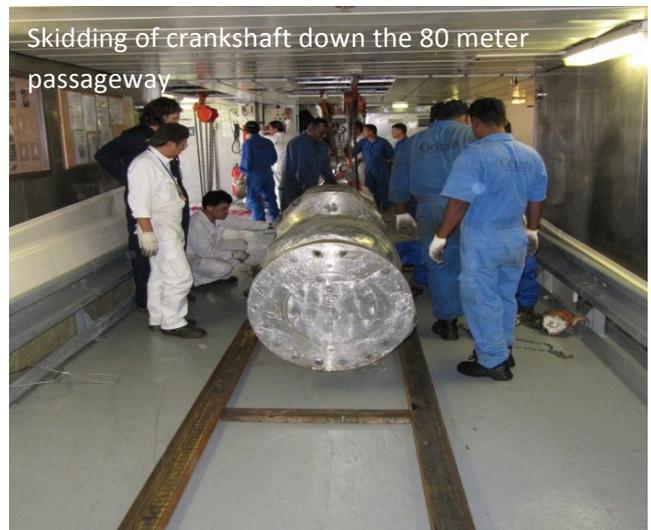
Skidding of crankshaft down the 80 meter passageway

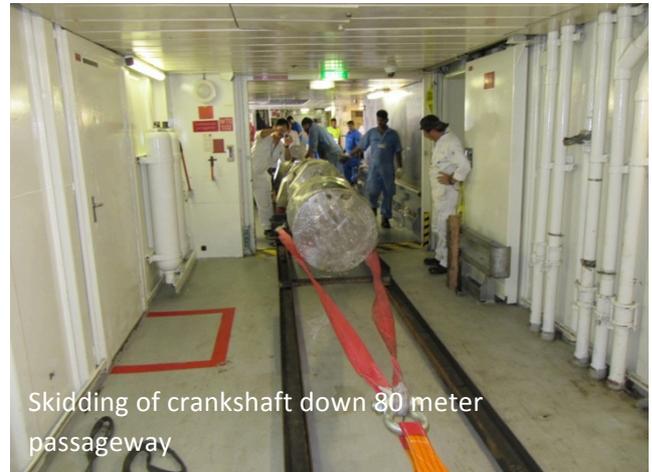
Skidding of crankshaft down 80 meter passageway

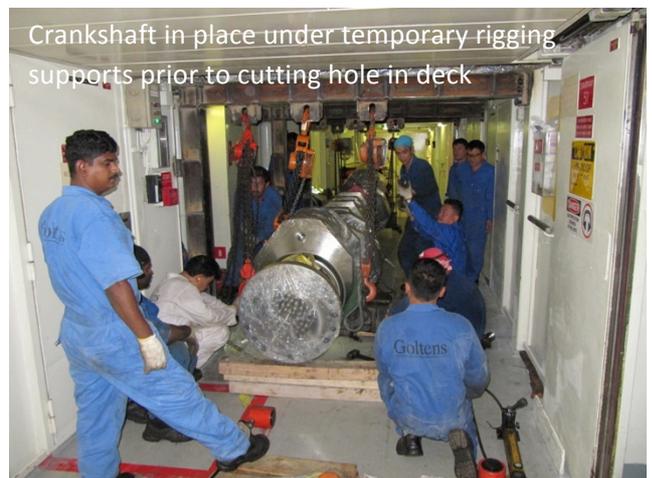
Crankshaft in place under temporary rigging supports prior to cutting hole in deck

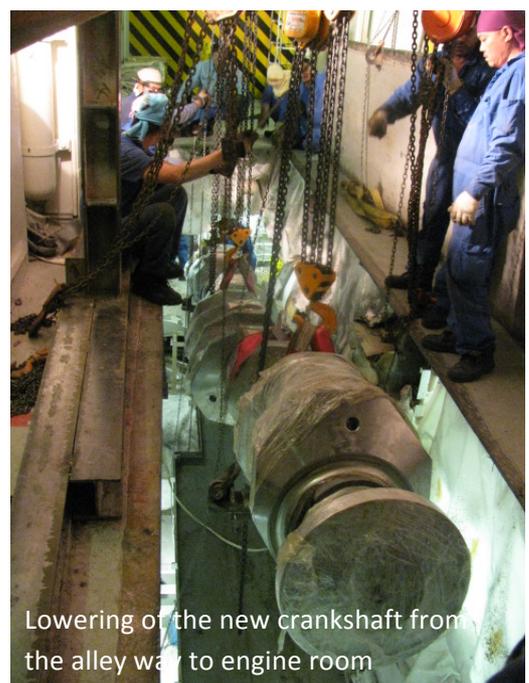
Lowering of the new crankshaft from the alley way to engine room

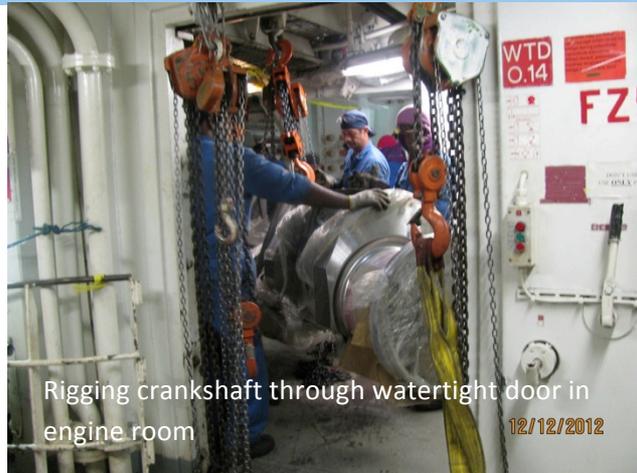
Rigging crankshaft through watertight door in engine room  
12/12/2012

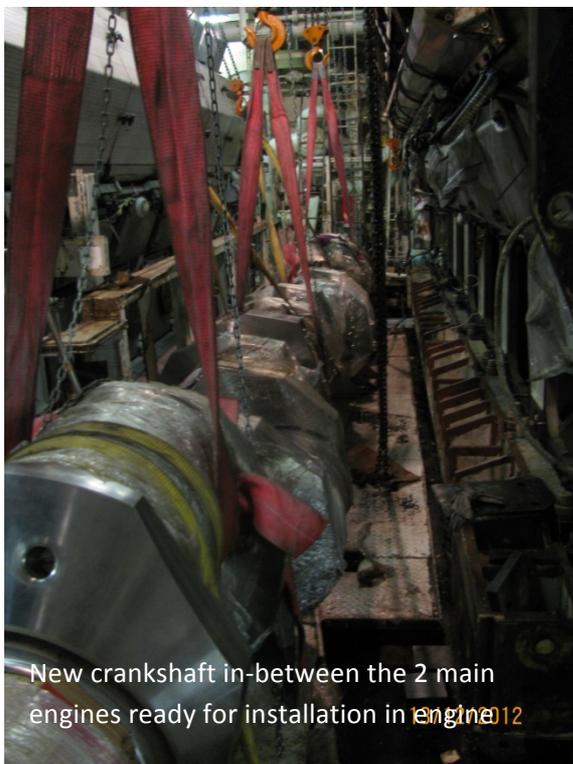
New crankshaft in-between the 2 main engines ready for installation in engine  
13/12/2012

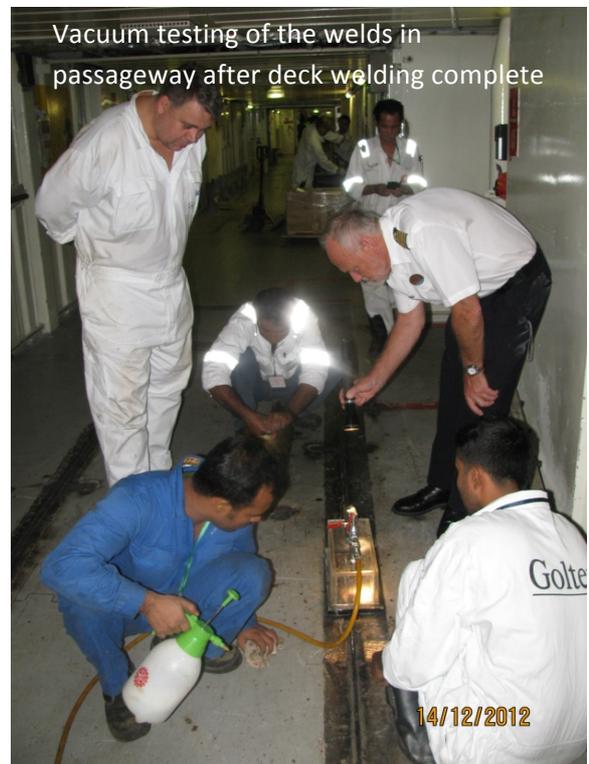
Vacuum testing of the welds in passageway after deck welding complete  
14/12/2012
