REMETALLING AND MACHINING RESTORE AGITATOR SHAFT

GOLTENS' IN-PLACE MACHINING RESTORES INDONESIAN POLYESTER PLANT TO SERVICE

PROJECT FACTS: SHAFT REMETALLING

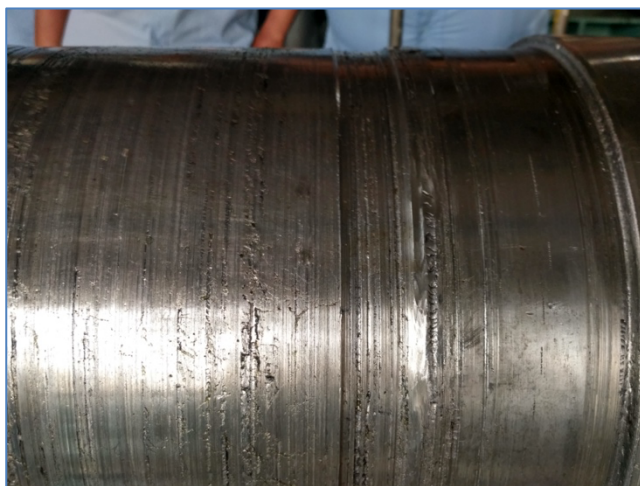
Goltens deployed a team of specialists to the plant coincident with the shutdown of the plant. The team removed all the covers from the unit to complete the inspection. The In-Situ Specialist's inspection revealed significant ovality and scoring/scratches on the journal's running surface.

Figure 1: Scoring damage on Agitator Shaft's journal surface

The extent of the damage would require Goltens to machine away the surface damage to restore the running surface. Complicating the repair, the customer required the diameter to be restored to the original 285mm so Goltens proposed a process to remove the damage, remetal the surface and machine the diameter to nominal measurement.

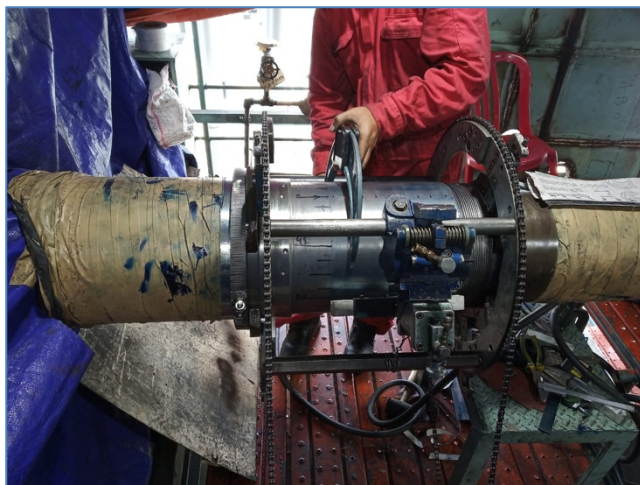
Figure 2: Measurement of undercut shaft at (3.30mm)

Goltens installed its journal machining tools and removed 3.30mm of material from the diameter. Goltens then deployed thermal spraying machinery to remetal the shaft diameter slightly above the 285mm original diameter. Once completed, Goltens finish machined and machine polished the running surface of the agitator shaft to the required original 285mm diameter.

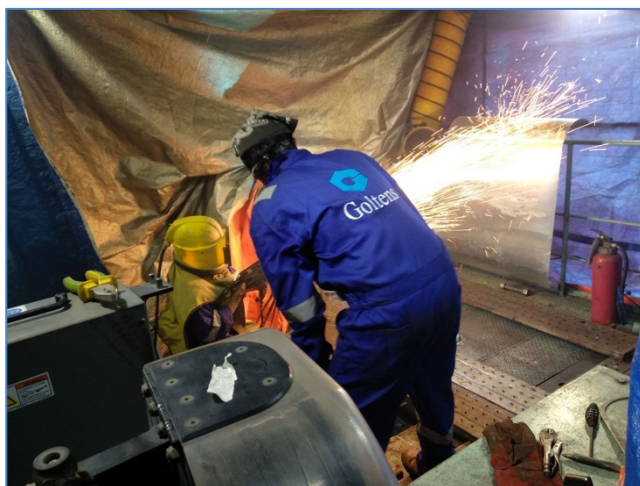
Figure 3: Remetalling/Thermal Spraying of agitator shaft

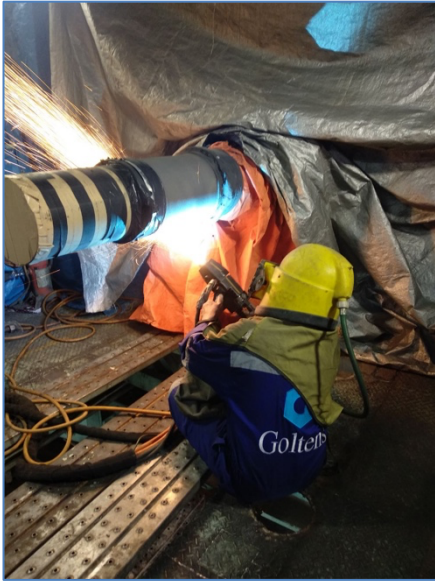
Figure 4: Thermal Spraying of agitator shaft

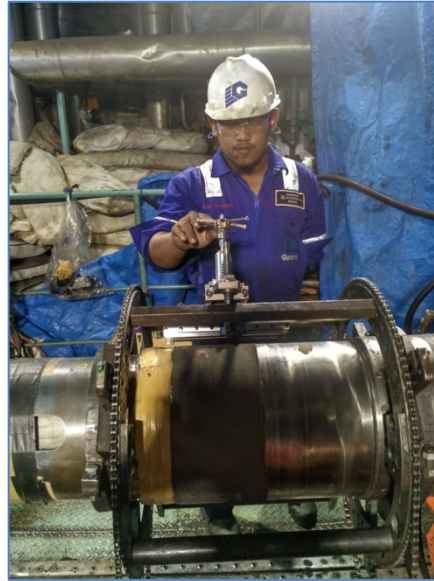
Figure 5: Machining shaft to nominal dia.

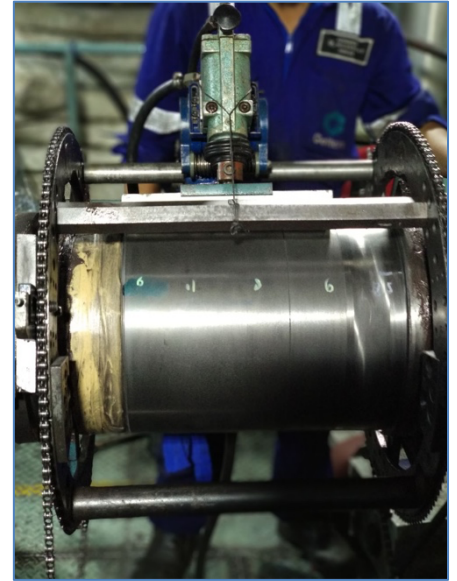
Figure 6: Honing of shaft surface

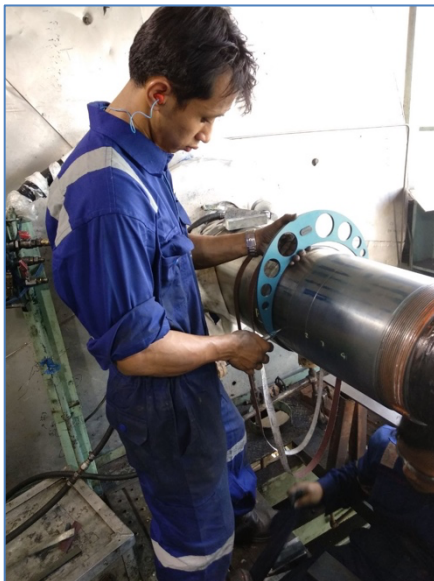
Figure 7: Verifying shaft diameter measurement

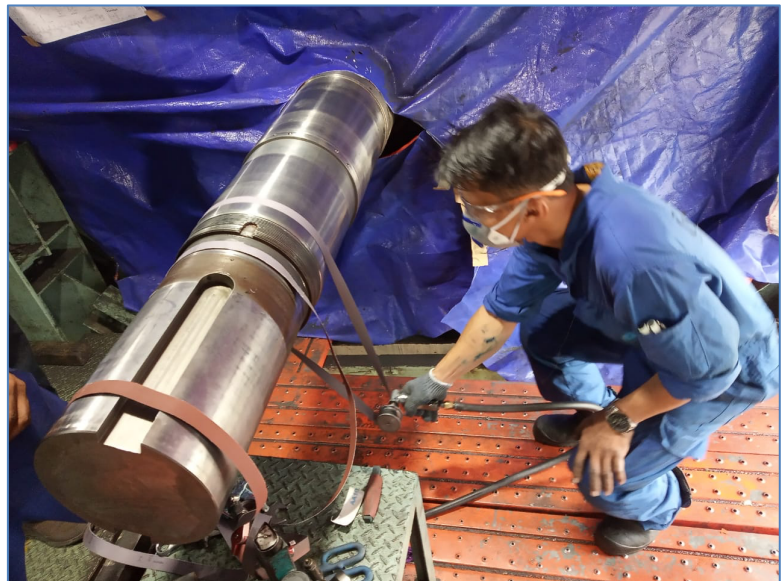
Figure 8: Final polishing of agitator shaft

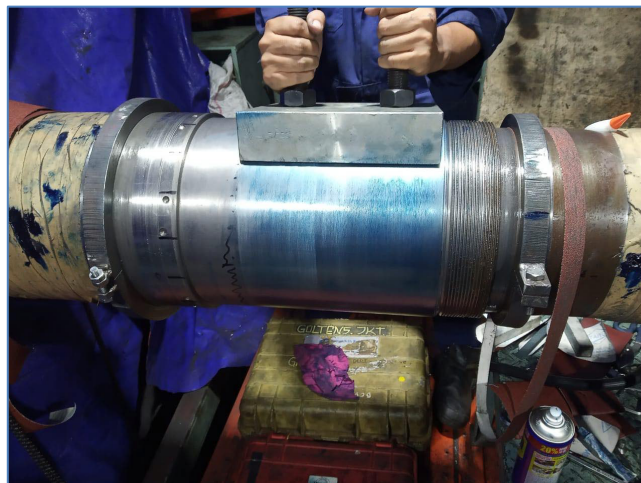
Figure 9: Blue contact test with dummy bearing
