## IN-SITU TAIL SHAFT MACHINING EXPENSIVE SHAFT REMOVAL AVOIDED WITH IN-SITU MACHINING

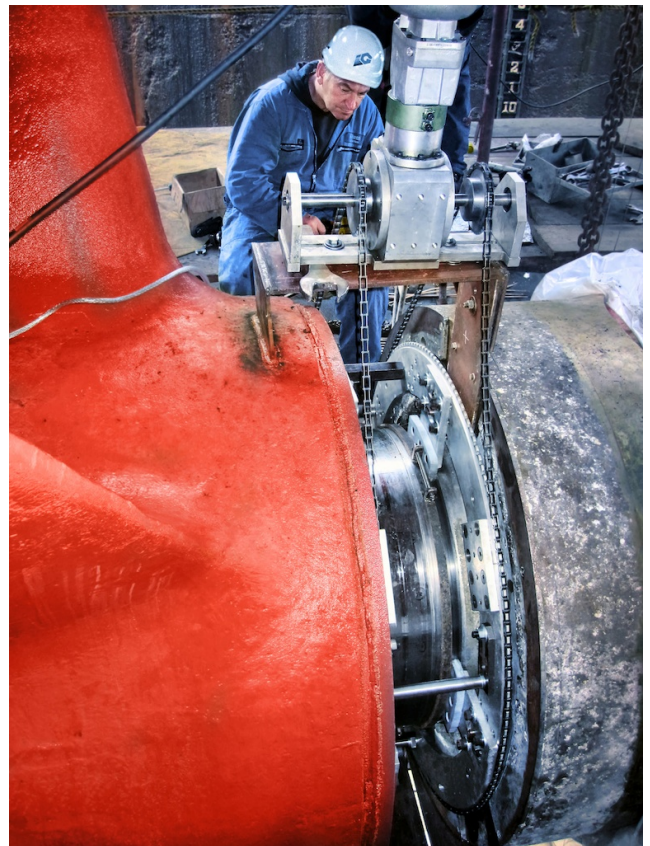
### PROJECT FACTS: Damaged Tail Shaft

Goltens was engaged to undertake the In-Situ inspection of the port and starboard tail shafts on a large military transport vessel while in dry dock. Inspection of the port and starboard tail shafts revealed that the Simplex shaft seal had worn deep grooves in the shaft liners.

- Machined and honed the port shaft 1.0mm to a final diameter of 849 over a length of 220mm
- Machined and honed the starboard shaft 4.0mm to a final diameter of 846mm over a length of 190mm
