SIMULTANEOUS MACHINING OF CRANKPINS SPEEDS REPAIR

GOLTENS' MACHINISTS MACHINE 4 OF 5 DAMAGED CRANKPINS AT THE SAME TIME ON WARTSILA W6L32 ENGINE IN ONLY 8 DAYS

PROJECT FACTS: 5 CRANKPIN REPAIR

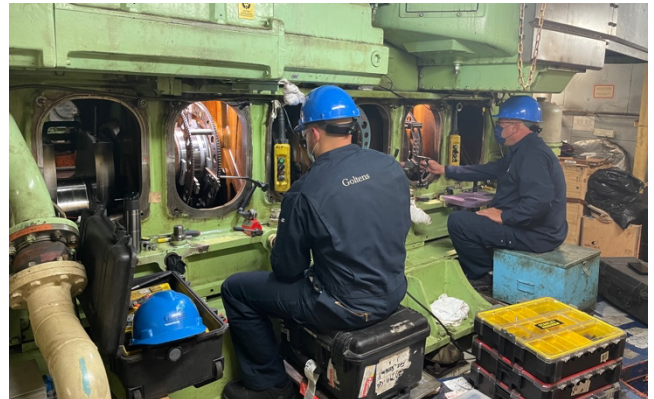
Figure 1: Goltens' In-Place Machinists machining crankpins 2 & 5

Goltens mobilized the team and two sets of tooling to Newark, NJ to meet the vessel. Onboard measurements confirmed that crankpins #2 and #6 were at their maximum wear limits and the others showed ovality. The owner decided to proceed with machining of crankpins #2 to #6 to the next undersize diameter at (0.5mm). Goltens installed two sets of machining tooling on crankpins #2 and #5 and completed machining before moving the machines to crankpins #3 and #4. Crankpin #6 was machined alone to complete the repair work.

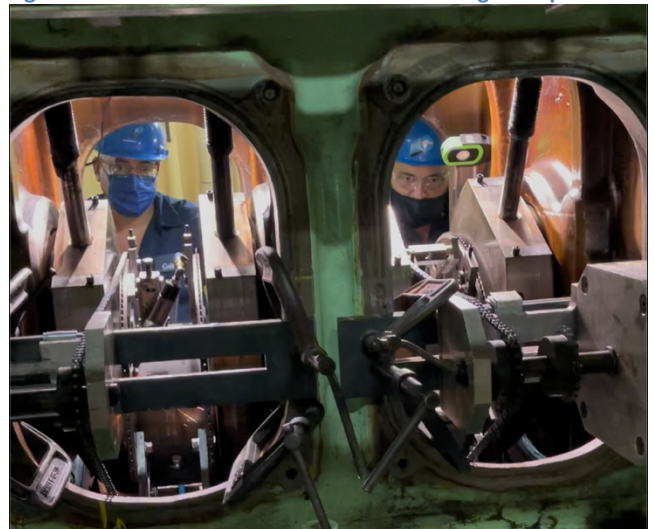
Figure 2: Simultaneous machining of crankpins 3 and 4

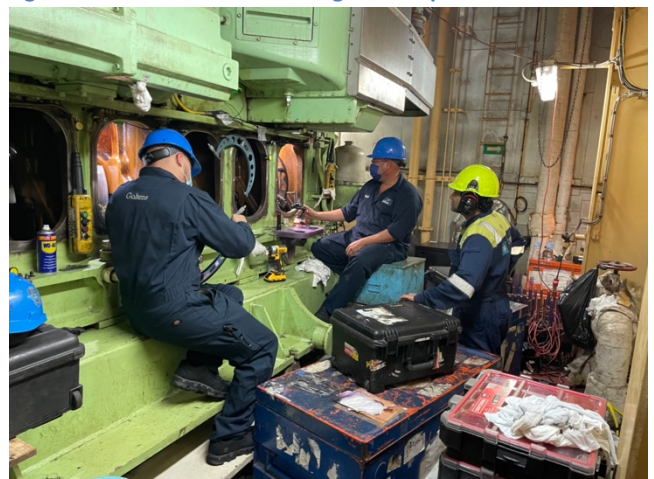
Figure 3: Machining crankpin #6 under observation of ship's crew

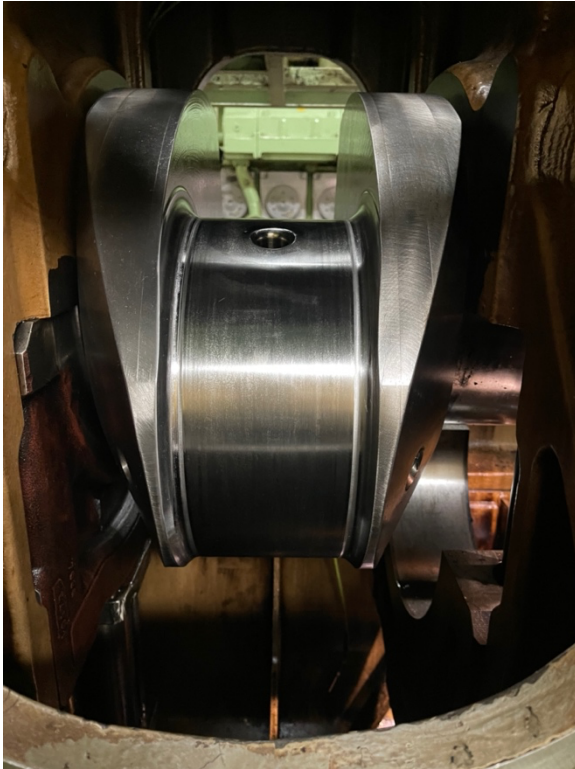
Figure 4: Machine polished surface prior to final surface contact checks

After removal of the (0.5mm) from the five crankpins, all crankpins were machine polished and contact surfaces were verified by use of a bluing dummy. Final surface finish showed roughness values of between 0.27 and 0.30 Ra.

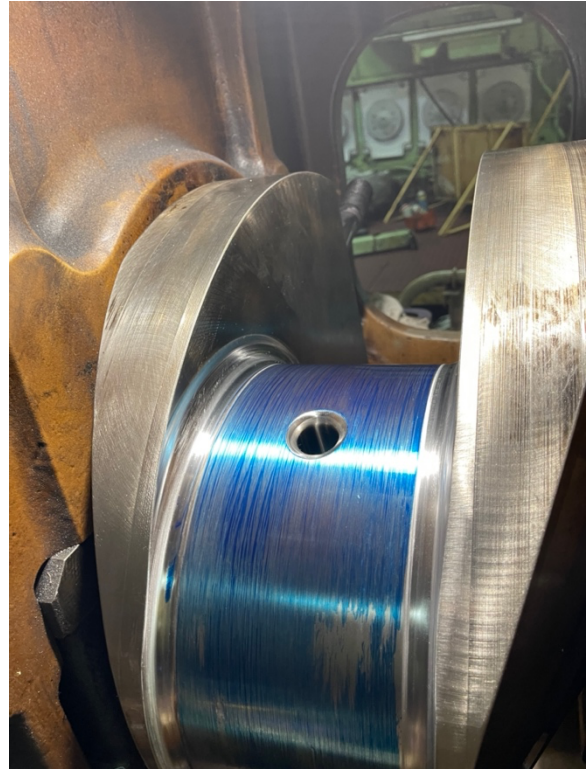
Figure 5: Blue fitting of crankpin journal surface to verify proper contact

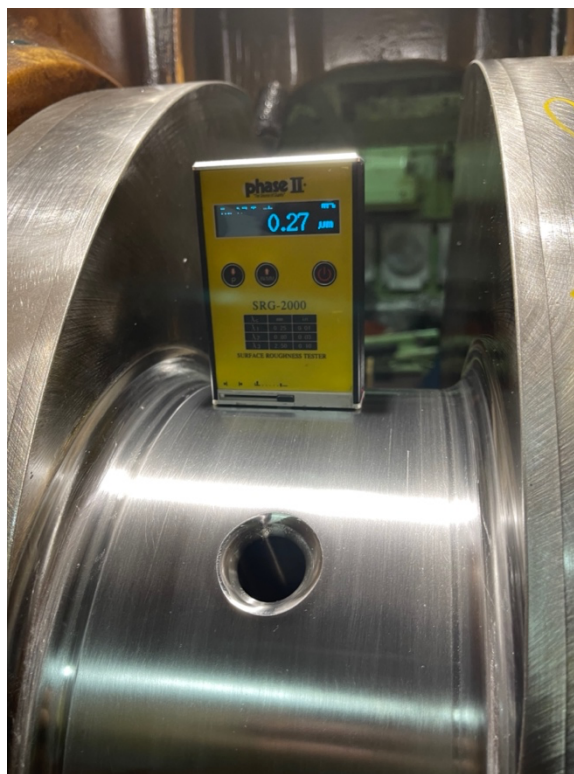
Figure 6: Final check of surface roughness on crankpin journal found within limits
