IN-SITU CRANKPIN GRINDING - PAKISTAN POWER STATION SULZER 16ZA40S CRANKSHAFT

Goltens received an inquiry from the management company of a power station in Pakistan to complete a 50,000-hour inspection of their Sulzer 16ZA40S Diesel Generator.

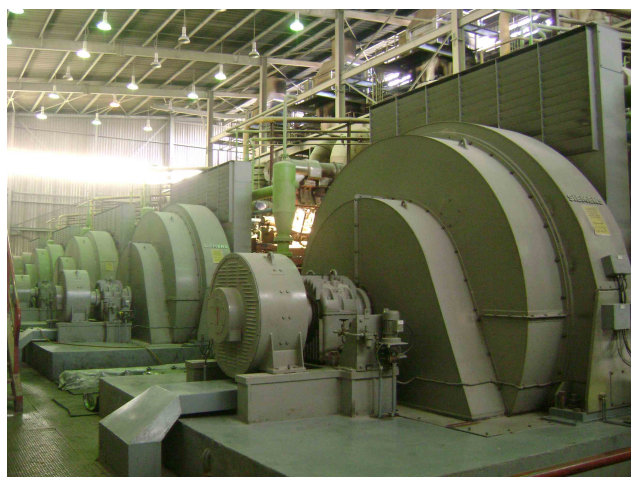
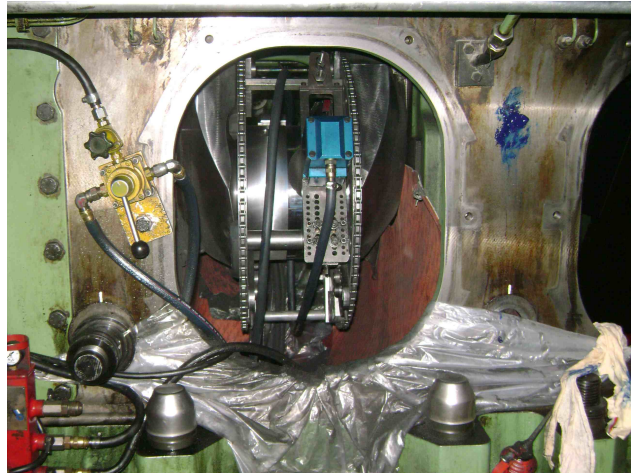
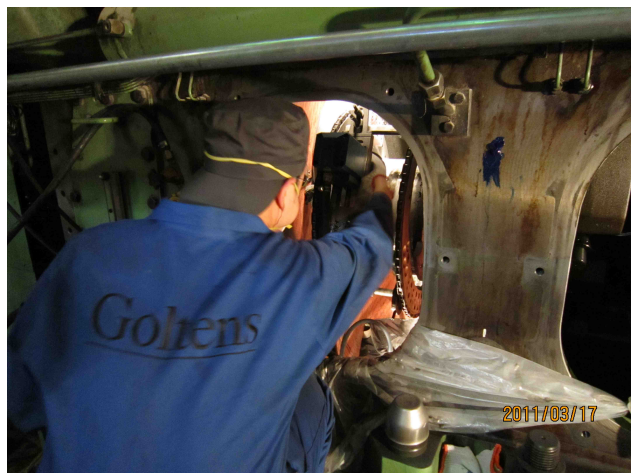
During the inspection, Goltens' specialists opened the main journal bearings and crankpin bearings and found that the No.1 crankpin journal and fillet radius of generator No.3 were damaged and required repair.

- Full cleaning and Magnetic Particle Inspection (MPI) of all 8 crankpin journals
- Full cleaning and MPI inspection of 9 main journals
- Grinding the fillet radius of crankpin journal A1 & B1
- Grinding of No.1 crankpin journal to undersize 5.00mm (345.00mm)
- Finish polishing of No.1 crankpin journal
- Polishing of No.2-No.8 crankpin journals
- Final Inspection of crankpins

Goltens' In Situ machinists completed the grinding and polishing job within 18 days, restoring the generator to full operation.
