## ENGINE BLOCK REPAIR - METAL STITCHING WARTSILA 18V32LN

### CEMENT PLANT – DOMINICAN REPUBLIC

### WARTSILA 18V32LN ENGINE BLOCK REPAIR

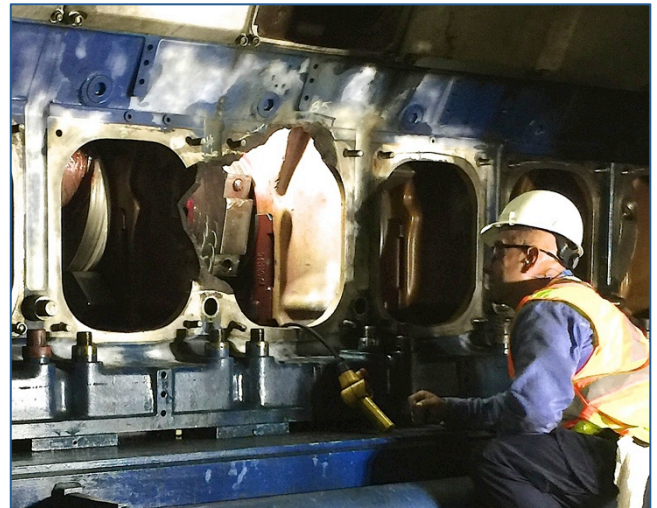
Such was the case for a leading cement producer in the Dominican Republic. During routine operation, one of its Wartsila 18V32LN engines suffered a connecting rod failure resulting in major damage to the engine block and the crankshaft. Collisions with the connecting rod knocked large pieces of the block free between the inspection doors and smaller pieces inside the crankcase. The casualty also resulted in significant damage to the lower liner landing surface and the engine's crankshaft.

Inspection of exterior block damage

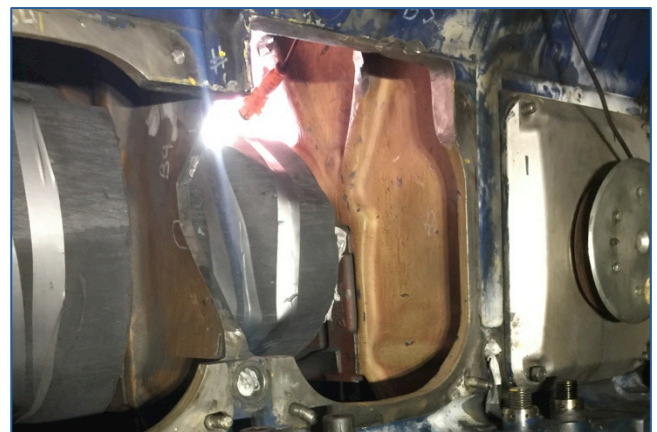
Damaged section cropped from engine block

Goltens performed laser scanning on the damaged areas to facilitate the casting of precise inserts for the block. Goltens cropped the damaged interior and exterior sections of the engine to ensure clean mating surfaces and then measured the areas for the fabrication of cast inserts to be stitched into the block. The inserts were carefully positioned and metal stitched into place using Lock-n-Stitch tooling. With metal stitching complete, Goltens machined the stitched surfaces and performed thorough crack testing to ensure the repairs were successful.

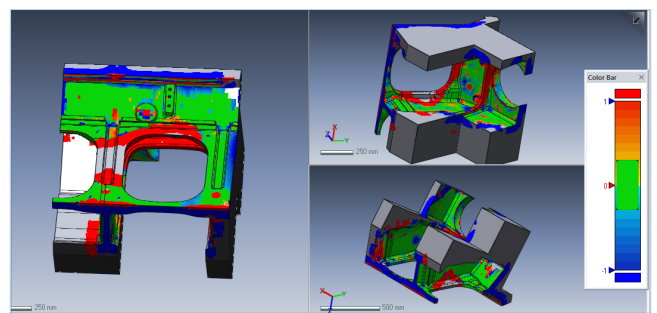
3D Laser scan of the damaged section of the block
