IN-SITU ANNEALING & MACHINING RESTORES DOMINICAN POWERPLANT TO SERVICE

WARTSILA 18V46 CRANKPIN CASUALTY

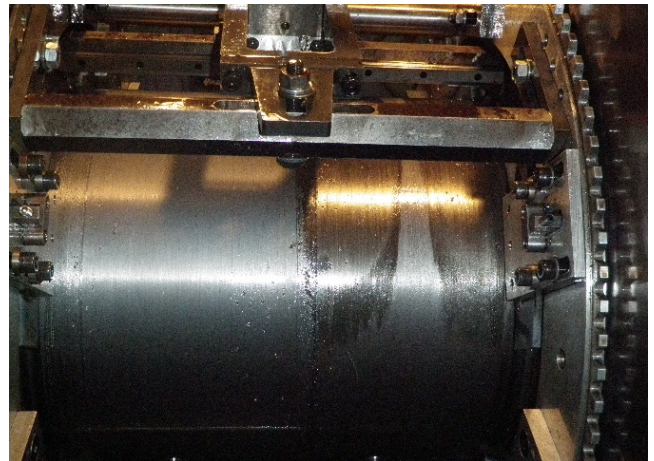
Inspection of the damage revealed that the crankpin had excessive hardness and surface cracking. Goltens recommended machining the surface of the crankpin to remove bearing material, assess the extent of the cracks and evaluate the extent of the hardness.

High hardness visible on surface at -2.00mm

At -2.0mm, the crankpin surface was cleaned of debris but the surface still had a 7.0mm crack. Local grinding was performed to remove the crack at a depth of 2.6mm. The crankpin was machined to -3.0mm and a mapping of the crankpin hardness was performed. Two large areas of hardness above 600Hb (measuring 270mm x 80mm and 260mm x 20mm) remained and Goltens recommended annealing the crankpin to save the shaft with the least amount of material removed from the crankpin.

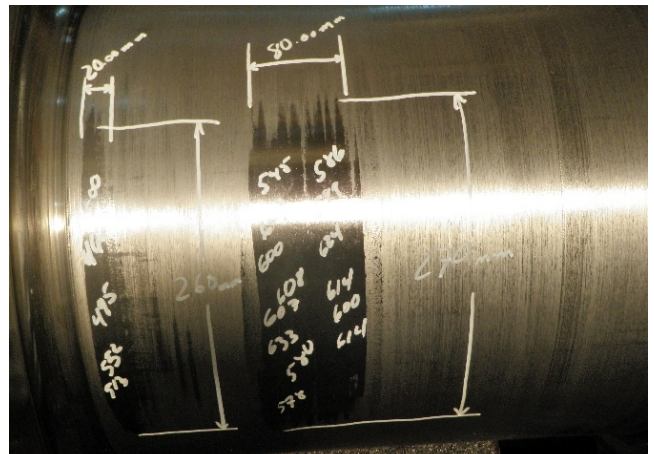
2 hard spots mapped at -3.00mm (>600Hb)

Goltens mobilized its in-situ annealing equipment to the plant and undertook its well proven, marine class approved annealing process on the crankpin.

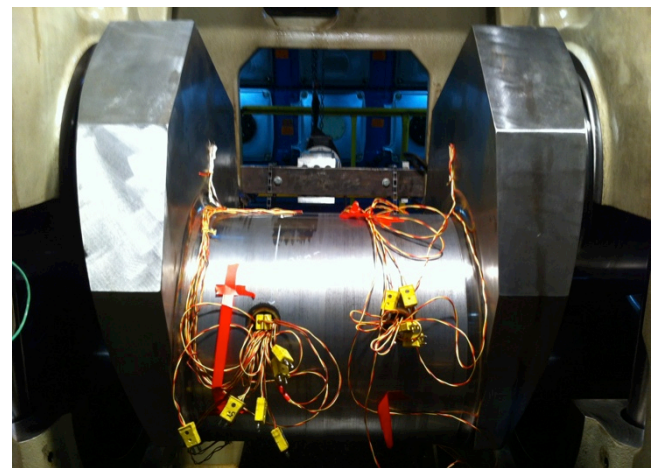
Thermocouples installed for annealing

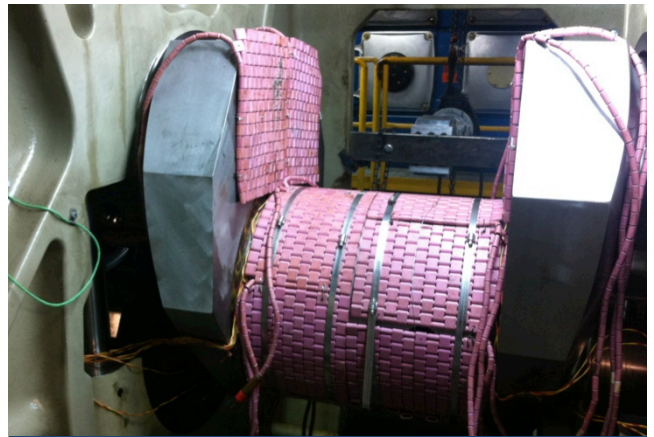
Annealing equipment installed on crankpin #7

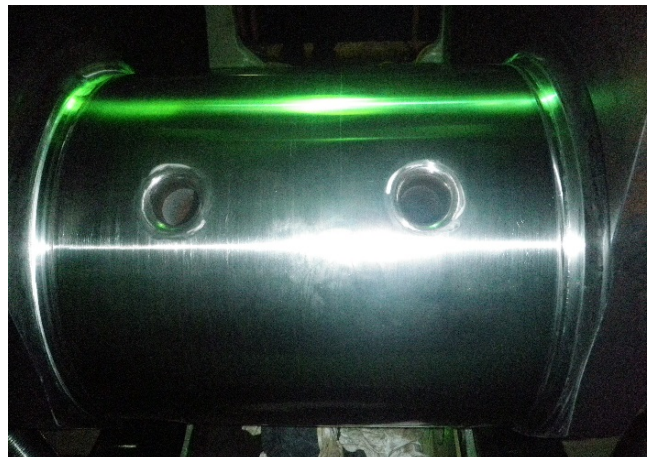
Post-annealing finished crankpin surface

Crankpin #7 was finished at -4.00mm per the instructions of the customer. With the concurrence of the engine maker, a small dimple was left in the surface of the crankpin where the local grinding had been performed to further limit the diameter loss on the shaft.

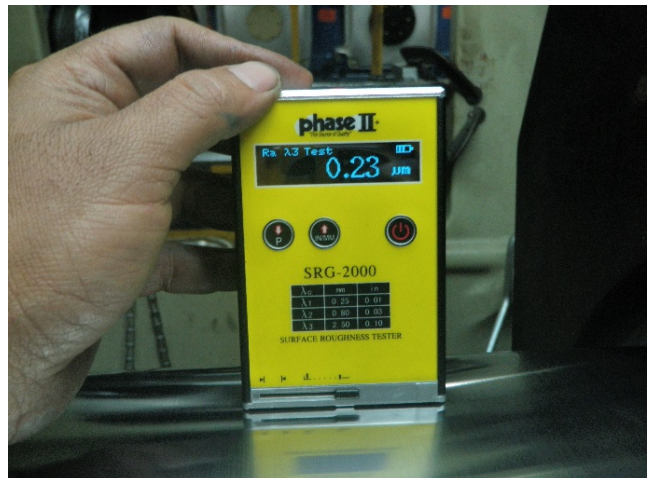
Final surface roughness 0.23Ra
