## IN-PLACE MACHINING AND MAJOR MAINTENANCE SERVICE-WARTSILA 18V50DF

### IN-SITU ANNEALING SAVES ANOTHER 18V50DF CRANKSHAFT FOR TRINIDAD POWERPLANT

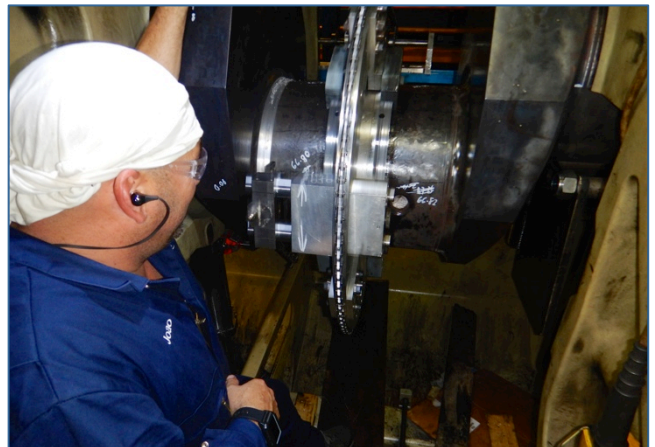
Machining new fillet radii after annealing

After the tender was awarded, Goltens in-place machinists first machined the crankpin to  $-4.5\text{mm}$  to remove all surface cracks leaving a hard spot  $250\text{mm} \times 120\text{mm}$ . Goltens then performed the annealing process and reduced the crankshaft hardness from 568HB to a maximum of 300HB. A new radius was then cut for the final undersize of  $-6.0\text{mm}$  and final machining and polishing was completed with a surface finish of  $0.4\text{Ra}$ .

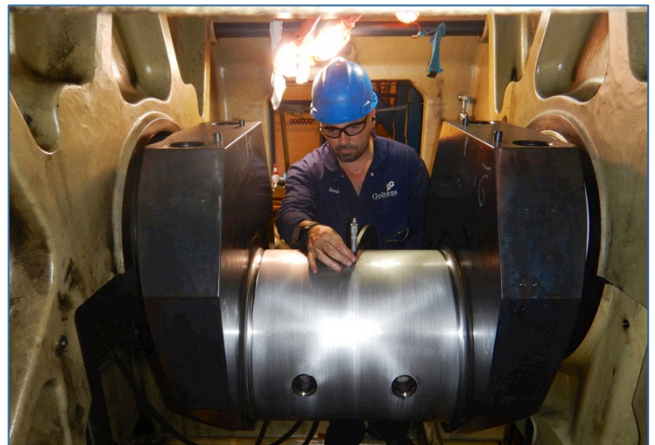
Calibration check after in-place machining

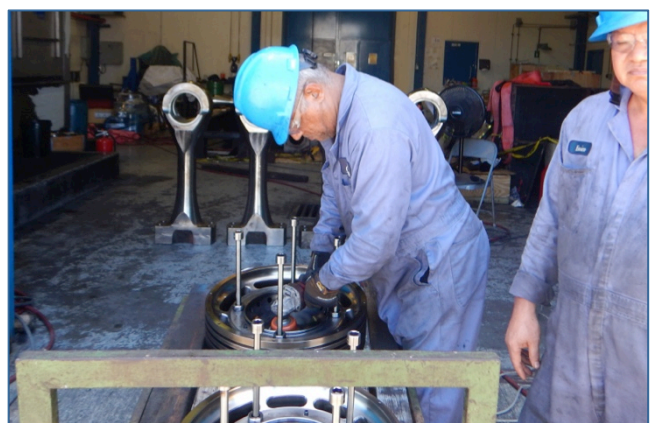
Calibration and overhaul of pistons

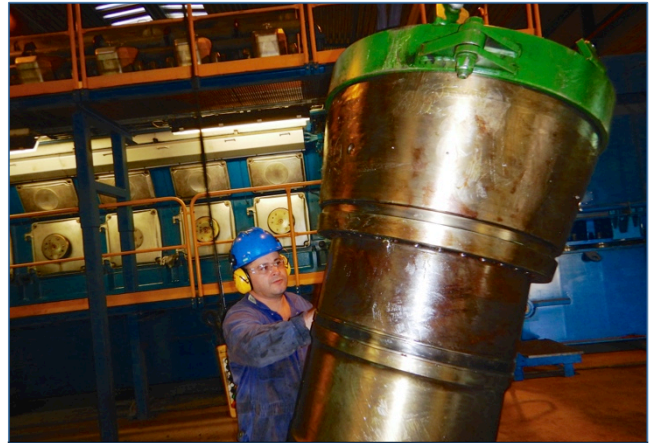
Rigging of honed liner into position

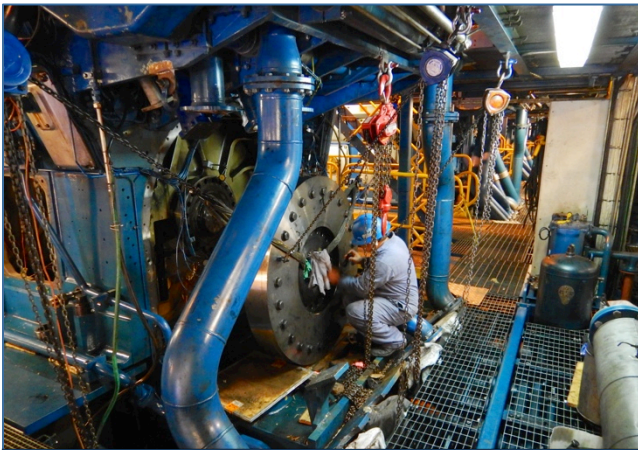
Removal of Vibration Dampener

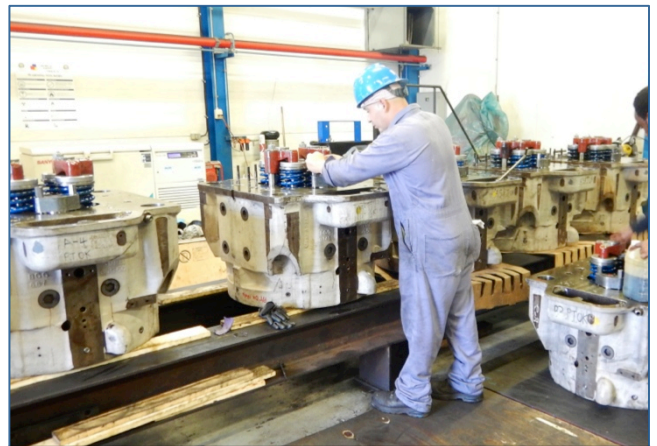
Overhaul of cylinder heads in powerhouse

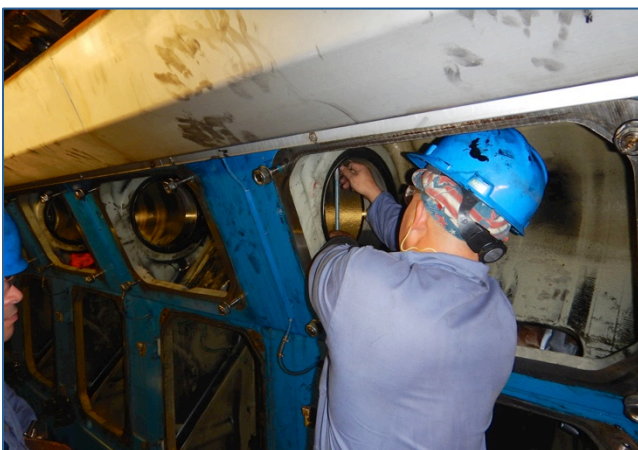
Calibration check on camshaft bores

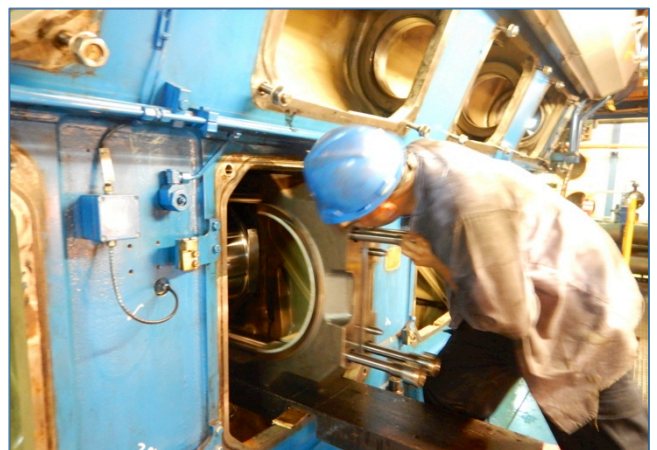
Installation of big end bearing housing
