## TURNING UP THE HEAT IN CAMEROON

### IN-SITU ANNEALING AND MACHINING SAVES WARTSILA 18V50DF GENERATOR CRANKSHAFT FOR KRIBI POWER PLANT

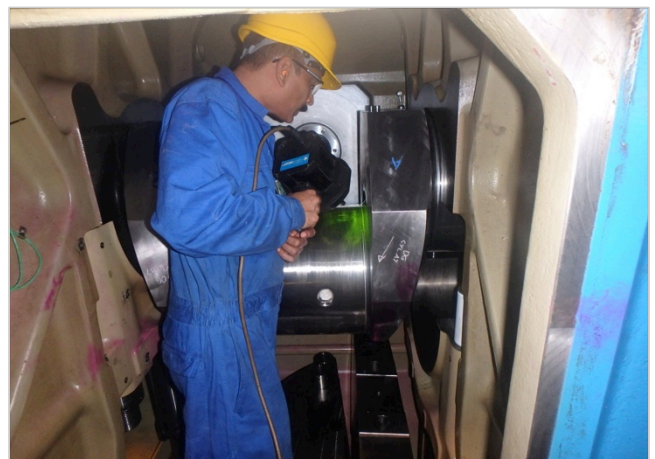
Goltens diesel experts were asked to inspect the damage and determined that the crankshaft could be salvaged within the rated diameter with in-situ machining and annealing. Crankpin journal number 7 (450mm diameter) and main journals number 7 and 8 (450mm diameter) all had damage but the most significant was to crankpin number 7. As in most cases of excessive journal hardness, the engine experienced a bearing failure and a large amount of heat was absorbed into the journal and emergency stopping of the generator introduced uncontrolled cooling which changed the metallurgical characteristics. In this case the hardness was exceptionally high measuring 653 Brinell (HB) and covered a large section at the bottom of the crankpin.

Crack tests performed on Crankpin #7

As the radius of the journal on number 7 had been damaged, Goltens machined a new radius to ensure the running surface for the journal machining was true. The crankpin journal was then pre-machined to -3.50mm to remove all surface cracks prior to annealing.

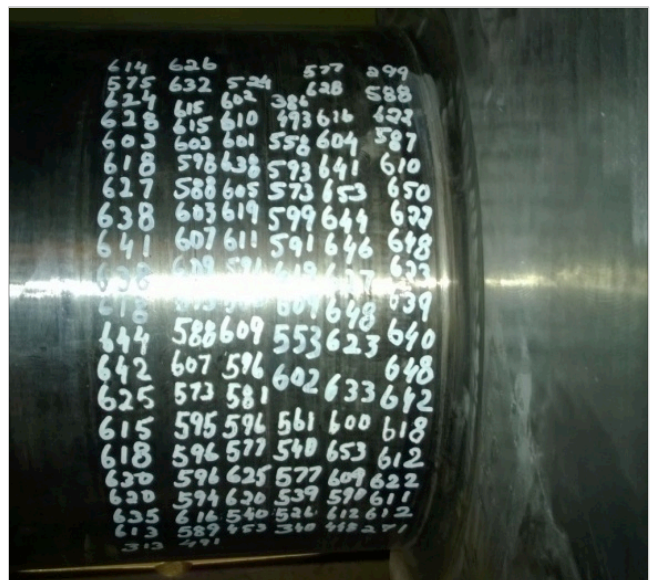
Hardness map showing extent of damage

Once the heating pads, control equipment and insulation had been installed, the computer controlled heating and cooling process was executed to return the hardness to acceptable levels. Once the crankshaft returned to a normal temperature, Goltens measured the hardness and found that it had been successfully returned to a safe operating range around 300 HB.

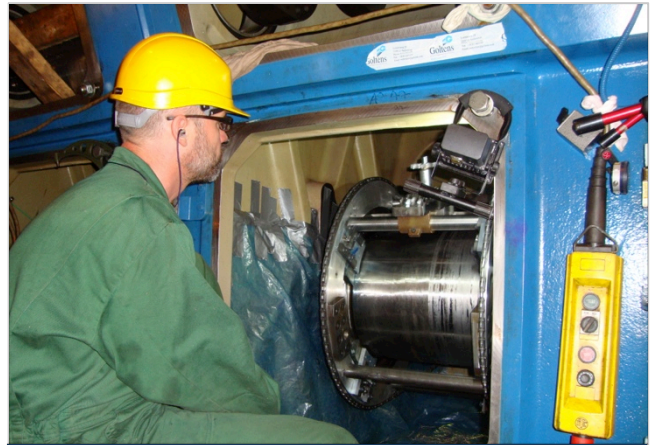
Pre-machining to remove cracks before annealing

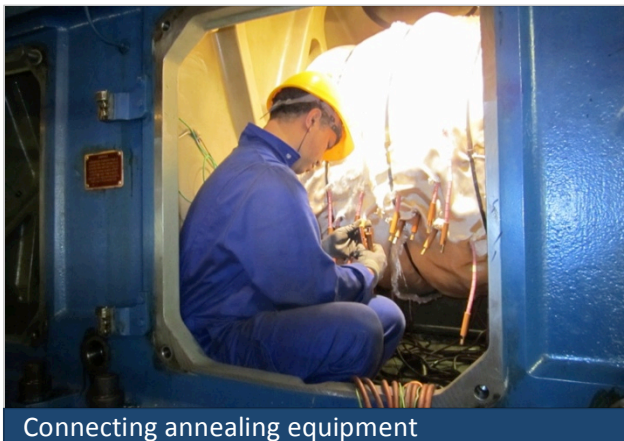
Connecting annealing equipment

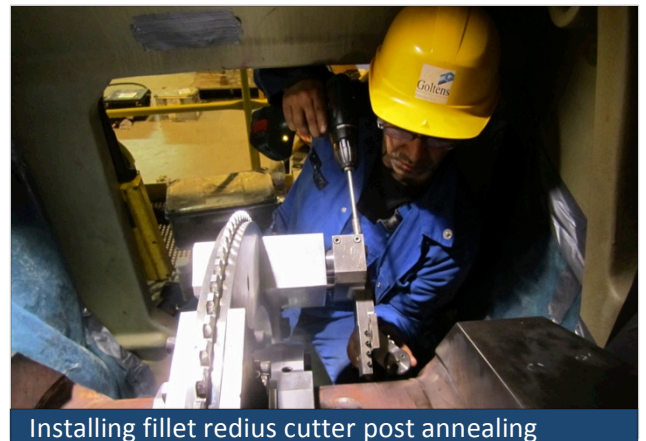
Installing fillet radius cutter post annealing

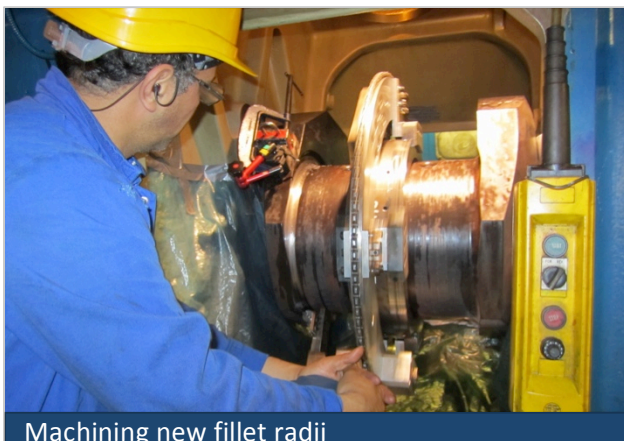
Machining new fillet radii

The in-situ teams then finish machined the radii and machined and super polished the crankpin to  $-5.00\text{mm}$  at  $0.03\text{ Ra}$ . The minor damage to the main journals was rectified by hand polishing.

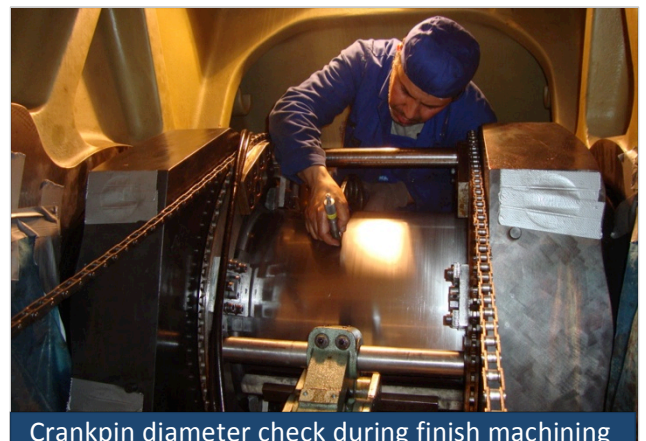
Crankpin diameter check during finish machining

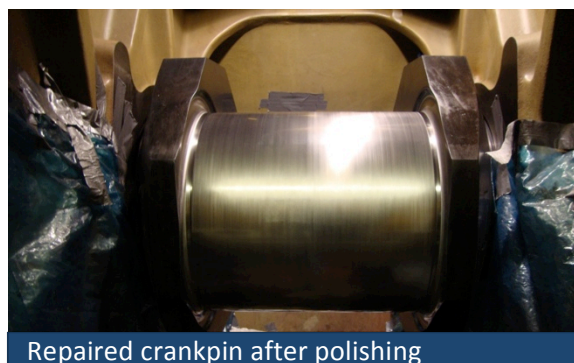
Repaired crankpin after polishing
