IN-SITU ANNEALING AT MEXICAN PAPER MILL WARTSILA W18V32 CRANKSHAFT

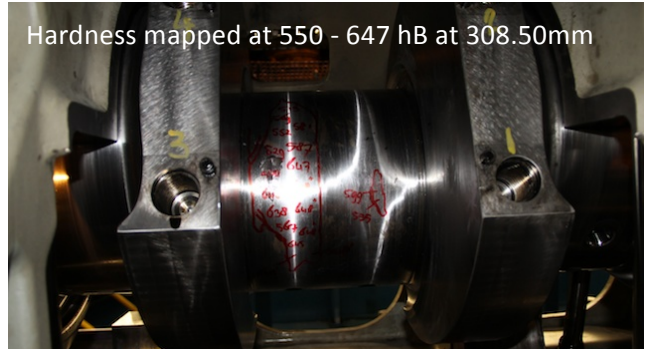
Inspection of the damaged journal revealed hardness values far in excess of the normal hardness for this type of crankshaft with the hardest areas showing hardness values of almost 650HB.

Hardness mapped at 550 - 647 hB at 308.50mm

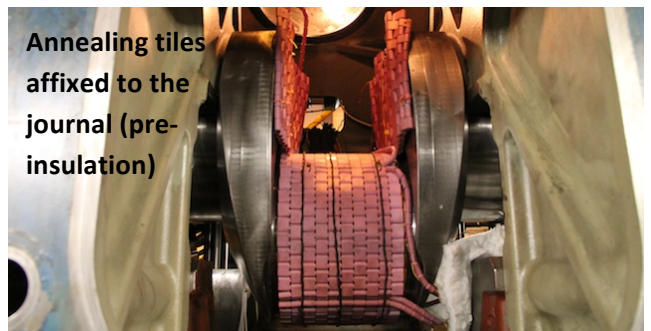
Annealing tiles
affixed to the
journal (pre-
insulation)

- Removed 1.50 mm from crankshaft prior to annealing
- Annealed the damaged crankpin to reduce hardness to acceptable levels.
- Machined new fillet radii
- Removed an additional 1.5mm from crankshaft post annealing to finished size of 307.00mm (-3.0).
- Superpolished crankpin journal to acceptable roughness limits

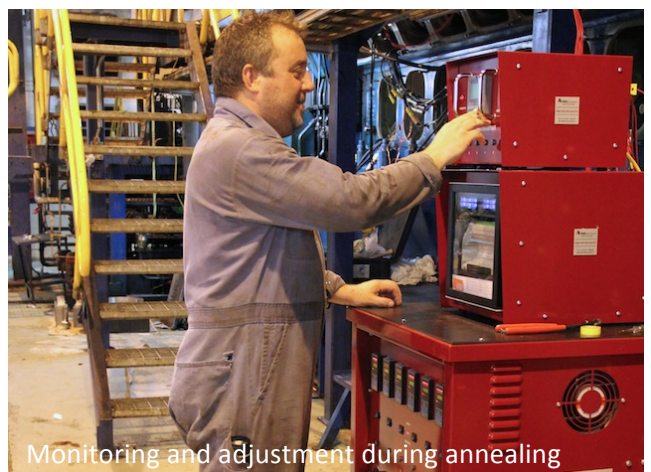
Monitoring and adjustment during annealing

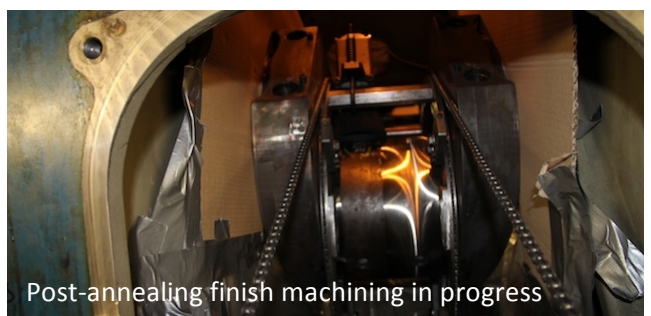
Post-annealing finish machining in progress
