# ENGINE EXPERTISE, CRANKSHAFT MACHINING AND LASER ALIGNMENT RESTORE GAS ENGINE TO SERVICE IN INDONESIA

## ONSITE CRANKSHAFT AND ENGINE BLOCK REPAIR WAUKESHA 12V-AT27GL SERIES

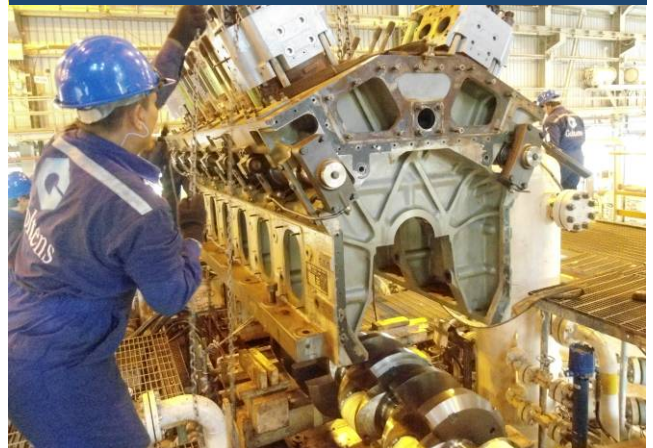
Disassembly of engine for crankshaft removal

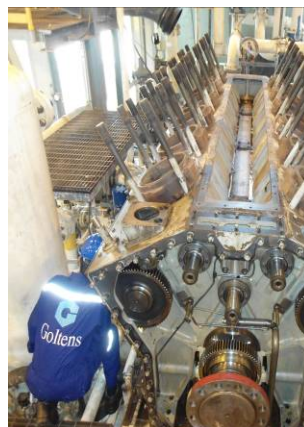
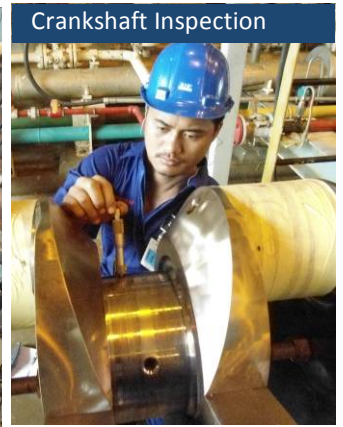
Crankshaft Inspection

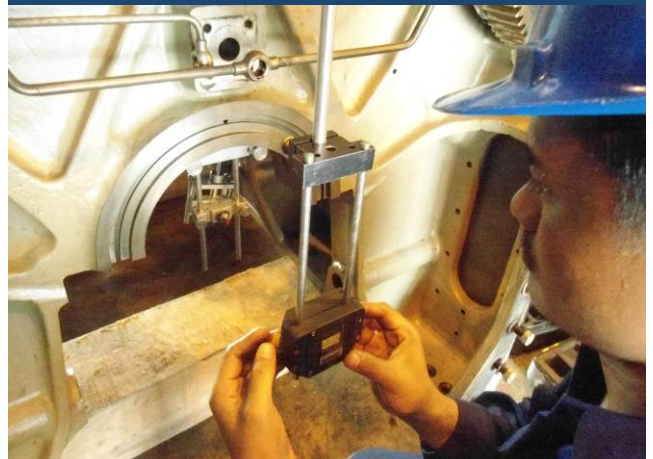
Laser Alignment check of engine bore
