## IN-PLACE XY MILLING RESTORES NICKEL AND COBALT CUTTERS

### FAST RESPONSE AND PRECISION WORK AT KRISTIANSAND, NORWAY METAL REFINERY

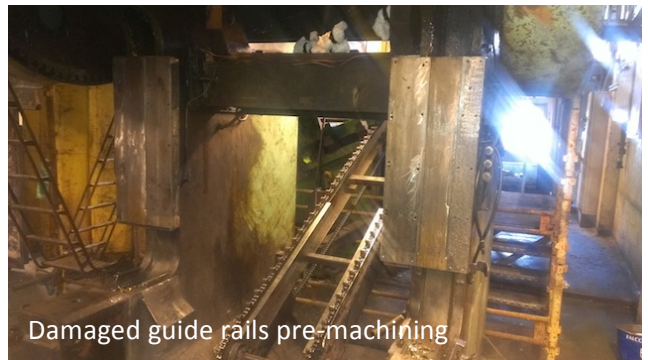
Goltens received an urgent call from a large metal refinery in Kristiansand, Norway that refines Copper, Nickel and Cobalt and precious metals into finished product. The refinery experienced a casualty to the nickel cutter forcing an immediate stop to production. The cause of the casualty was worn guide rails on the nickel cutter and they required an immediate on-site machining response.

Damaged guide rails pre-machining

- XY Milling of 2 nickel cutter guide rails measuring 1,000mm x 150mm, machining about 1.5mm from the surface of the rails
- XY Milling of 2 cobalt cutter guide rails measuring 1,200mm x 200mm, machining about 1.5mm from the surface of the rails

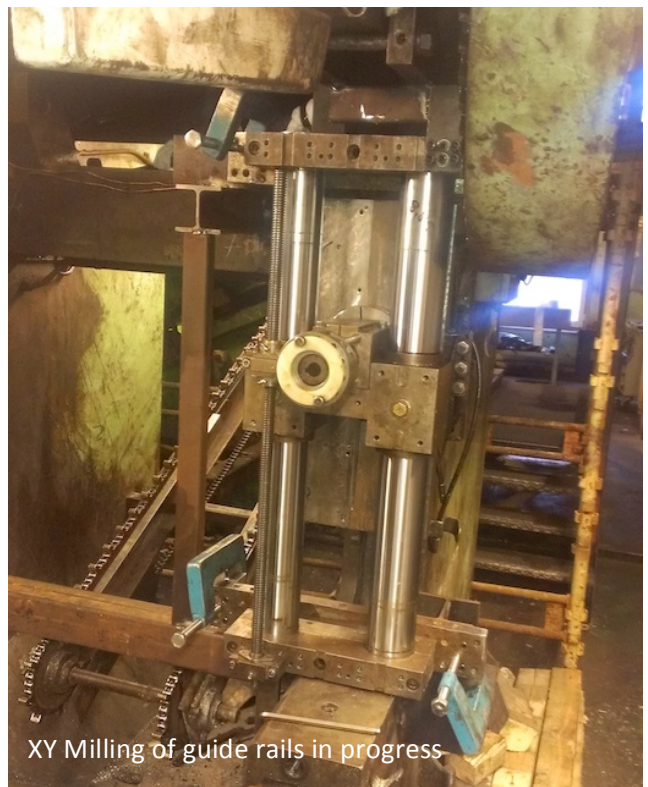
XY Milling of guide rails in progress

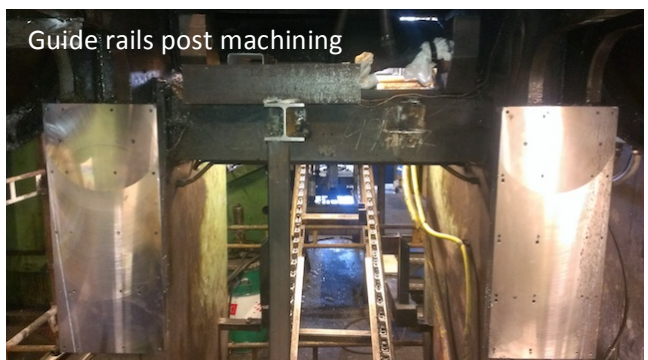
Guide rails post machining

Both jobs were finished in 7 days by a two man in-situ machining team using the X/Y tool. Both metal cutters were restored to operation and production resumed.
